NO.65 (CHARLOTTE HOUSE),  
NOS.67 & 69 AND 71 UPPER  
BOGNOR ROAD, BOGNOR  
REGIS, WEST SUSSEX

HERITAGE STATEMENT  
(including Archaeological Desk Based Assessment)

A report to inform the refurbishment and alteration  
of existing Grade II listed buildings and the  
construction of new buildings within their setting  
and within a designated conservation area

**Document Title:** Heritage Statement – Alterations to Grade II listed building and development within setting of Grade II listed building and within a conservation area

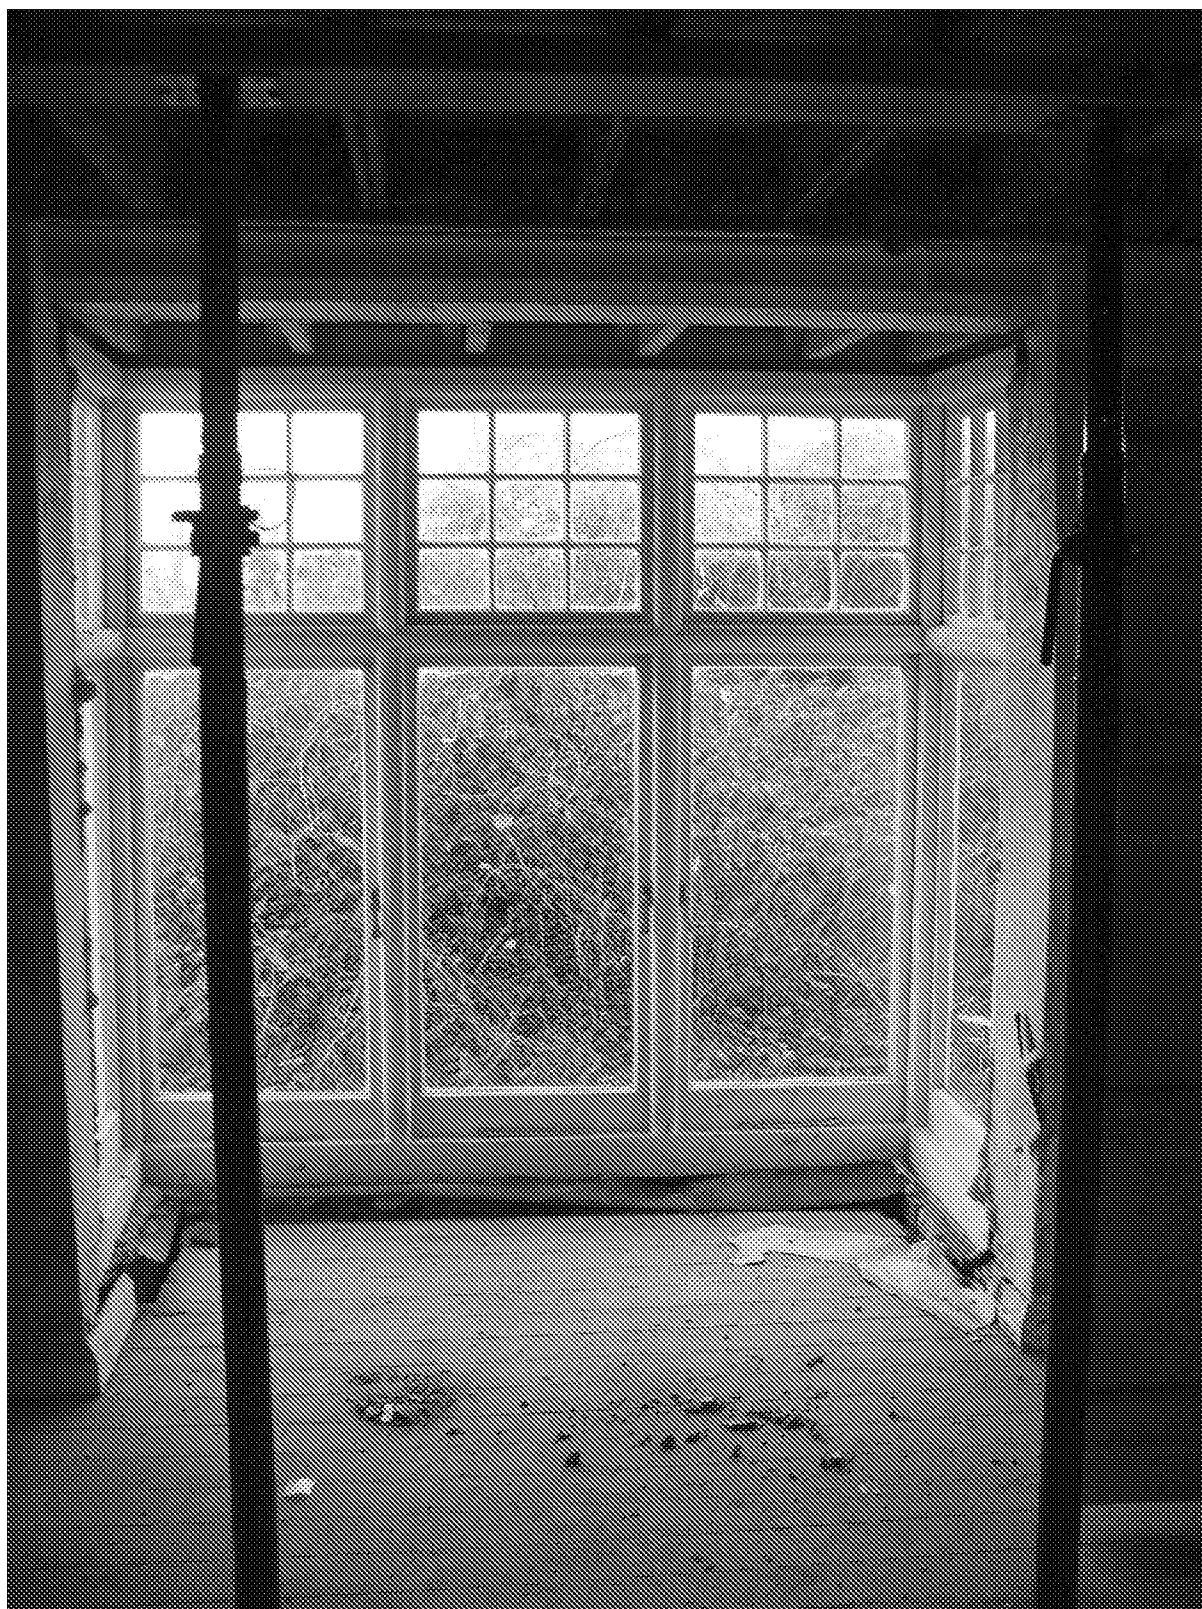
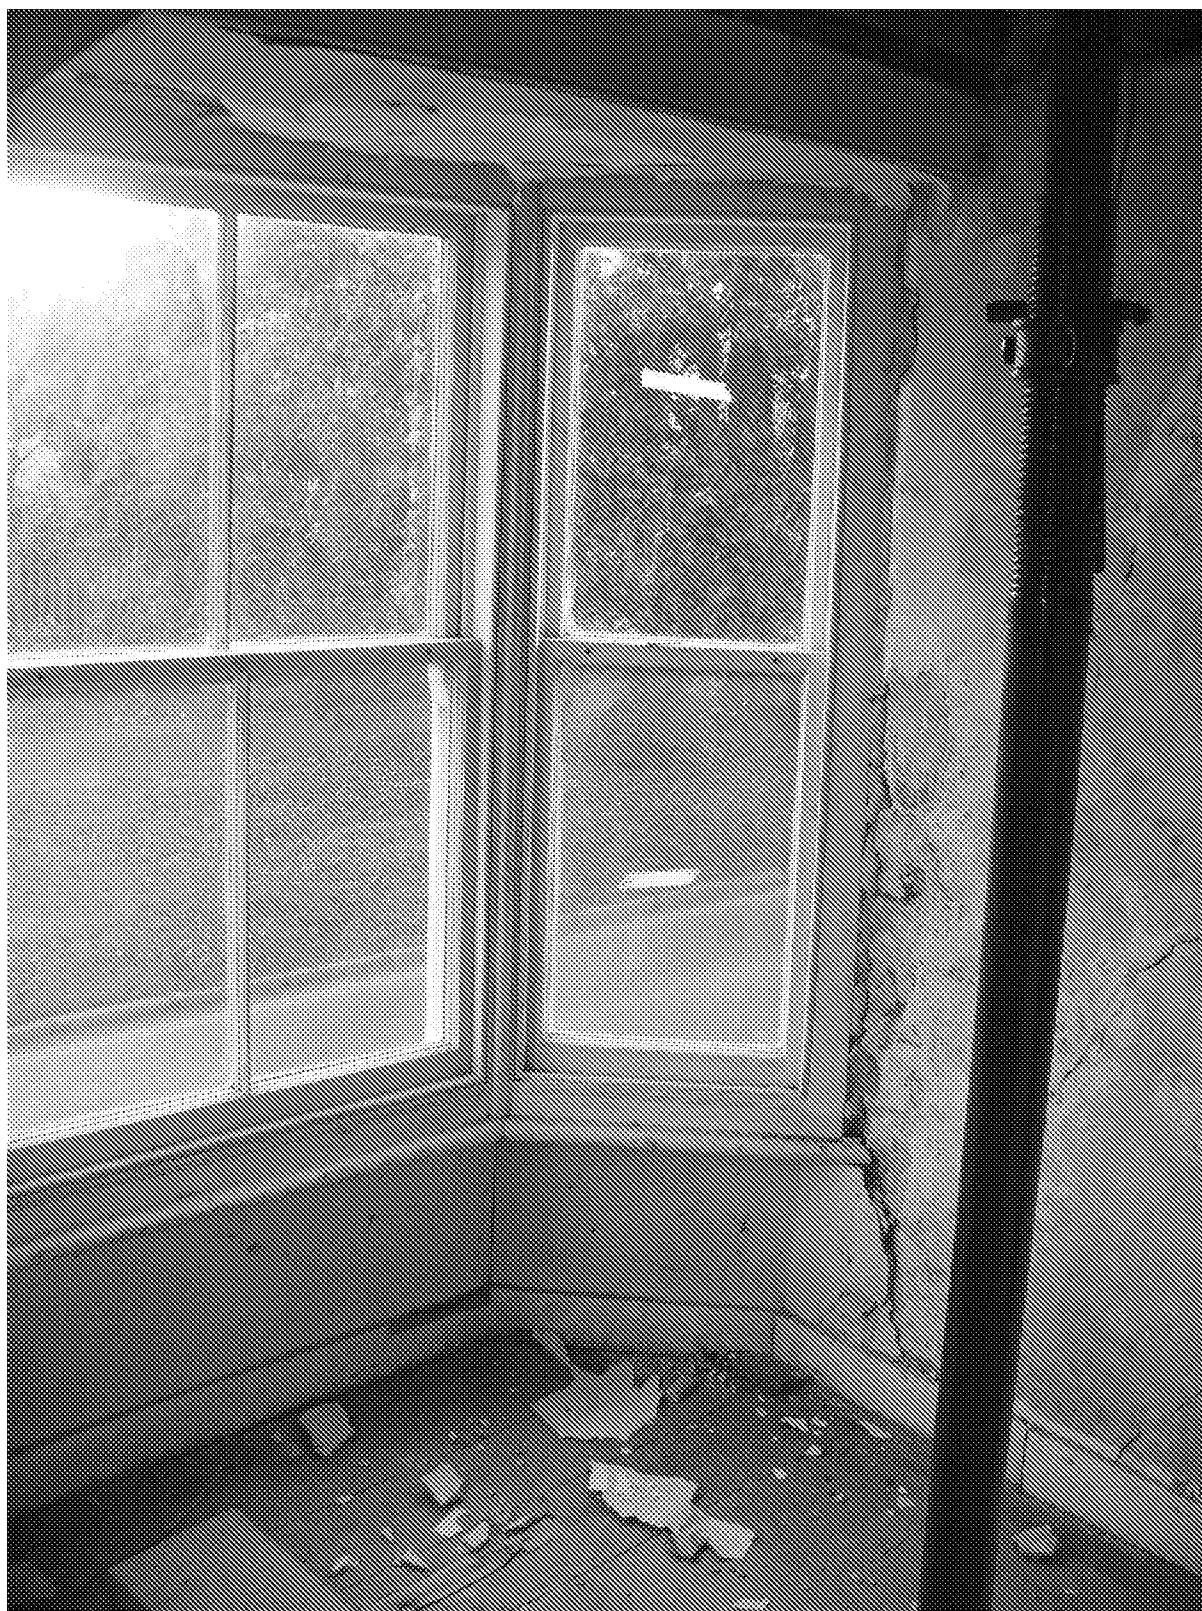
- 3.14 The interiors of both cottages are in a poor state of repair. There is some survival of original lime plaster to walls. Some ceilings survive but will require extensive repair and possible replacement (please also refer to the Structural Survey provided with this application). Roofs have been strengthened and in the case of the rear outshut replaced throughout (c2015).
- 3.15 Staircases are modern. Chimney breasts survive within the houses but have modern fireplaces and surrounds (**Figure 23 Appendix C**). There are simple unmoulded skirtings to some rooms which may be original. Windows are generally modern timber casements (**Figures 24 and 25 Appendix C**) probably replicating original window patterns.

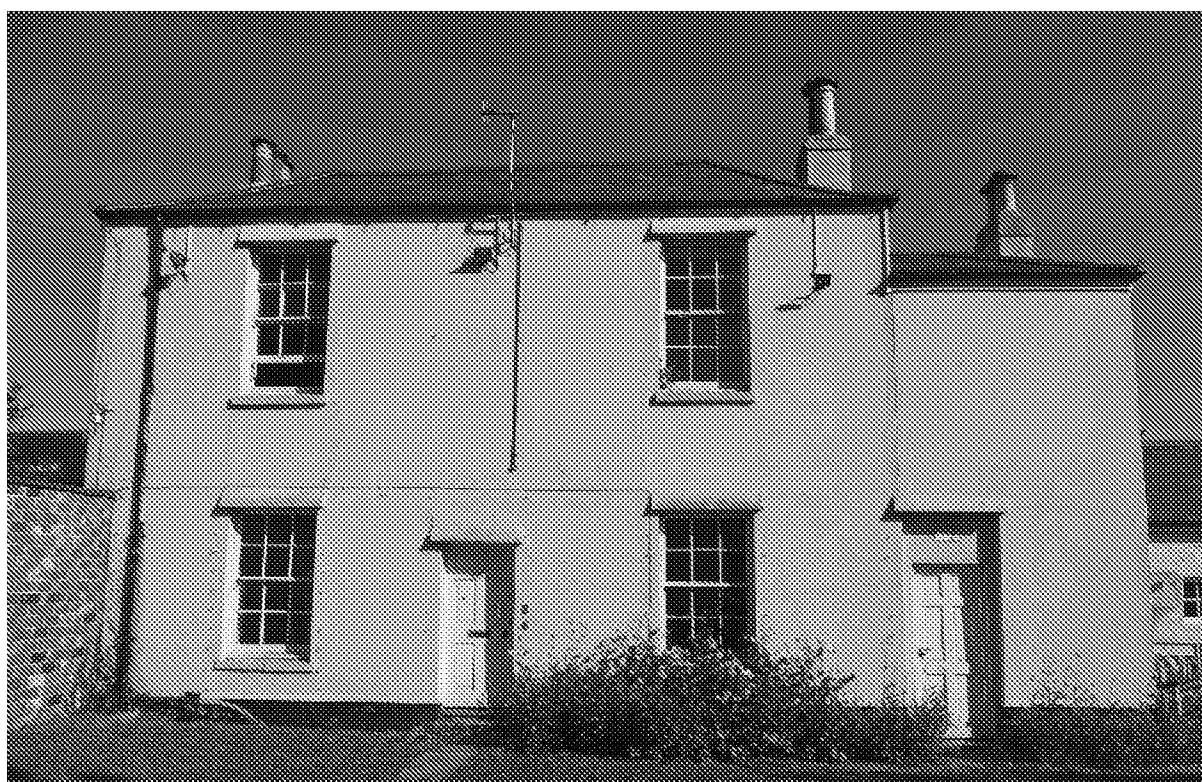
**Figure 27:** No. 71 Upper Bognor Road – south elevation (part)

- 3.17 No.71 is a two-storey detached dwelling constructed circa 1830. There is a lower two storey bay to the east and further single storey brick extension to the east of this. The south elevation (**Figures 27 and 28 Appendix C**) is the principal elevation of the house. It is almost symmetrical set around a central main entrance door. The main entrance door is a modern six panel painted timber door. There is a single two storey bay to the east which has a modern painted timber six panel door to the ground floor. The south façade along with its extended bay is painted stucco render on brick. There are projecting 'bell' moulds over all windows and doors to this elevation which would suggest a relatively late rendering or re-rendering of an earlier façade. The windows are grouped symmetrically around the entrance two to each floor, one either side of the main door. They are painted timber vertical sliding sashes with glazing bars in a six over six configuration. The door appears unusually small when compared with the proportions of the windows which could suggest a major remodelling of an earlier building which was more vernacular in its use and appearance; possibly stabling and/or coach house.

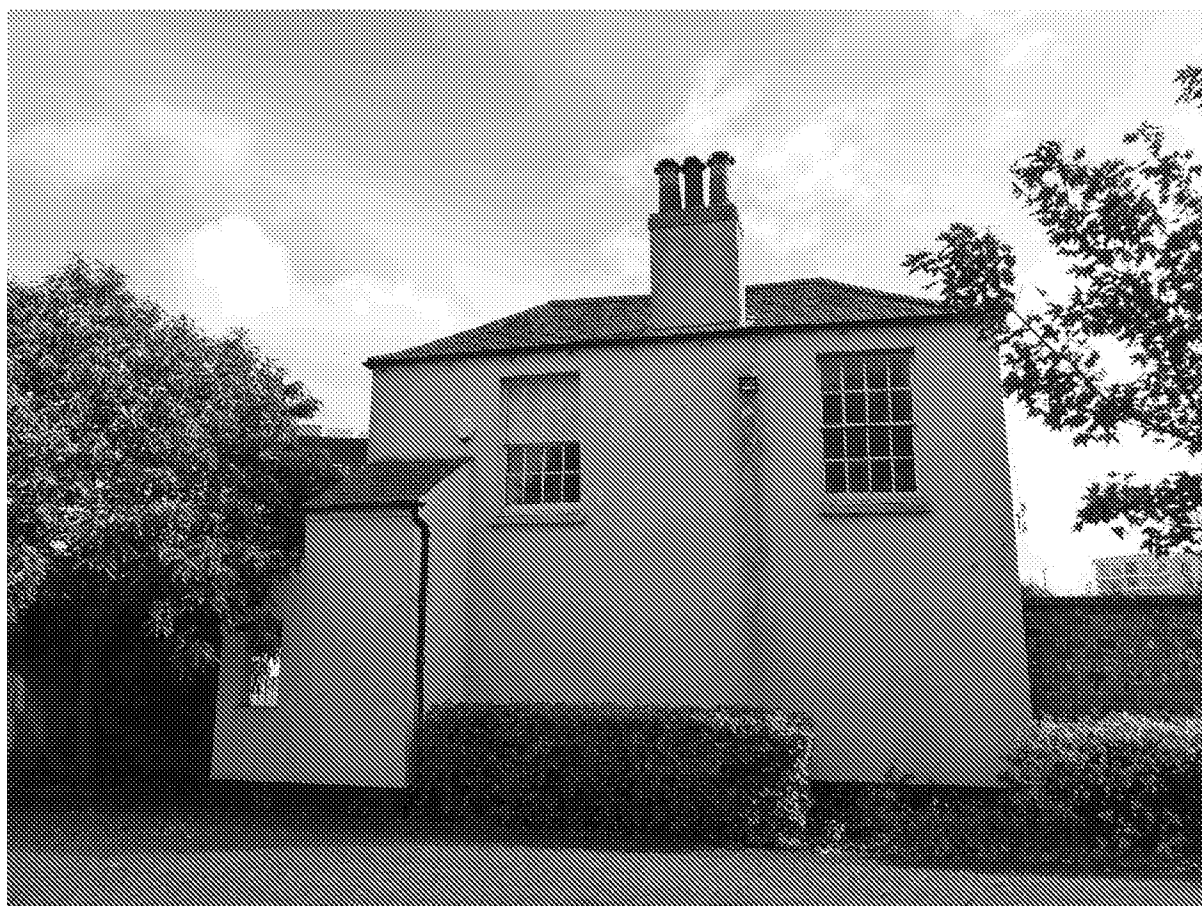
**Figure 29:** No.71 Upper Bognor Road – west elevation

- 3.21 The west elevation (**Figure 29 Appendix C**) is painted render with no windows to the ground floor and two painted timber vertical sliding sashes to first floor. There is the pent roof of the entrance to the (separate) first floor to the north-west corner. There is a centrally placed chimney at eaves level with three clay pots one is plain and two are Fareham pots.

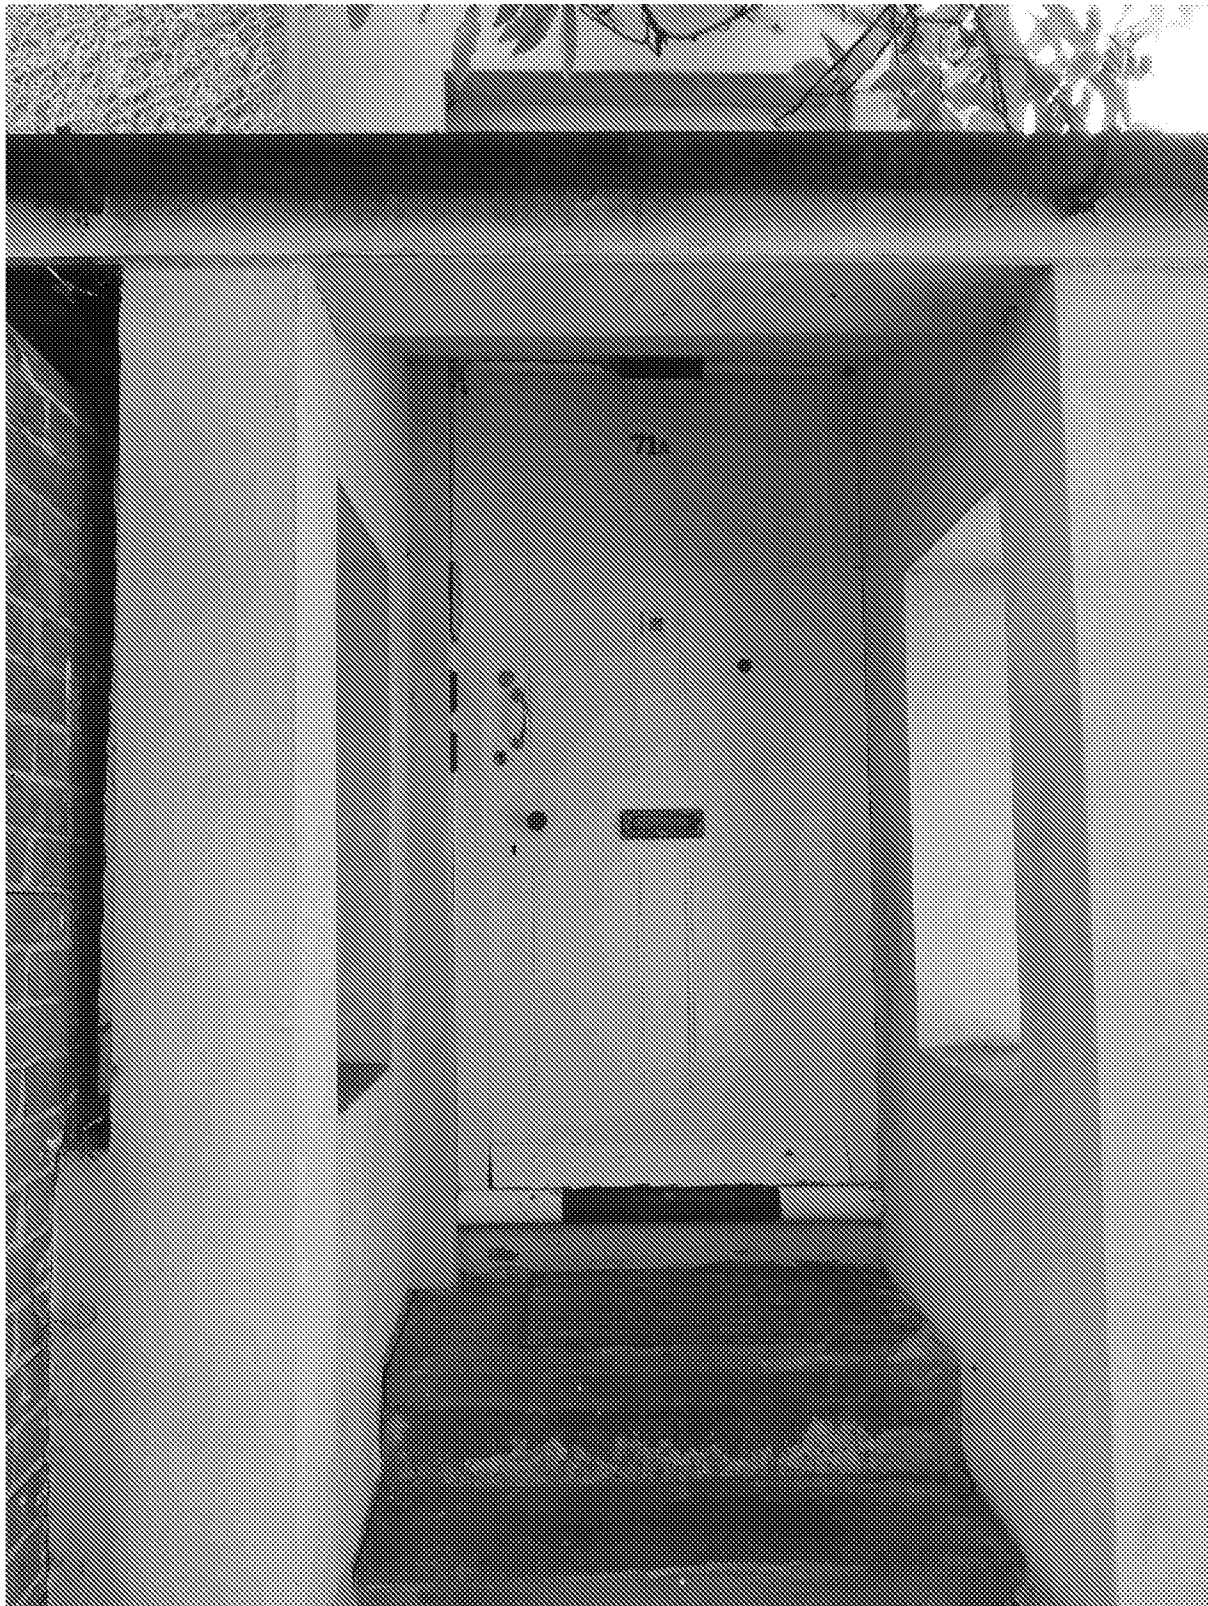
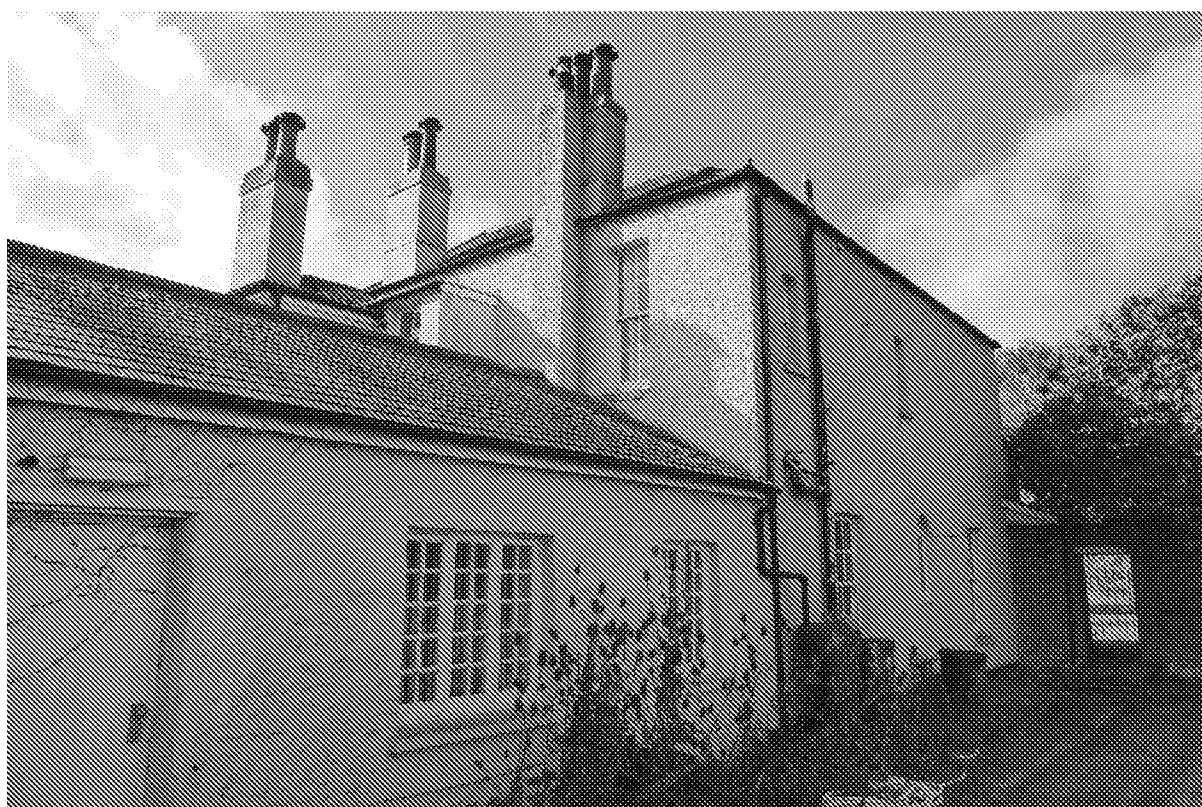
- 3.20 The north (garden) elevation of No.71 (**Figures 30 and 31 Appendix C**) has irregular fenestration (further evidence that this is a much altered building from its original form) with clear evidence for the infilling of a former door with arch to ground floor. The eastern ground floor extension has been built up from the former stone and brick boundary wall. There are two casements to the single storey extension, each with glazing bars one two-light and one three-light. Beyond the rap-trap bond brick boundary wall which runs perpendicular from the north elevation of No.71 there is the stepped entrance to the first floor (now separate). This comprises an open rendered porch with natural slate roof (**Figure 30 Appendix C**). The steps are stone on concrete bases and the door is an early to mid 19<sup>th</sup> century four panel configuration with beaded mouldings.

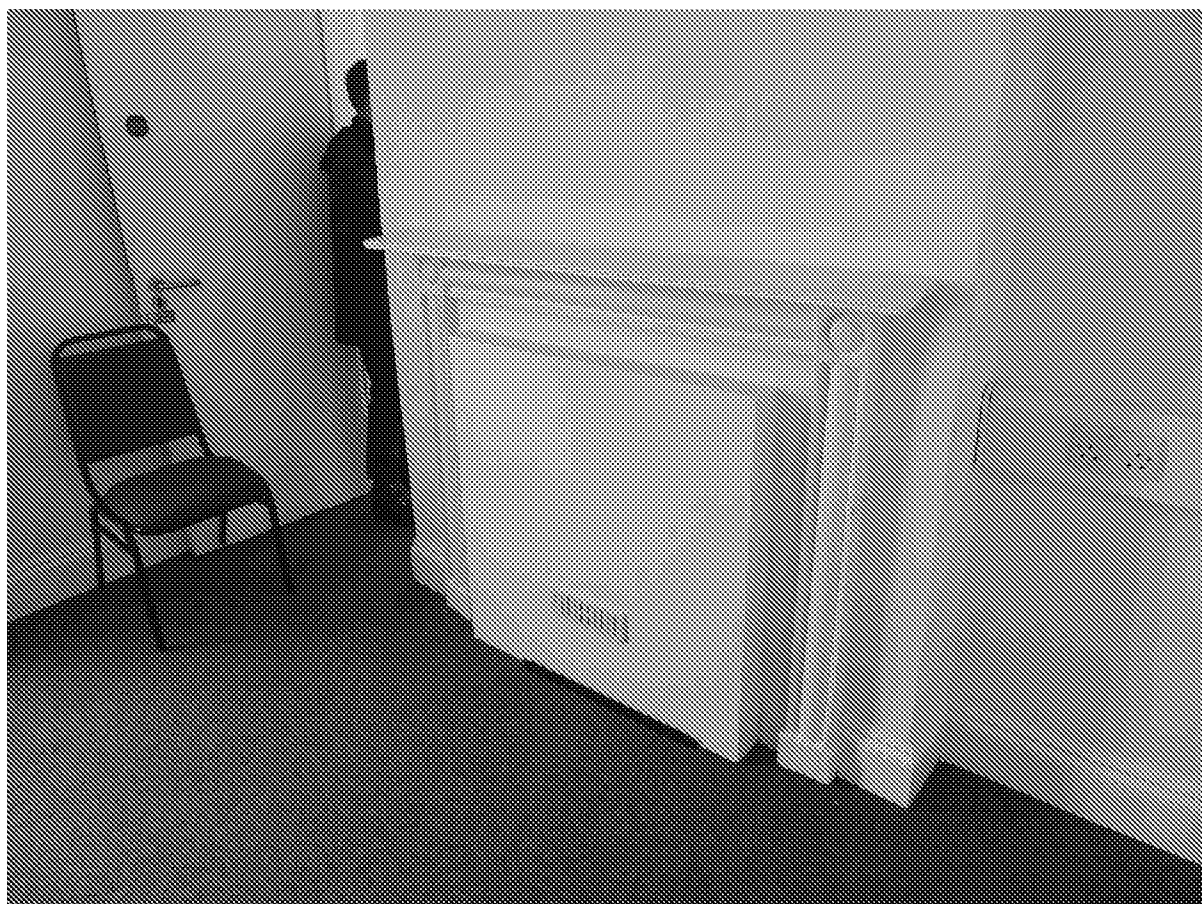
**Figure 33:** Fireplace with chimney piece to ground floor (rear west) No.71 Upper Bognor Road

- 3.24 Internally however, chimney breasts survive throughout the main range and there is one (believed to be ) early 19<sup>th</sup> century chimney piece (**Figure 33 Appendix C**) surviving and a possible survival of a decorative mantel shelf (although this could be a replica chimney piece given the general lack of paint) (**Figure 34 Appendix C**) and one further early 20<sup>th</sup> century cast iron corner fireplace (**Figure 36 Appendix C**) to the extended bay at first floor. Otherwise, most fabric has been replaced.
