NO.65 (CHARLOTTE HOUSE),  
NOS.67 & 69 AND 71 UPPER  
BOGNOR ROAD, BOGNOR  
REGIS, WEST SUSSEX

HERITAGE STATEMENT  
(including Archaeological Desk Based Assessment)

A report to inform the refurbishment and alteration  
of existing Grade II listed buildings and the  
construction of new buildings within their setting  
and within a designated conservation area

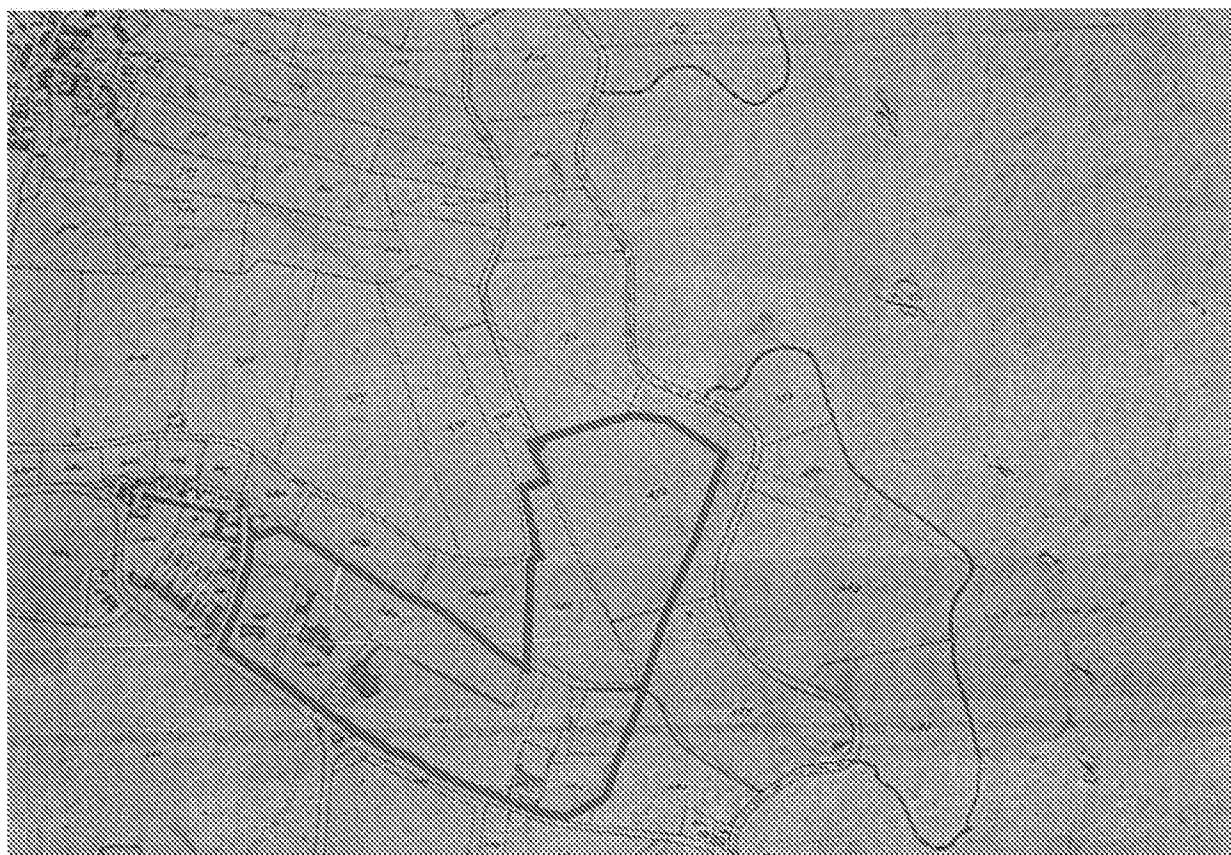
**Figure HM8:** Tithe Map for the Parish of South Bersted, 1842 (WSRO Ref. Par/19/21/2)

- 2.10 The Tithe Map for the Parish of South Bersted (**Figure HM8 Appendix B**), dating from 1842 provides considerable detail on field boundaries and buildings, supplemented by the descriptive particulars of the accompanying Tithe Apportionment. The messuage of 71 Upper Bognor Road appears to extend towards the north up to the watercourse and also appears to be defined by walls at this time. The open land to the east of 71 Upper Bognor Road includes a narrow strip aligned approximately north-south in which there appears a structure of unknown function. To the east of Mordington House the Mordington Cottages and other ancillary buildings are depicted on the frontage with Brewery (Later Mead) Lane. The serpentine (crinkle crankle wall) can be

seen to the rear of the buildings now known as No.71 Upper Bognor Road. There is a long narrow building adjacent to the wall on the west side to the south of the junction of the serpentine wall with the east boundary wall.

- 2.11 The title map appears to show some considerable sub-division of the space later taken up by No.67 and 69 with a number of walls forming a series of enclosures, presumably for livestock. Neither No.65 Charlotte House or Nos.67 and 69 appear on the 1842 title map.

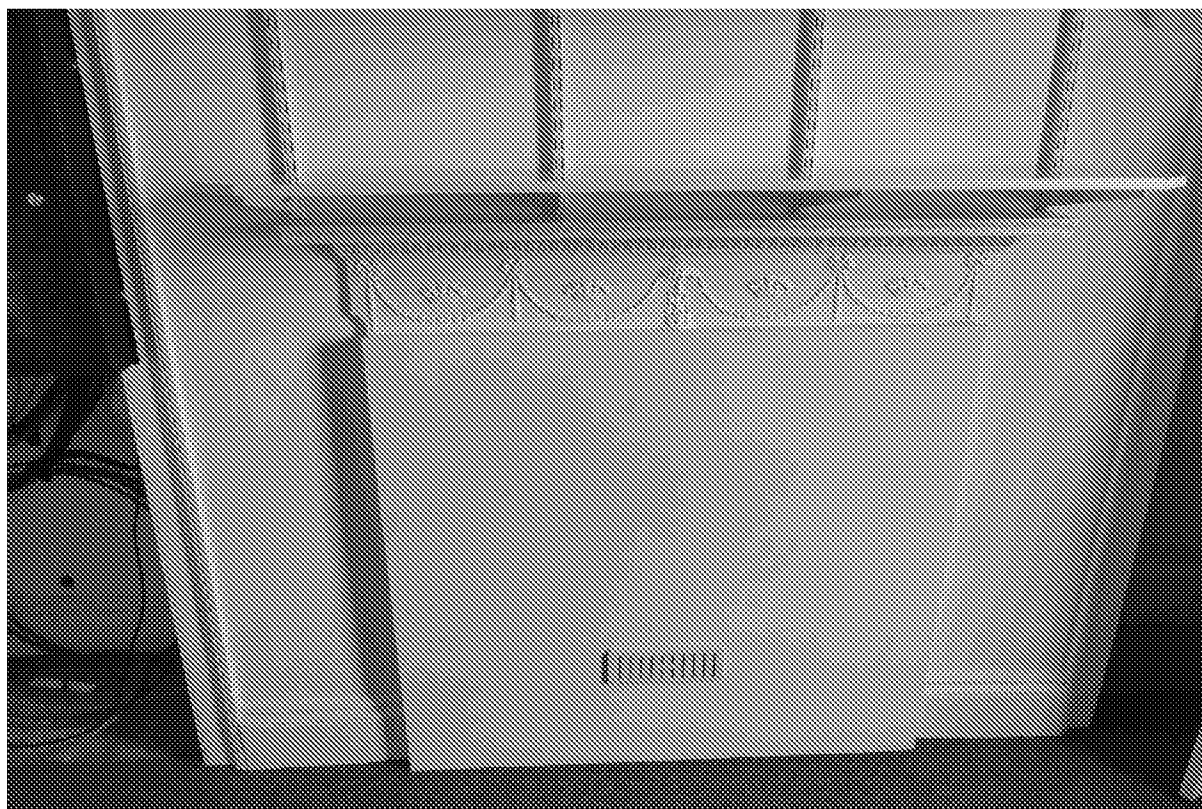
**Figure 33:** Fireplace with chimney piece to ground floor (rear west) No.71 Upper Bognor Road

**Figure 34:** Fireplace with chimney piece to ground floor (rear east) No.71 Upper Bognor Road

- 3.24 Internally however, chimney breasts survive throughout the main range and there is one early 19<sup>th</sup> century chimney piece (**Figure 33 Appendix C**) surviving and a possible survival of a decorative mantel shelf (**Figure 34 Appendix C**) and one further early 20<sup>th</sup> century cast iron corner fireplace (**Figure 36 Appendix C**) to the extended bay at first floor. Otherwise, most fabric has been replaced.
