NO.65 (CHARLOTTE HOUSE),  
NOS.67 & 69 AND 71 UPPER  
BOGNOR ROAD, BOGNOR  
REGIS, WEST SUSSEX

HERITAGE STATEMENT  
(including Archaeological Desk Based Assessment)

A report to inform the refurbishment and alteration  
of existing Grade II listed buildings and the  
construction of new buildings within their setting  
and within a designated conservation area

December 2019

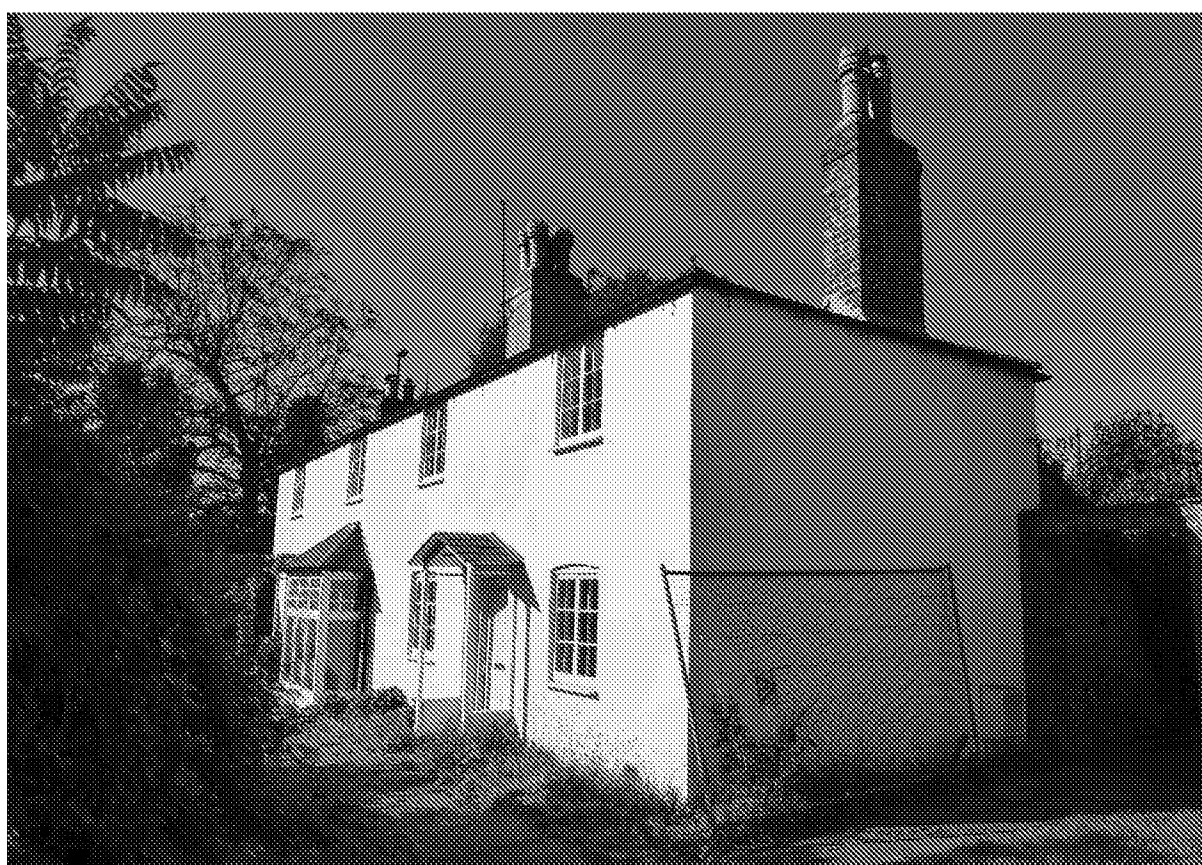
**Figure 18:** Nos.67 and 69 Upper Bognor Road – east and north elevations

- 3.9 Nos.67 and 69 Upper Bognor Road a semi-detached pair of mid-19<sup>th</sup> century cottages (**Figure 18 Appendix C**). They are listed at Grade II. No.67 is particularly prominent in the street scene with a projecting oriel canted bay window to the street and stuccoed walls interrupting the galletted rubble stone and brick wall fronting Upper Bognor Road and running up to the edge of the undeveloped section of the site to the east and along to the secondary entrance to the site adjacent to No. 65 Upper Bognor Road.

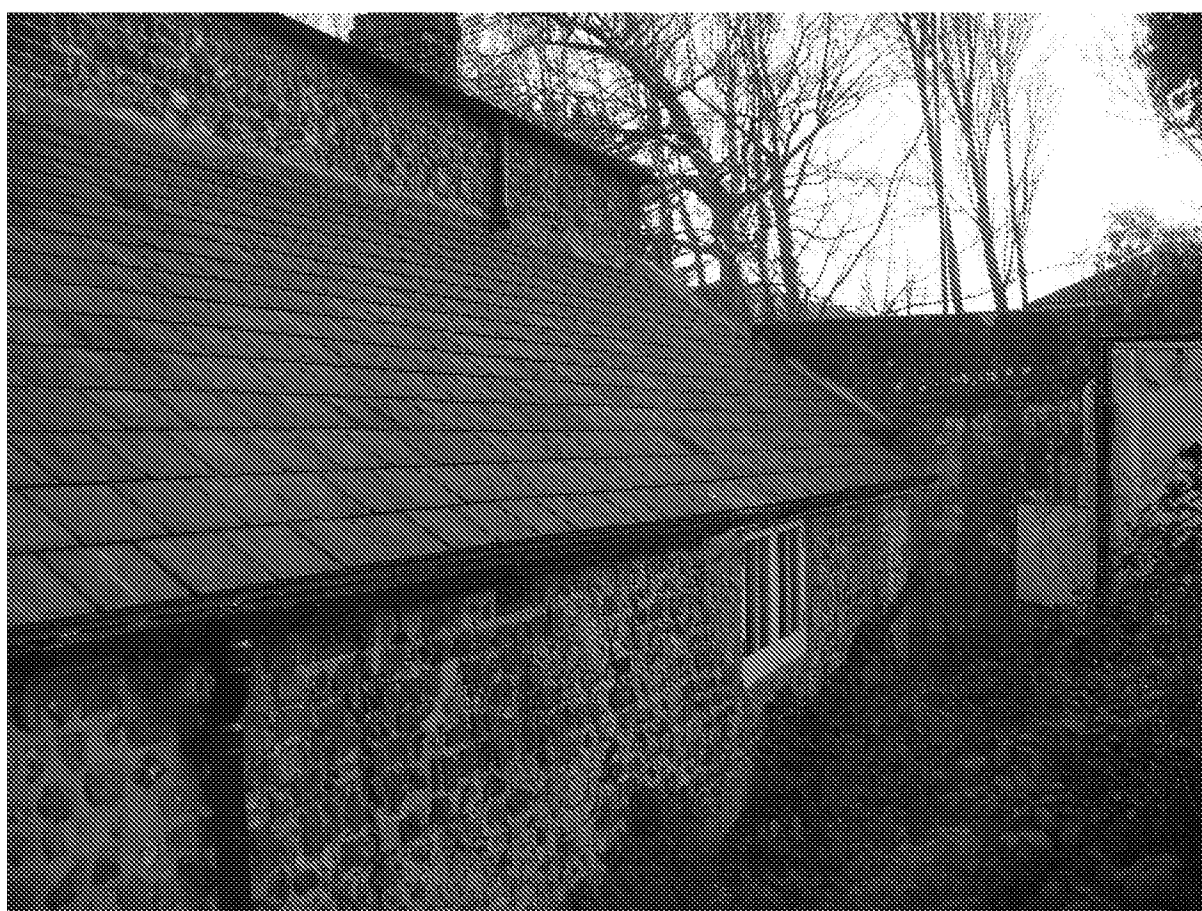
**Figure 20:** Part of rear elevation - outshut to Nos.67 and 69 Upper Bognor Road

- 3.10 The pair of cottages, formerly known as Anne's Cottages have principal façades facing east. These comprise painted stucco over brick. The north elevation is also stucco on brick (**Figure 19 Appendix C**). The south elevation (to No.67) is brick built (at first floor) onto a continuation of the stone with brick dressings wall which continues to the west and east of the south façade (forming the boundary walls to enclosed gardens). This south elevation (**Figure 22 Appendix C**) appears to have been built up from the wall. The roof is a shallow hipped pitched natural slate with a continuous single storey lean-to rear extension with pent roof. The rear elevation is exposed brick. The brick is a random bond with some stone components and was probably intended to be rendered (or has lost its render) (**Figure 20 Appendix C**).

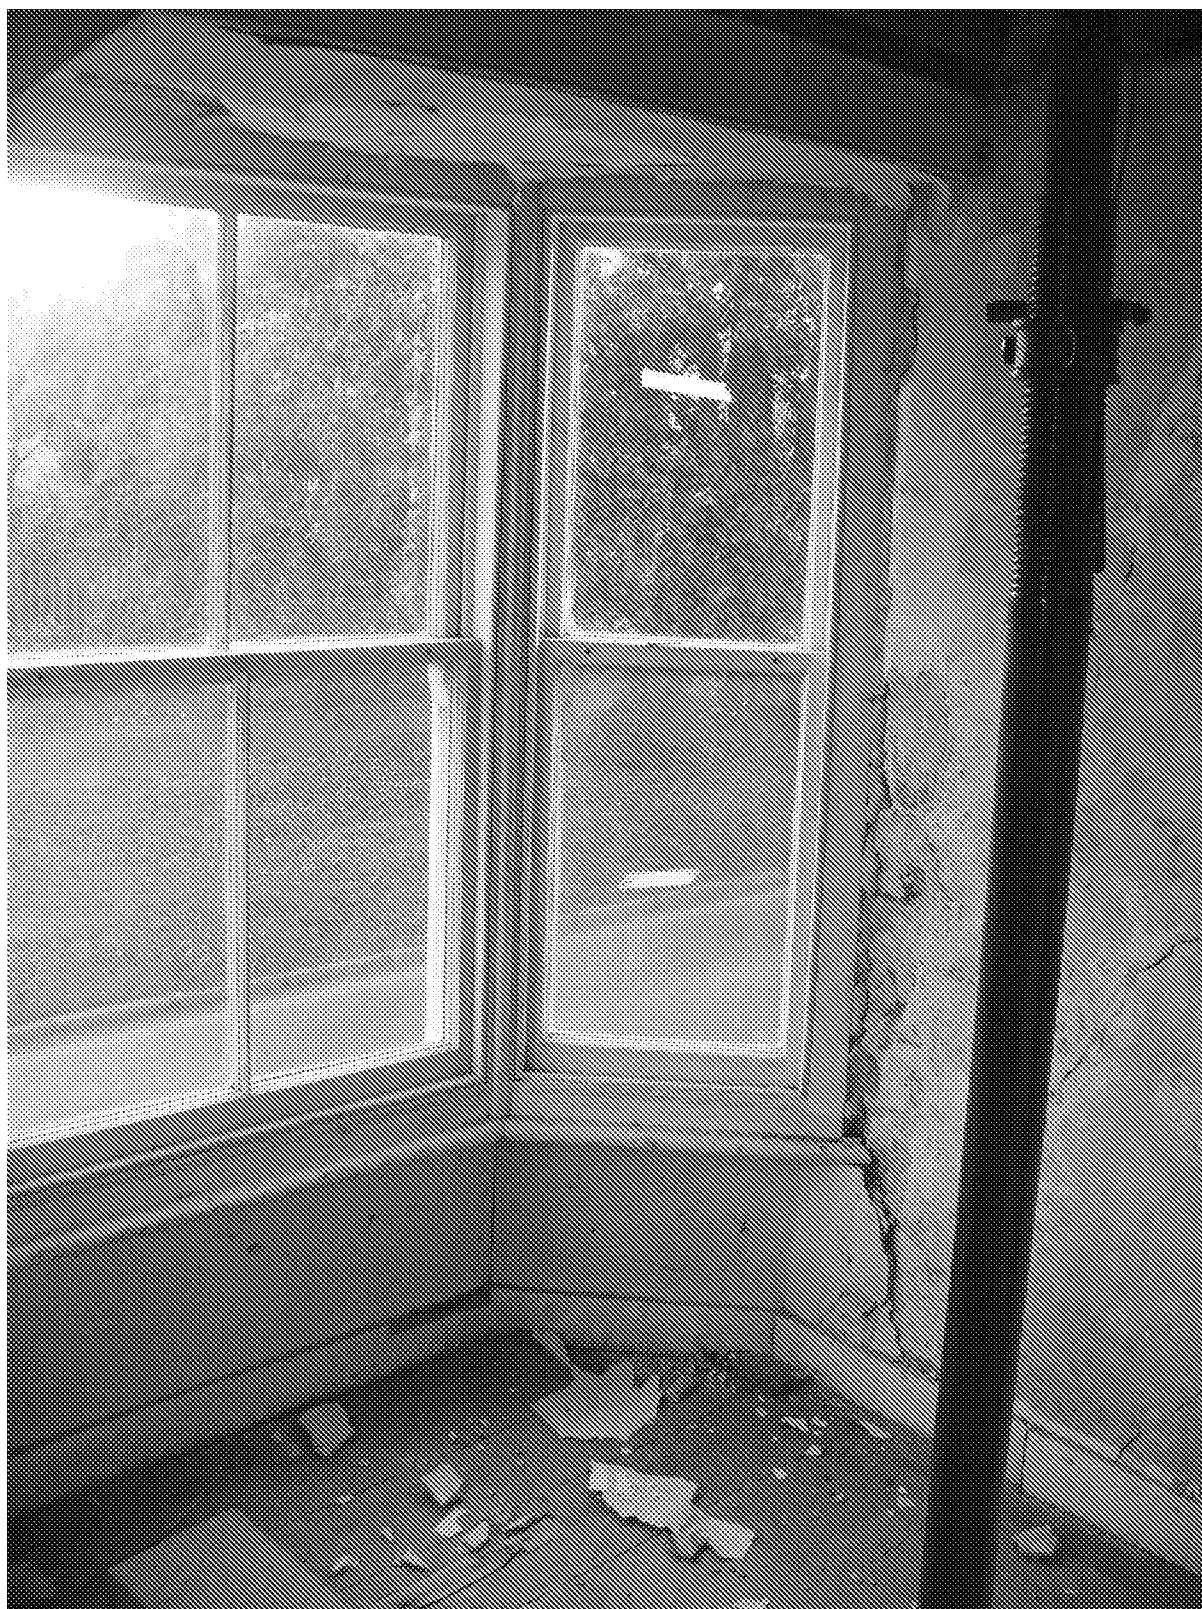
- 3.14 The interiors of both cottages are in a poor state of repair. There is some survival of original lime plaster to walls. Some ceilings survive but will require extensive repair and possible replacement (please also refer to the Structural Survey provided with this application). Roofs have been strengthened and in the case of the rear outshut replaced throughout (c2015).
- 3.15 Staircases are modern. Chimney breasts survive within the houses but have modern fireplaces and surrounds (**Figure 23 Appendix C**). There are simple unmoulded skirtings to some rooms which may be original. Windows are generally modern timber casements (**Figures 24 and 25 Appendix C**) probably replicating original window patterns.

**Figure 24:** Square bay window to No.67 Upper Bognor Road

**Figure 25:** Projecting bay to No.67 Upper Bognor Road

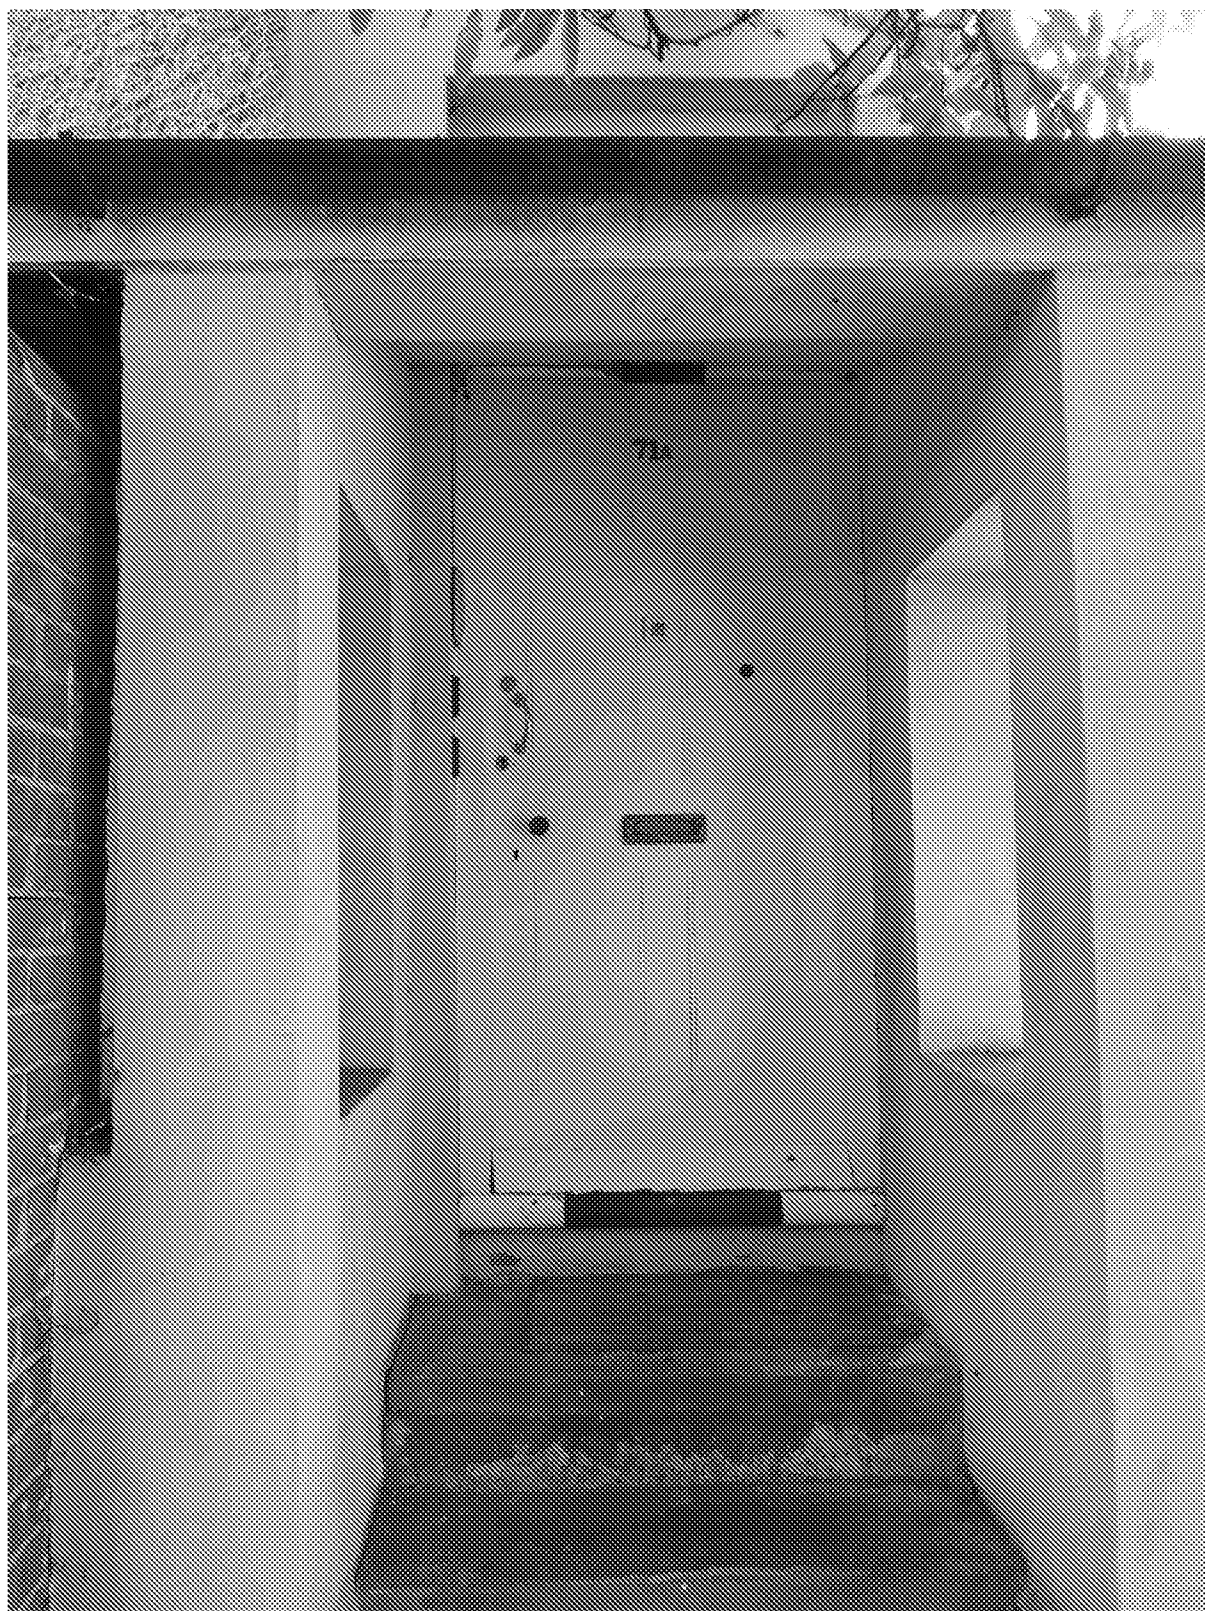
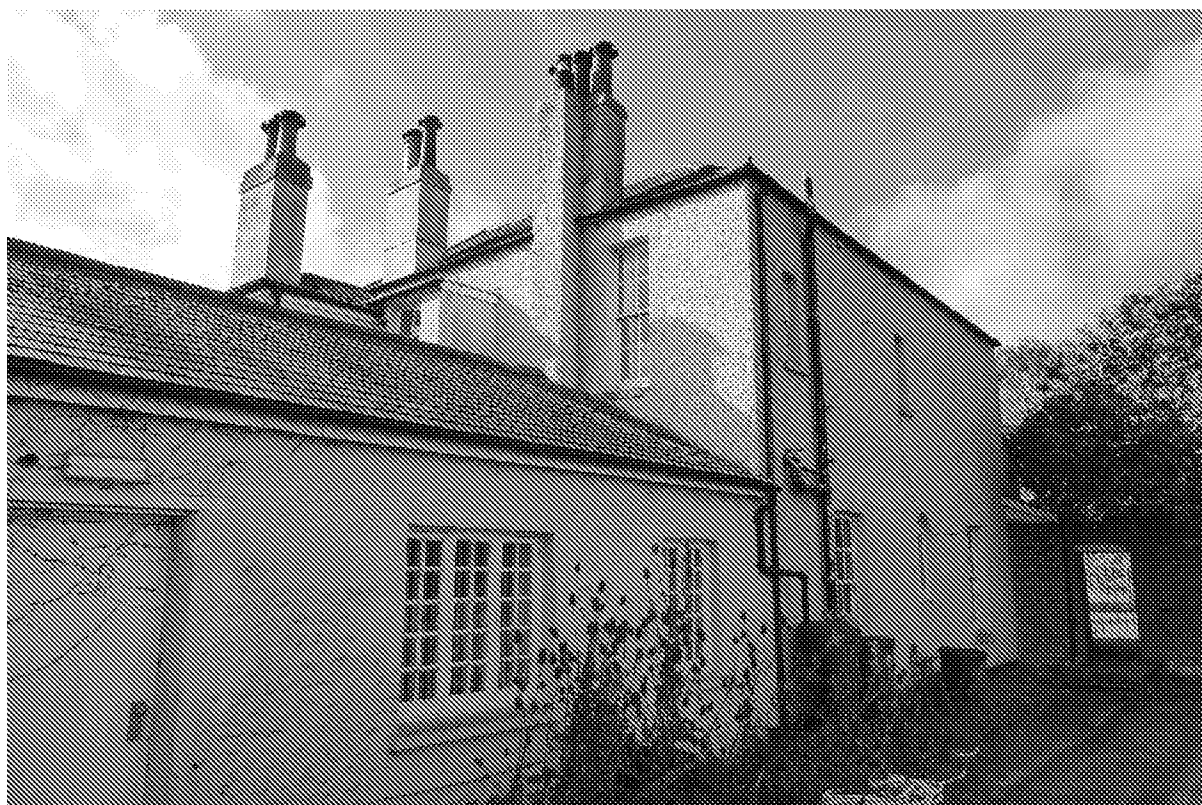
- 3.20 The north (garden) elevation of No.71 (**Figures 30 and 31 Appendix C**) has irregular fenestration (further evidence that this is a much altered building from its original form) with clear evidence for the infilling of a former door with arch to ground floor. The eastern ground floor extension has been built up from the former stone and brick boundary wall. There are two casements to the single storey extension, each with glazing bars one two-light and one three-light. Beyond the rap-trap bond brick boundary wall which runs perpendicular from the north elevation of No.71 there is the stepped entrance to the first floor (now separate). This comprises an open rendered porch with natural slate roof (**Figure 30 Appendix C**). The steps are stone on concrete bases and the door is an early to mid 19<sup>th</sup> century four panel configuration with beaded mouldings.

**Figure 30:** Entrance to separate first floor rooms (on north elevation) No.71 Upper Bognor Rd

**Figure 31:** No.71 Upper Bognor Road - North elevation
