**Students Residences, London Road,  
Bognor Regis**

**Preliminary Structural Feasibility Study**

12634

July 2017

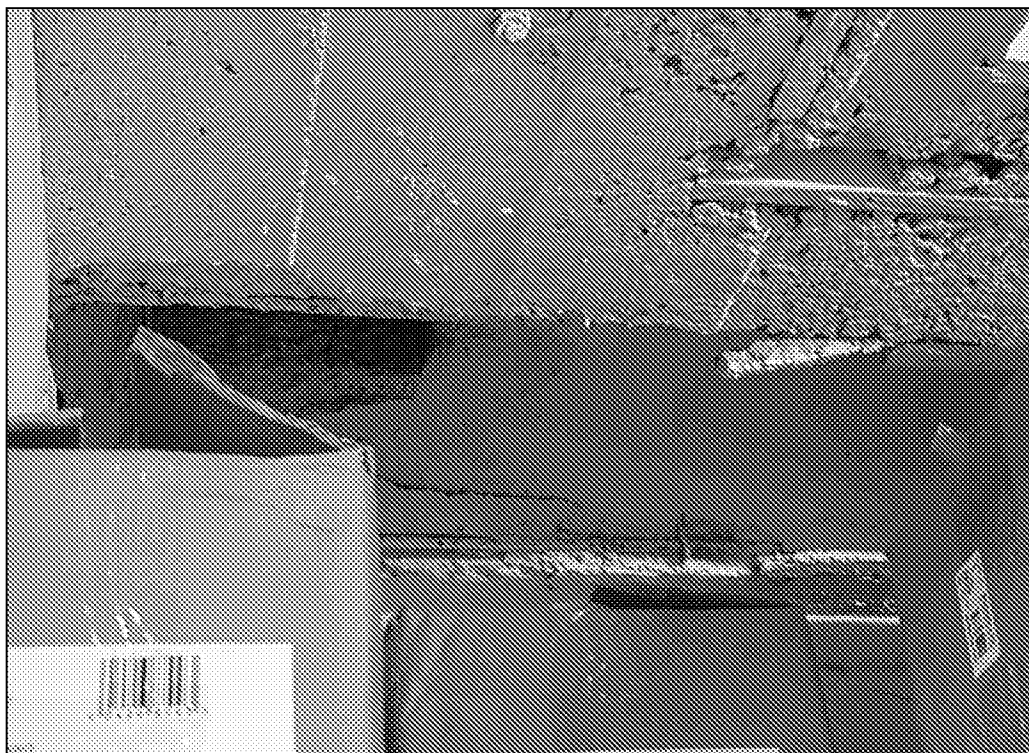
*Photograph 3 – Severed steel reinforcement*

In one location the main bar appears to have been severed (see photograph 3)

Whilst the roof slab in this area does not appear to be exhibiting signs of significant distress at this stage, it is recommended that a repair is carried out in the near future.

- 4.3. The input of a concrete repair specialist is recommended to address the concrete details identified in this report. A full detailed structural survey of the building should be carried out to establish the extent of repair works required.

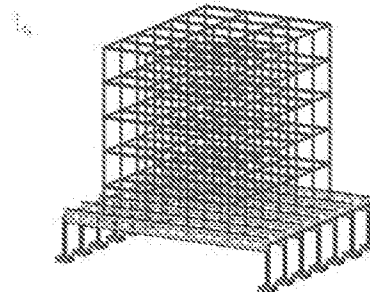
*Image 2: 5 Storey Frame*

- 3.9. On the western side of the building, where five storeys of additional accommodation is proposed, a structural zone of around 1500mm would be required at existing roof level.

- 3.12. It may be necessary to enhance the capacity of the new transfer beams at roof level in the area between the three storey accommodation and the five storey accommodation to negate the need for additional internal columns within the retail space at ground floor level. However, the 1500mm structural zone should be adequate to accommodate the necessary structure.

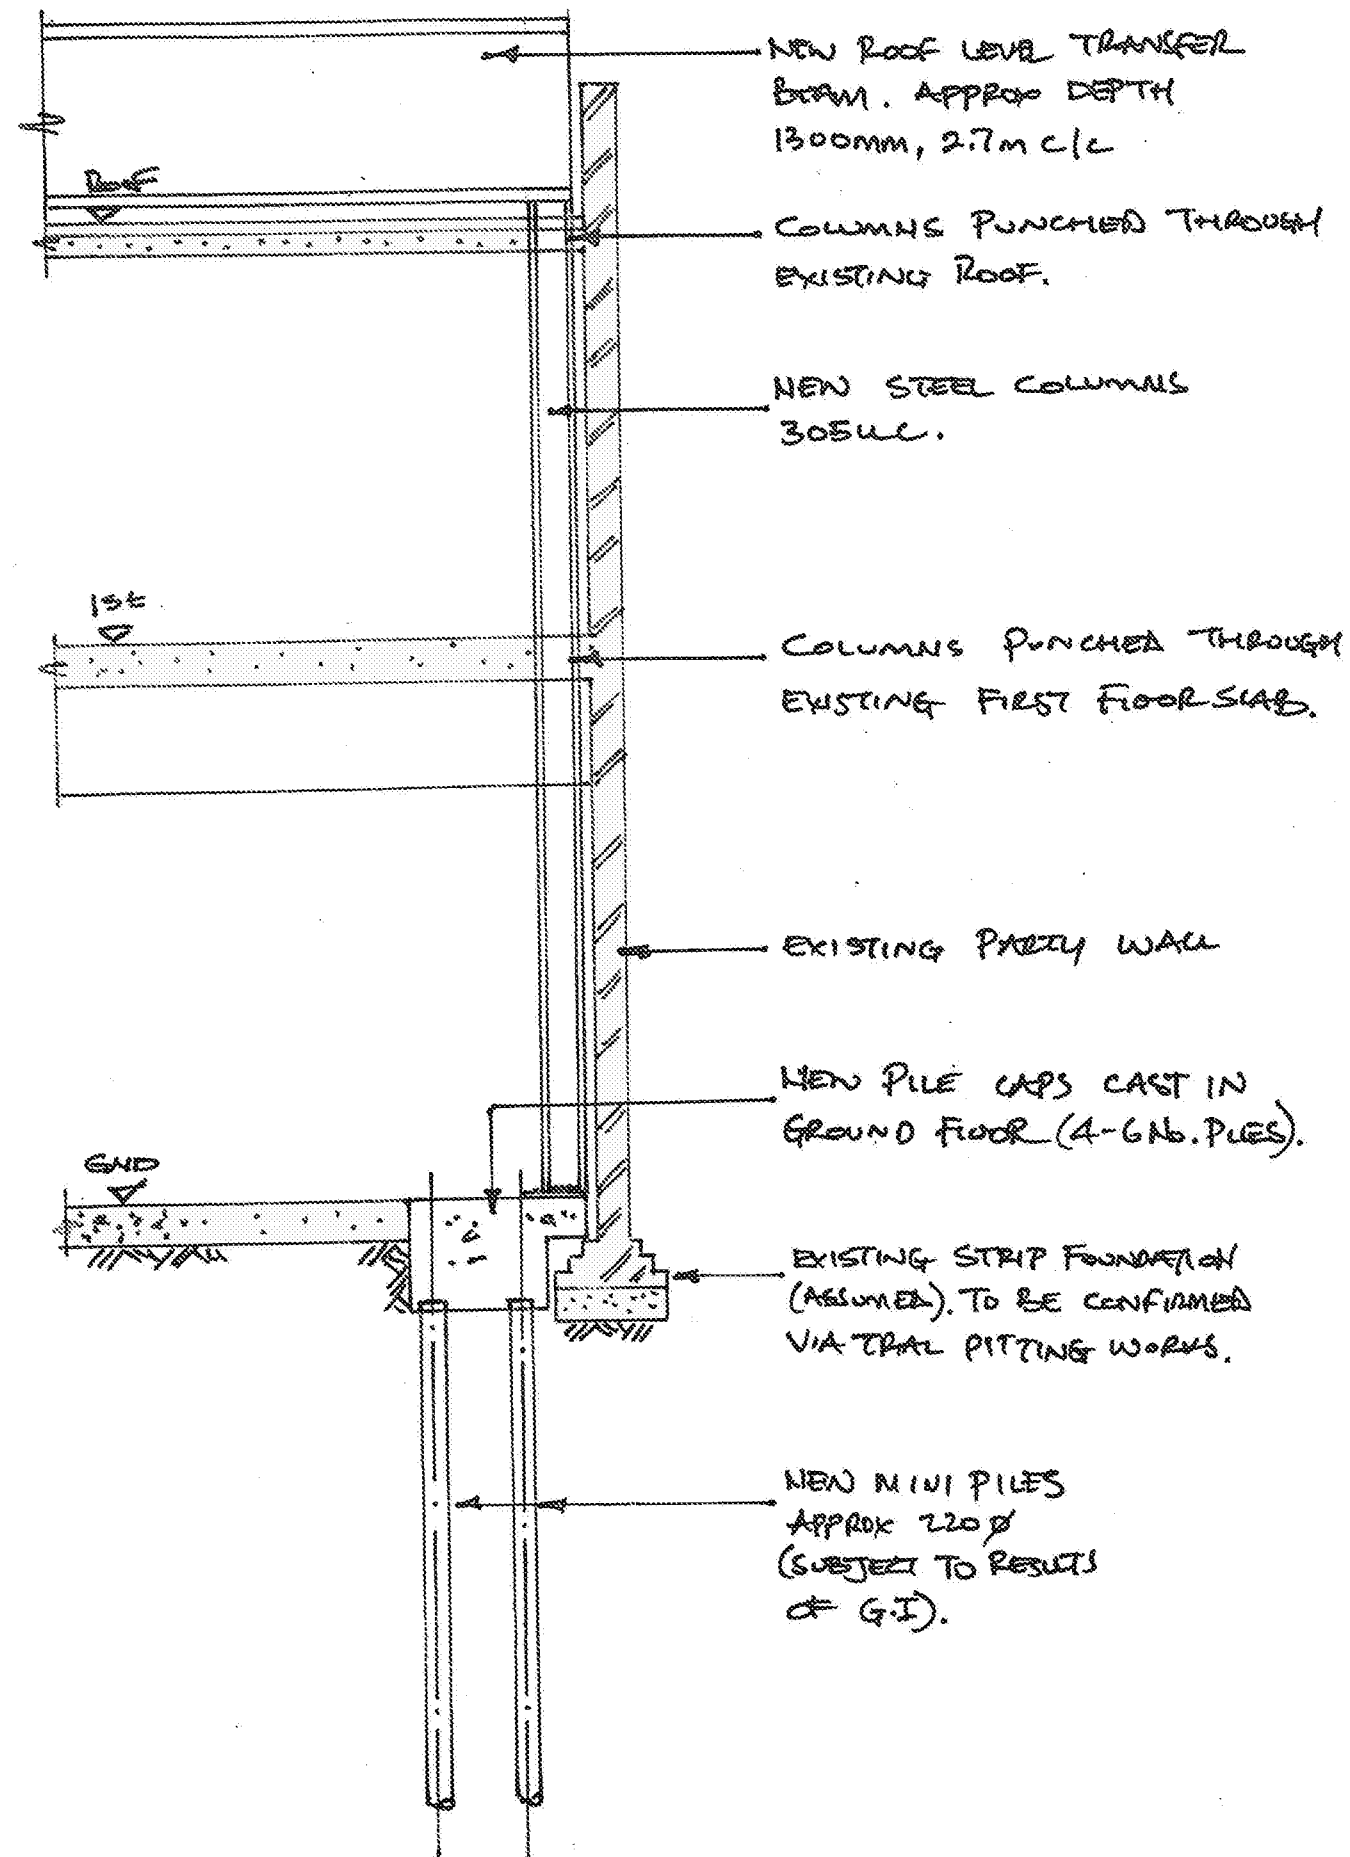
**SECTION X-X**

- 3.13. Sketch 12634/sk001 indicates a possible piling zone and hoarding line for the installation of the piles within the ground floor area. The areas shown are preliminary at this stage and the input of a piling specialist would be necessary to confirm the working space required. Sketch 12634/sk002 shows a typical section through the southern party wall including the new piles, pile cap, steel column and roof level transfer beam (all subject to confirmation following the completion of the surveys/investigations and detailed design).
