Bat Scoping Report and Preliminary Ecological Appraisal

**Land at Upper Bognor Road, Bognor Regis, West Sussex,
PO22 8AT**

13th January 2022

Project No: 3457

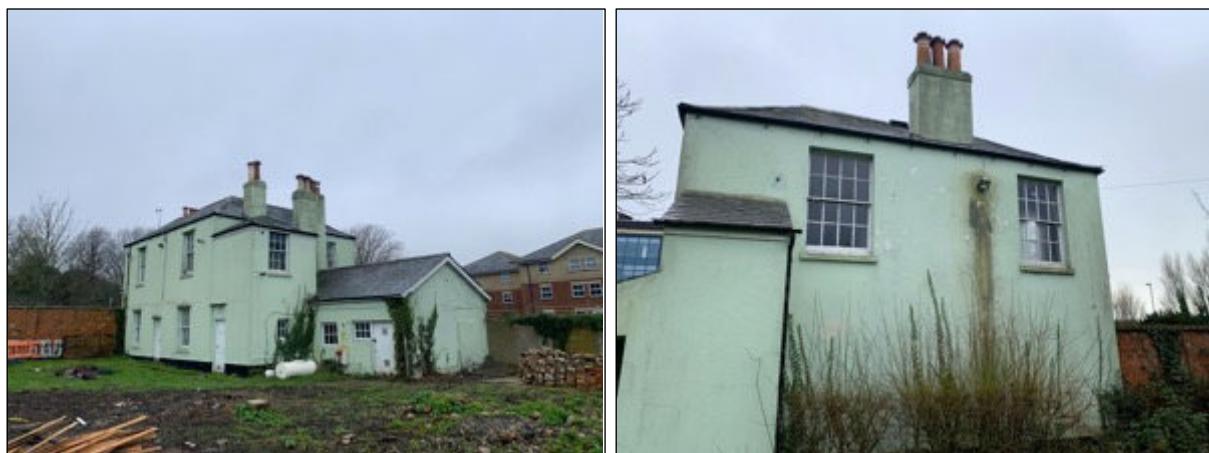
Photograph 1. Building 71/71A from the south-eastern corner (left), western face, location of proposed extension.

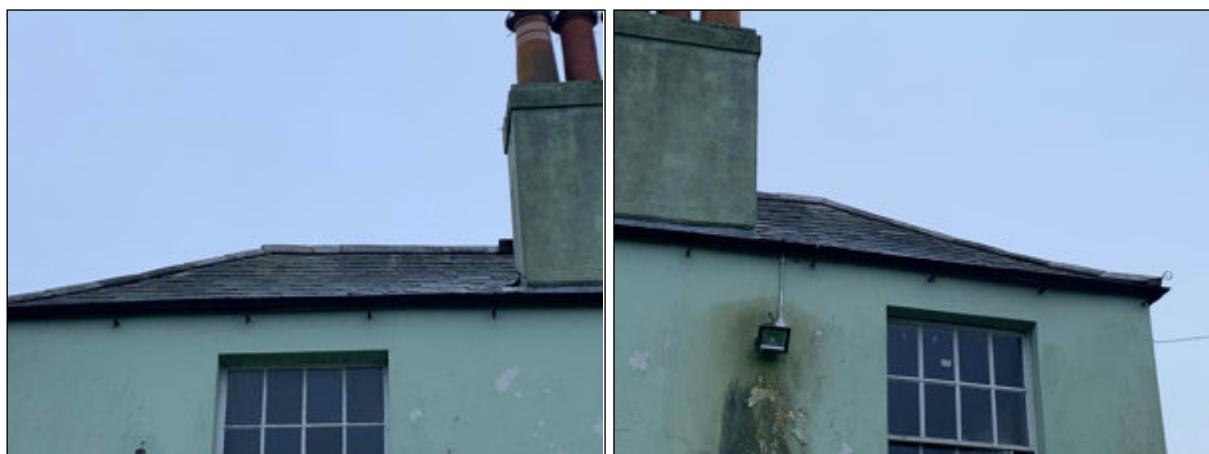
Photograph 2. The western elevation of the building. Note gaps at the ridge, hips and lead flashing to the left of the chimney.

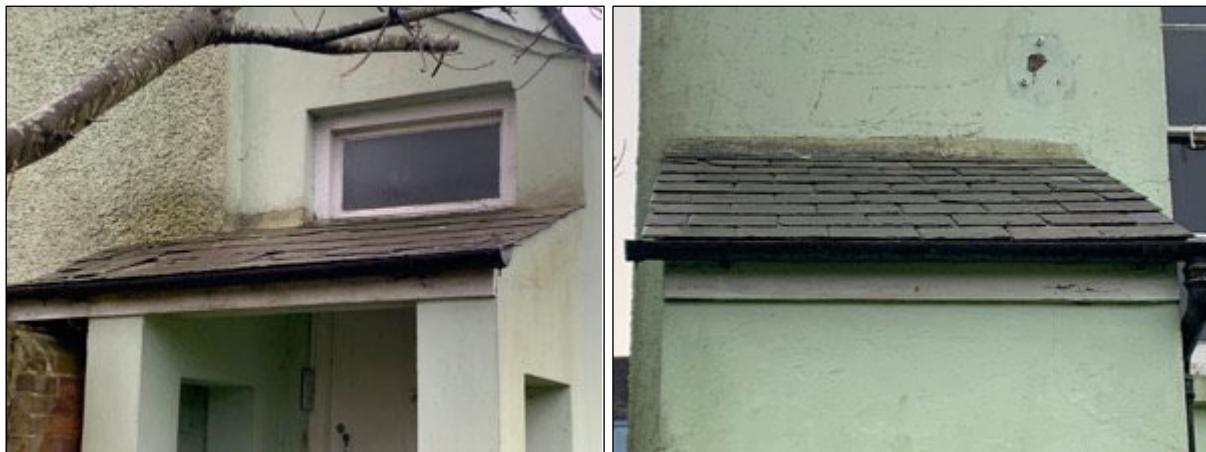
Overall, the bat roost suitability at this site is assessed as low considering the condition of the buildings and the context of the development. The porch on the western face has been brought down to negligible suitability after an endoscope was used to inspect inside the potential features, and no evidence of bats was observed, and features were rotten and in poor condition.

Photograph 3. The west and north elevation of the small porch on the west face of the building. Note gaps on the northern elevation (left). Gaps on the western elevation (right) were inspected and assessed as negligible due to size.

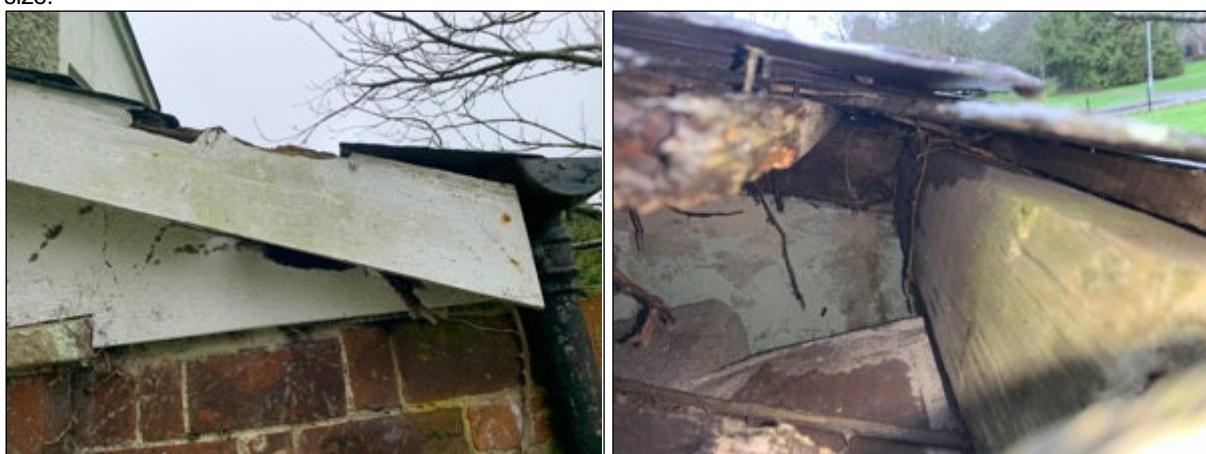
Photograph 4. Broken tiles and rotten timber revealing open cavity.

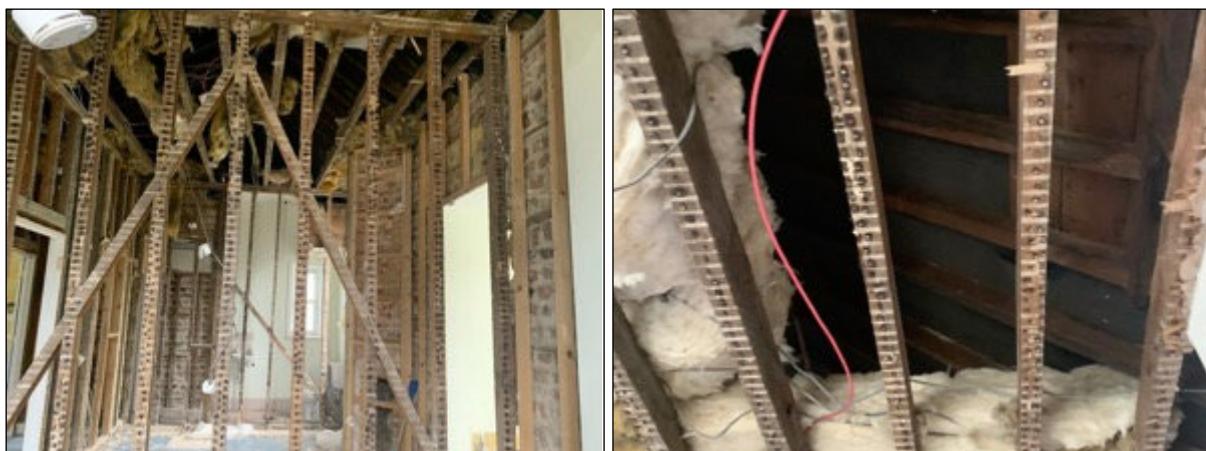
Photograph 5. Internals of building 71/71A. Walls and ceilings have been stripped exposing the roof void.

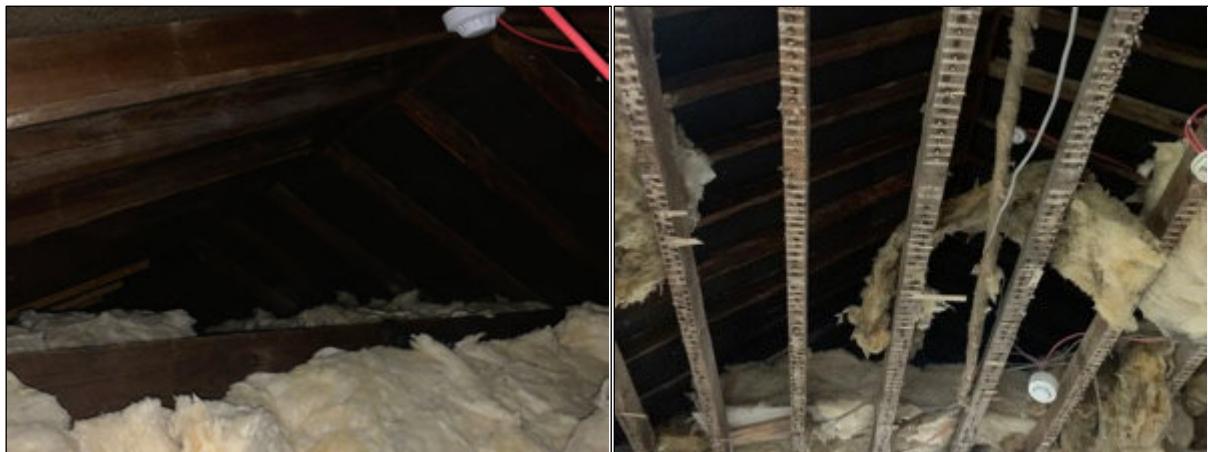
Photograph 6. Small section of void left but open at one end. Left illustrates the space above the hatch, right illustrates where the one end of this is exposed.

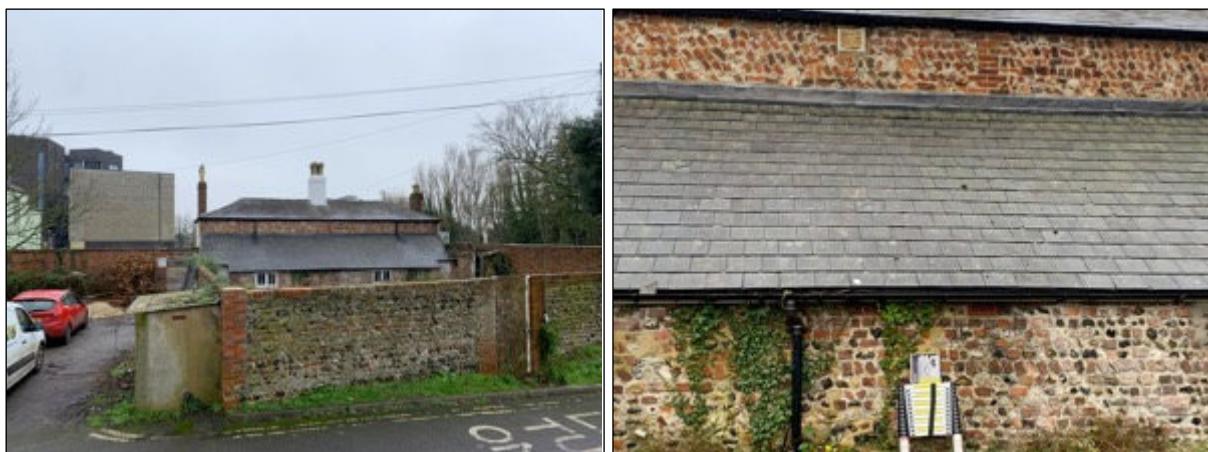
Photograph 7. Left illustrates the Building 67/69 from the west, right illustrates the lower pitch of the kitchen extension for both properties.

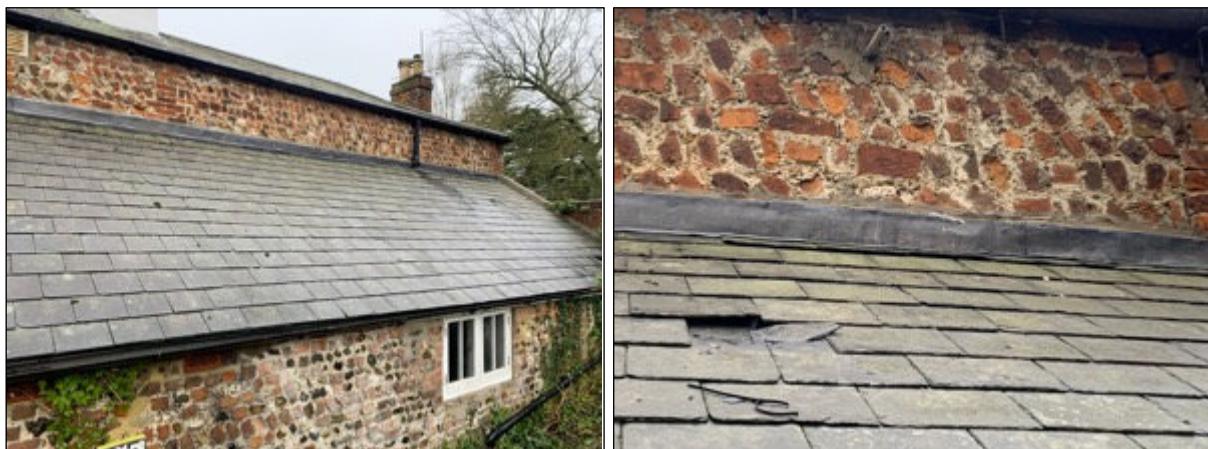
Photograph 8. Area of roof to be fitted with skylights (left), broken and lifted tiles towards the southern end of the pitch away from the proposed skylight area.

67/69 – The lower western pitch is scheduled to have two skylights installed. This will involve the stripping of some slate tiles. Features on this pitch are limited to some lifted tiles at the far southern end. Each skylight is to be placed in the middle of this pitch, away from any lifted or broken tiles. While unlikely, it is still possible that bats could gain access and move along the Tyvek lined roof to the skylights proposed location. For this reason, this feature is rated as low.

The guidelines state "If the structure has been classified as having low suitability for bats, an ecologist should make a professional judgement on how to proceed based on all of the evidence available"¹. In this instance no further surveys are recommended. However, as a precautionary measure a licensed bat ecologist should be present to inspect and oversee the soft stripping of the slate roof tiles prior to demolition, so that in the highly unlikely event a bat is present, the risk of injury/killing or destruction of a roost is avoided. The stripping of this feature should be undertaken carefully by hand under the supervision of the licensed ecologist. In the event a bat was to be discovered, the feature should be made good where possible and works would need to cease immediately. Work would likely not be able to continue until an EPS mitigation licence has been obtained. It is likely that any license application would need to be supported by further surveys to classify the nature of the roost (day/maternity/transitional). Any resumed works in the house should be done using hand tools where possible, and any workers on site must remain vigilant for bats present in the void. If any are spotted, work must cease immediately, and an ecologist must be notified. As the buildings as a whole have been

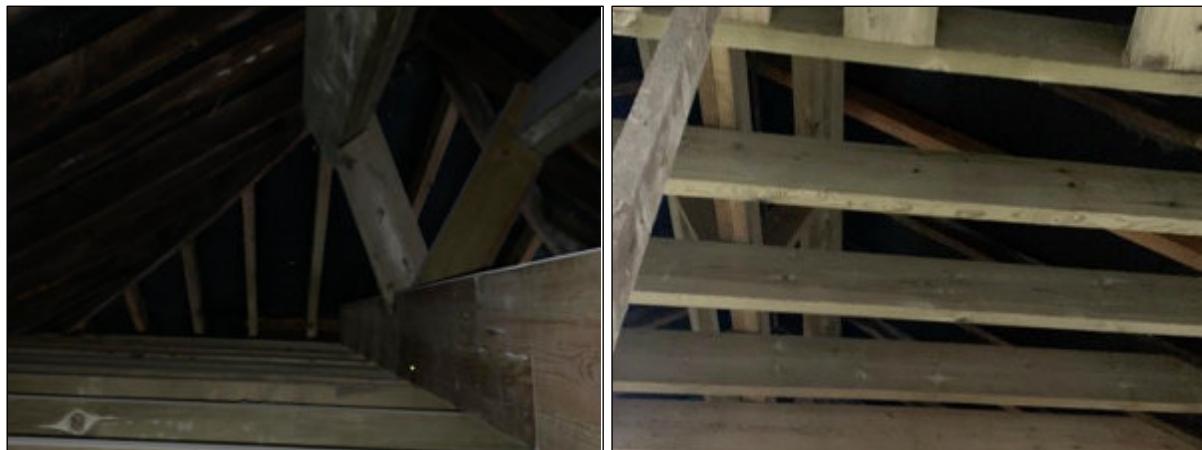
Photograph 9. Internal roof space of 67 where ceilings have been stripped exposing the void.

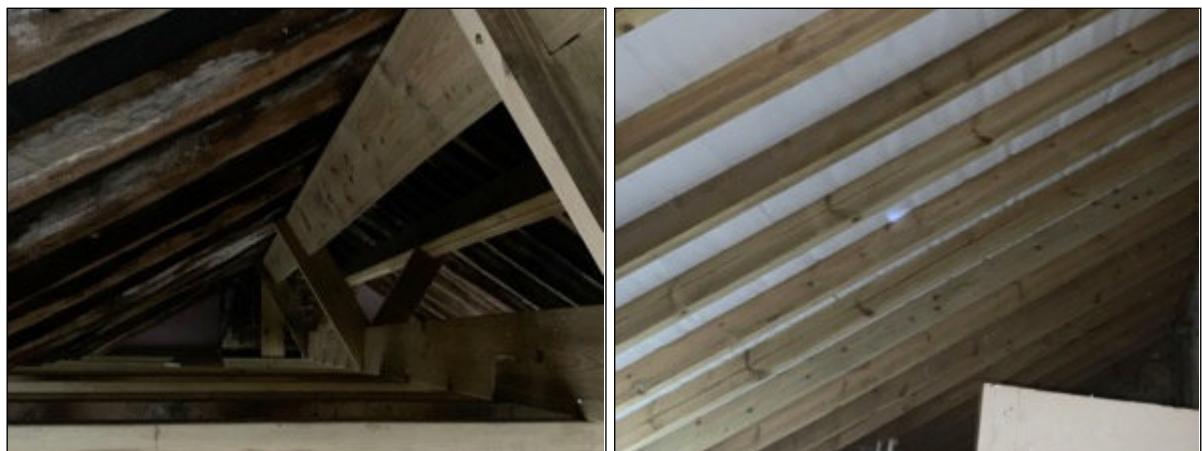
Photograph 10. Left illustrates the exposed void in 69 right illustrates the Tyvek lined roof over the kitchens of both properties.

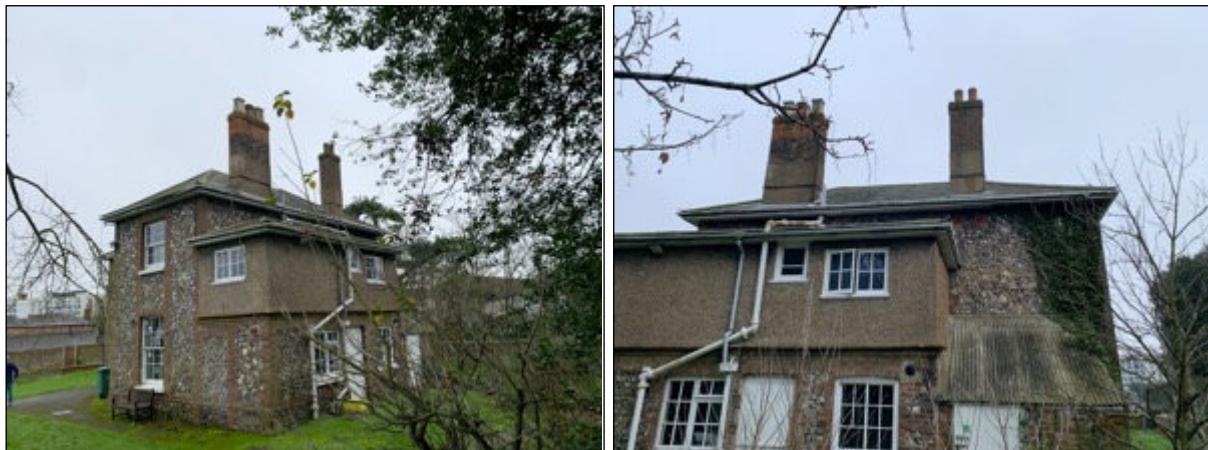
Photograph 13. Charlotte house, currently being used as student accommodation. Not to be affected by the works.

Charlotte House has been rated as moderate. Some features were observed in the roof, such as gaps under hip and ridge tiles, and some lifted lead flashing. As access to the roof void was not given, a full assessment cannot be made. Currently, there are no development plans for Charlotte House. Should Charlotte House be developed in the future, a full assessment of both the external and the internal of the property is required.
