# **SuDS and Drainage Report**

63 Annandale Avenue, Bognor Regis

Ref: **C4138**

**CGS Civils Ltd**  
Richard Cobden House  
Lion Street  
Chichester

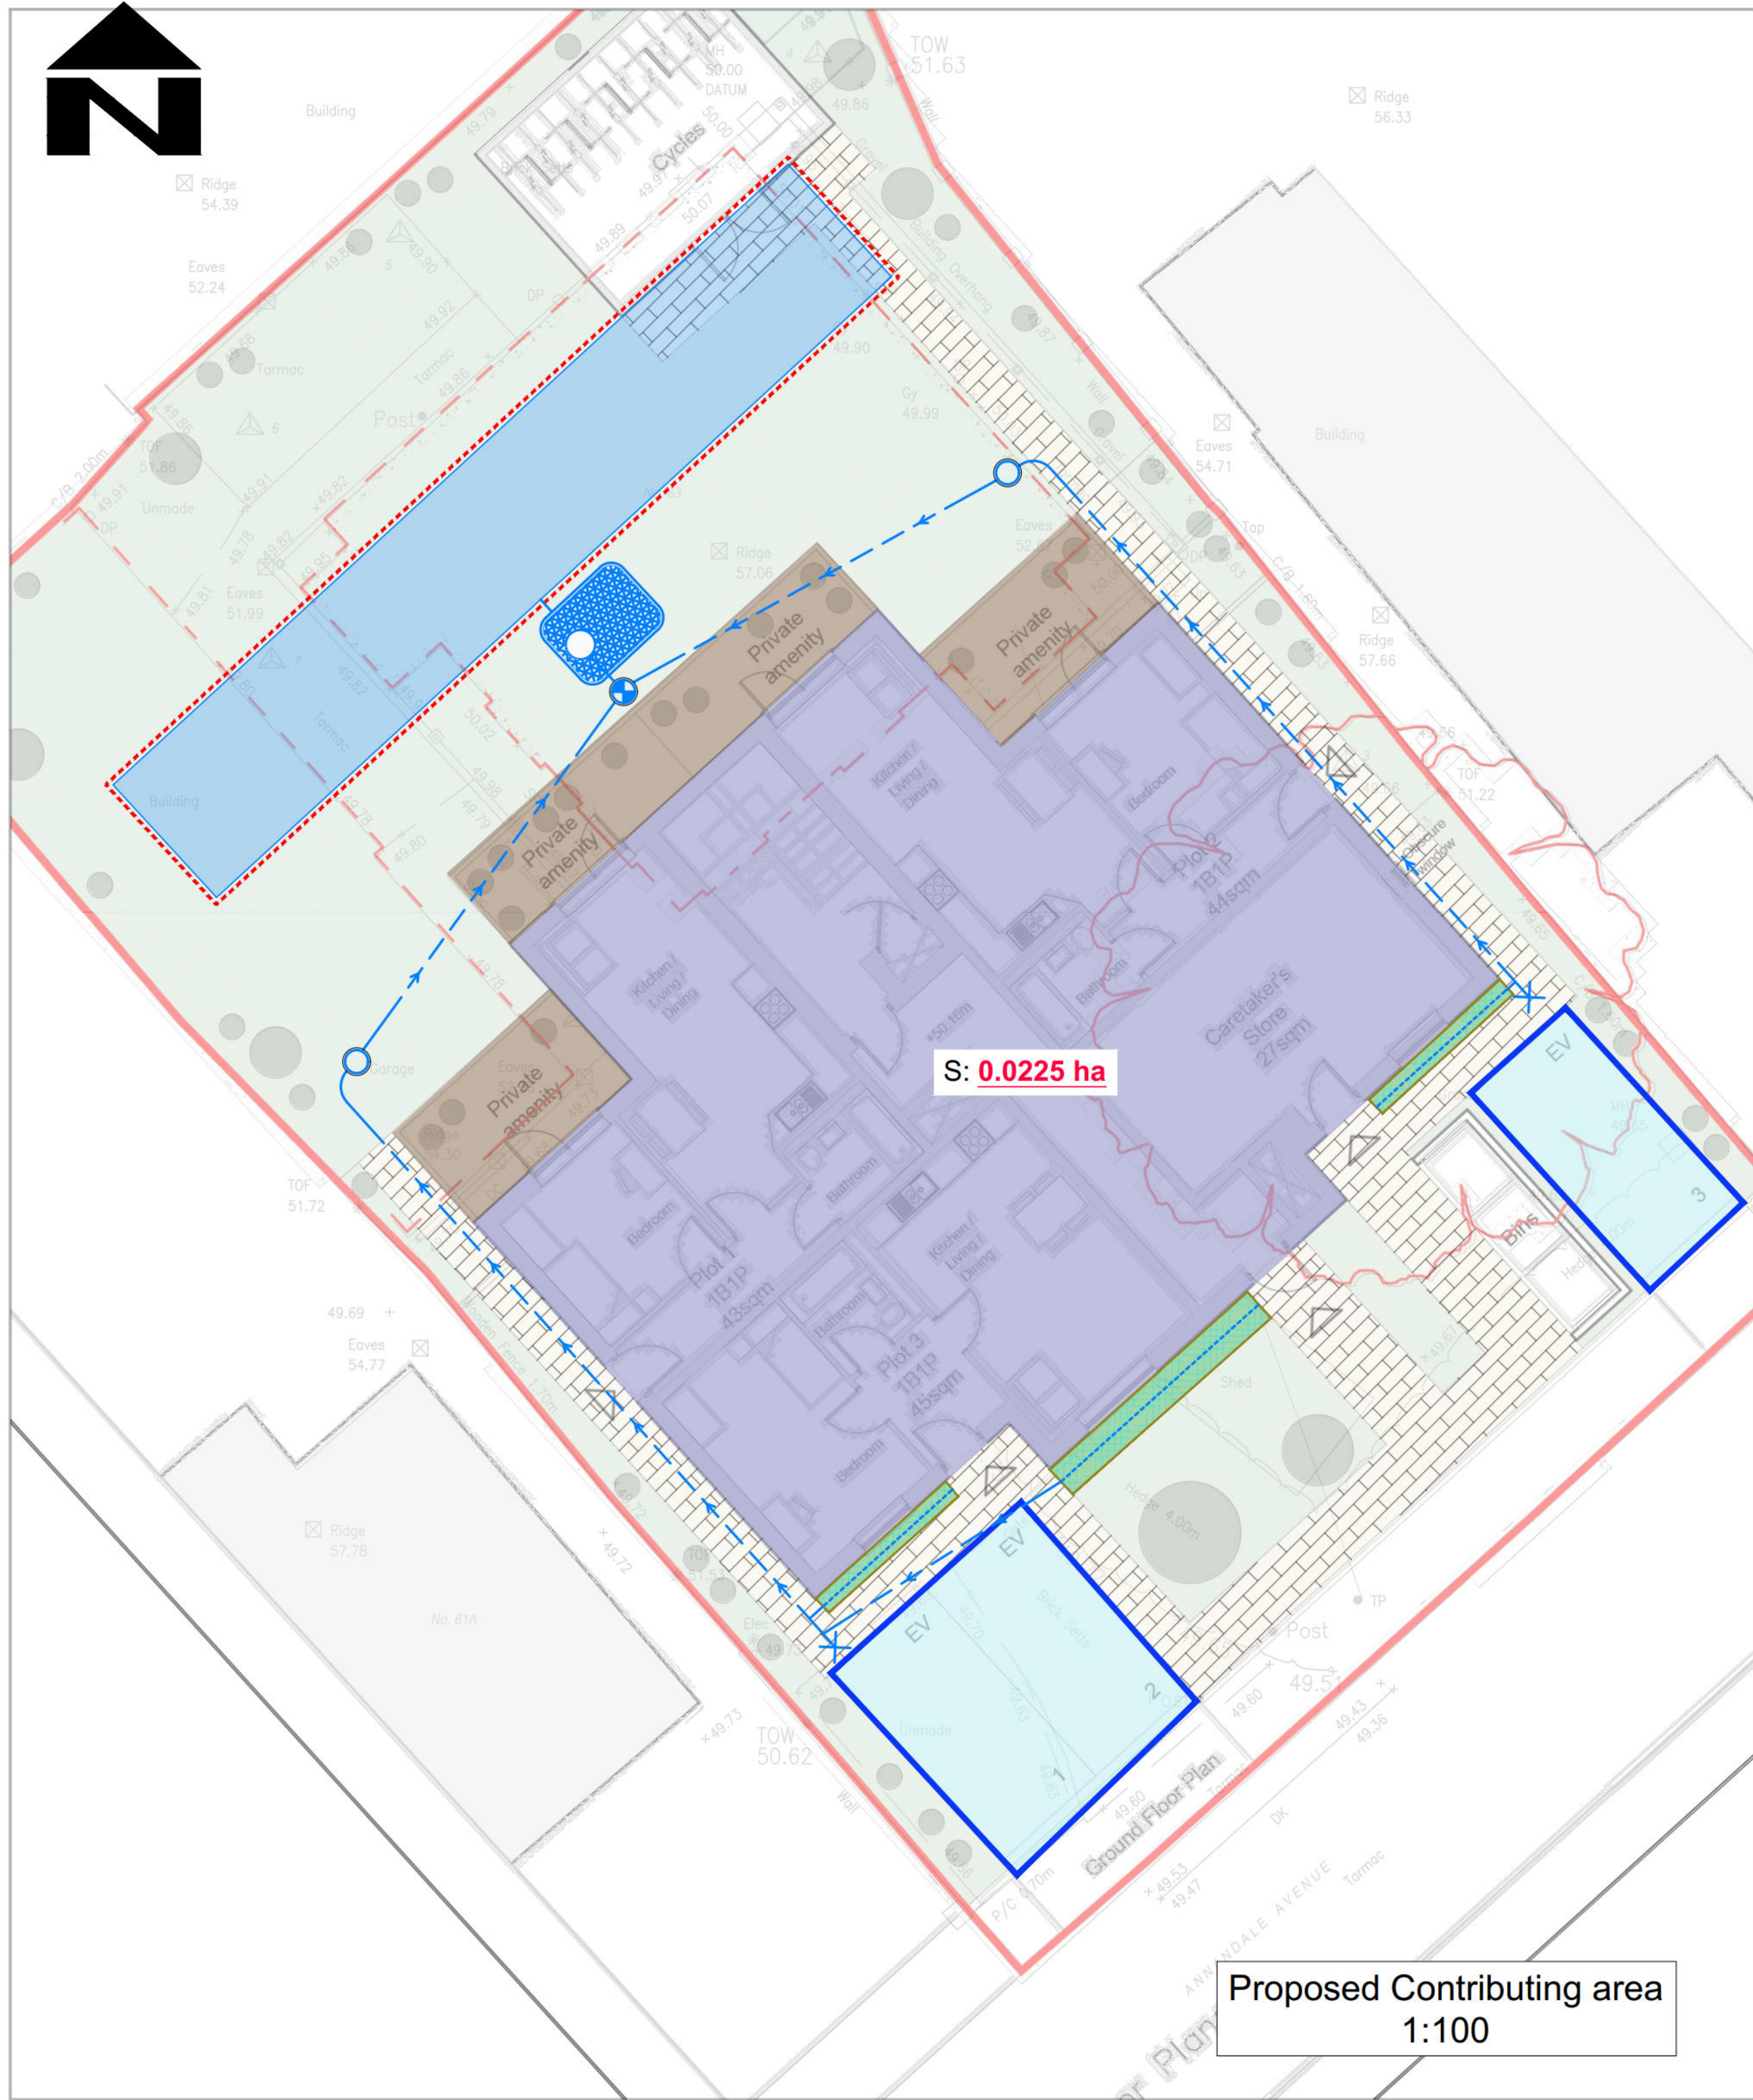
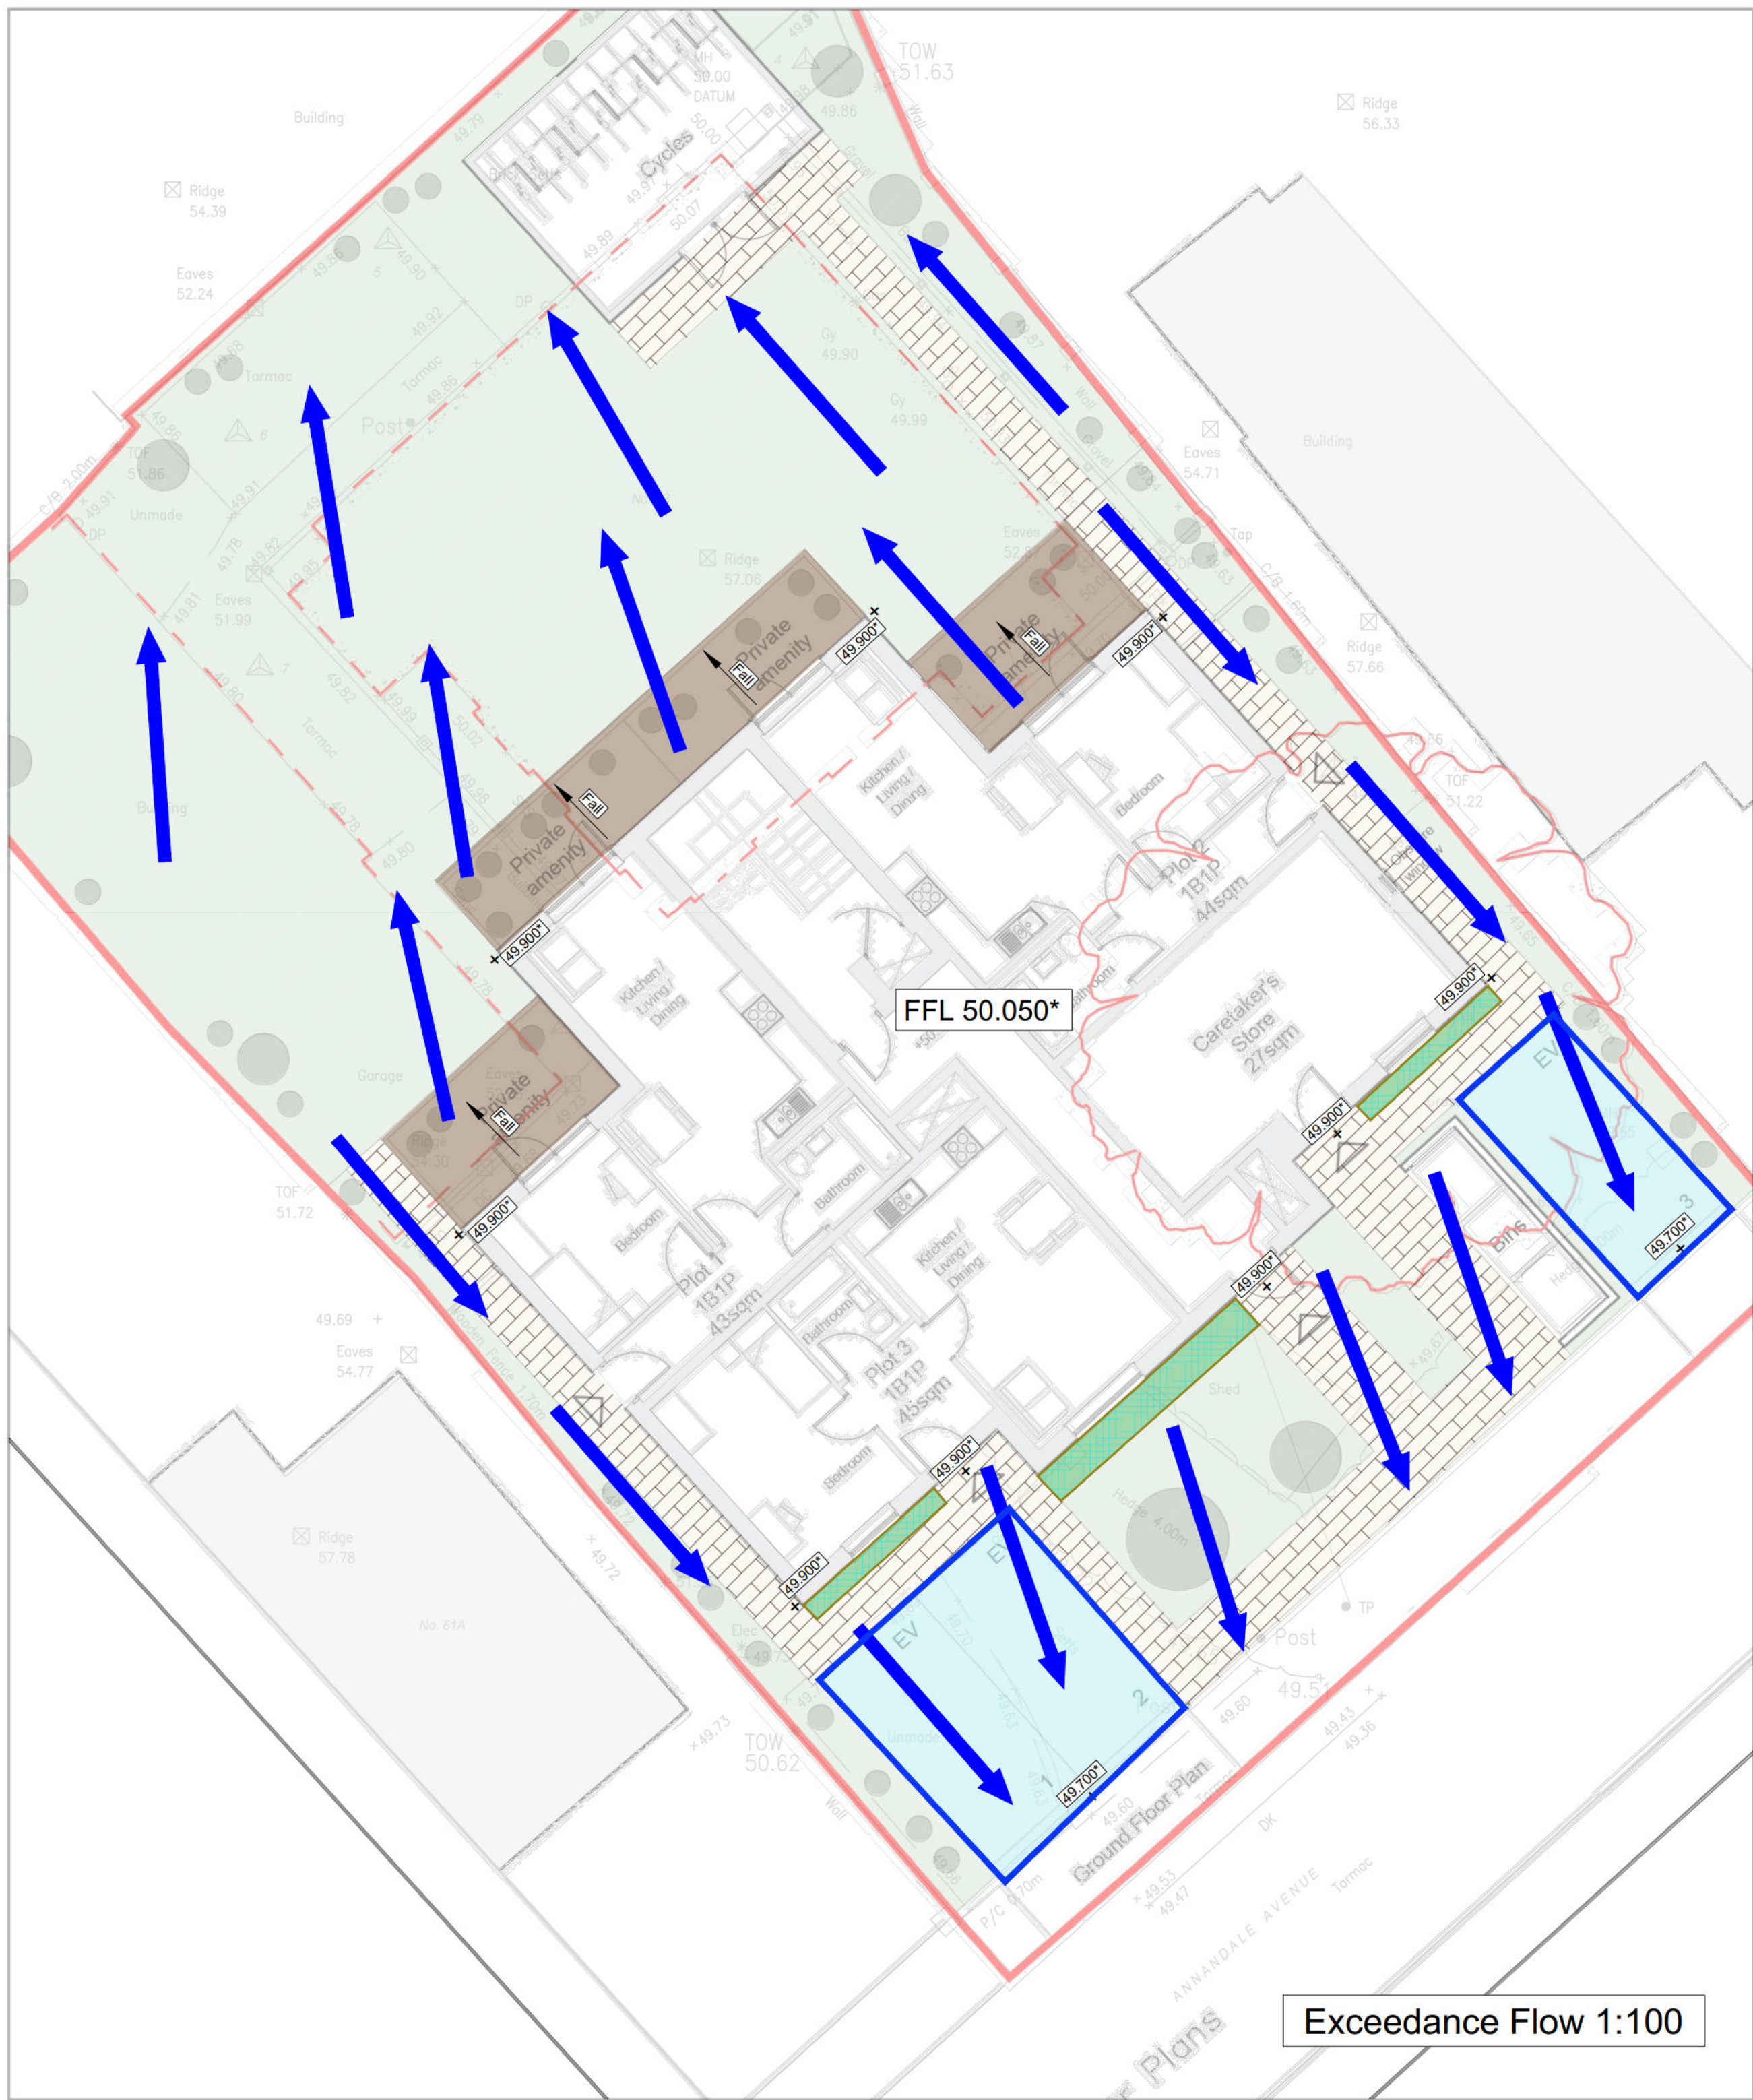
CONTRIBUTING AREA PLAN (1:200)

- Proposed roof areas: **0.0225 ha**
- Proposed permeable areas: **0.004 ha** (included from drainage calculations)
- Proposed permeable footpath areas (excluded from drainage calculations)
- Proposed Patio areas (excluded from drainage calculations)
- Proposed Bio-Retention

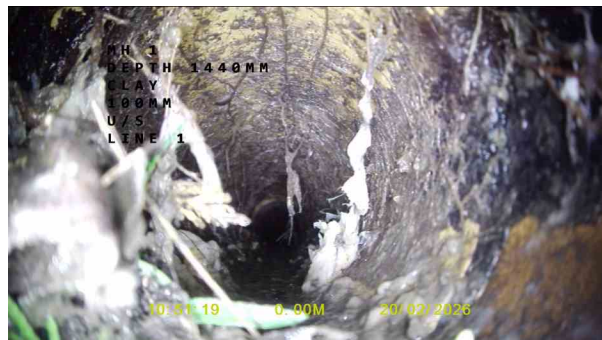
UNKNOWNX\_45a1e1be-29f3-454e-84f0-9b7c49525b5a\_202  
60309\_150219\_777.jpg, 00:00:09, 0.00 m  
Water level, 0% of the vertical dimension

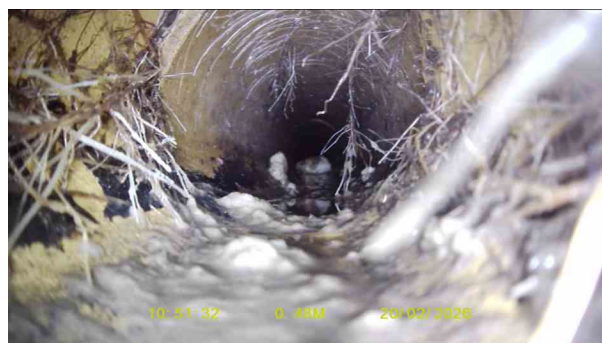
UNKNOWNX\_96da4866-93d6-40c9-935e-2d70b43f70ff\_2026  
0309\_150543\_965.jpg, 00:00:22, 0.48 m  
Roots, fine at joint

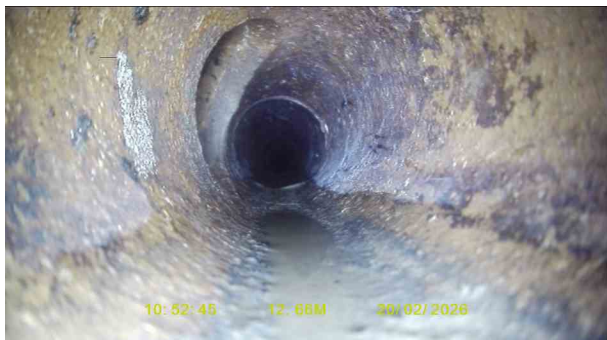
UNKNOWNX\_2e3493d6-f1b9-4e51-ab53-bfb978736c69\_20260309\_150812\_778.jpg, 00:01:35, 12.66 m  
Junction at 9 o'clock, diameter: 100mm

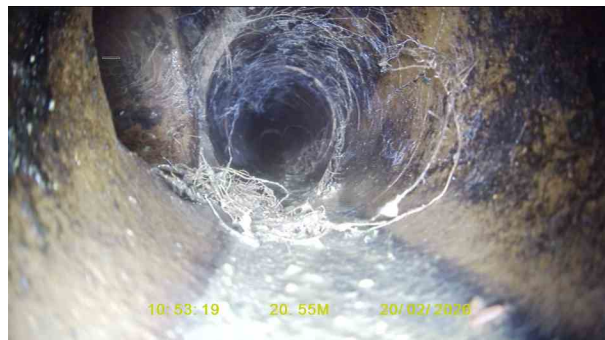
<table><tr><td>0.00</td><td>MH</td><td>Start node, manhole, reference: MANHOLE 1 (MH1)</td><td>00:00:09</td><td>UNKNOWN<br/>NX_3b2c1061-6c95-</td><td></td></tr><tr><td>20.55</td><td>JXD</td><td>Defective junction, damaged at 9 o'clock, diameter: 100mm: CRACKED &amp; ROOT INFILTRATED</td><td>00:02:09</td><td>UNKNOWN<br/>NX_8ab6bb7f-afb5-4</td><td></td></tr></table>

UNKNOWNX\_8ab6bb7f-afb5-46a2-97ad-c9e97d645cf4\_20260309\_150852\_478.jpg, 00:02:09, 20.55 m  
Defective junction, damaged at 9 o'clock, diameter: 100mm, CRACKED & ROOT INFILTRATED

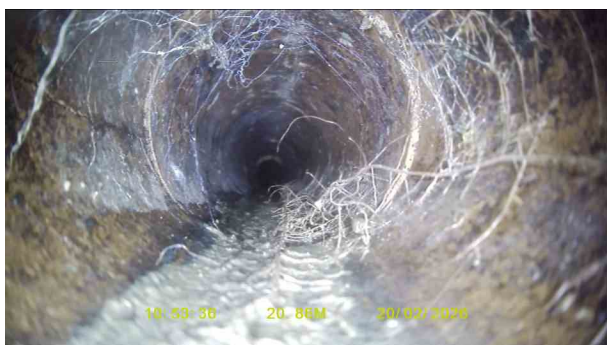
UNKNOWNX\_01b833da-1af9-40f4-82e7-59b4f9813641\_20260309\_150915\_546.jpg, 00:02:26, 20.86 m  
Roots, fine at joint

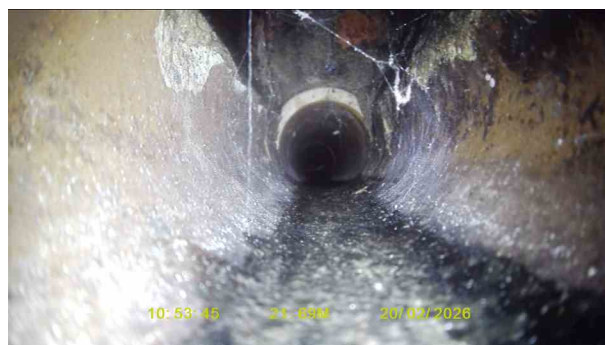
UNKNOWNX\_93352ea6-d9c8-4492-ad93-76e1ca90c46c\_20260309\_150944\_449.jpg, 00:02:35, 21.69 m  
General remark, \*\*ENTERS BURIED MANHOLE\*\*

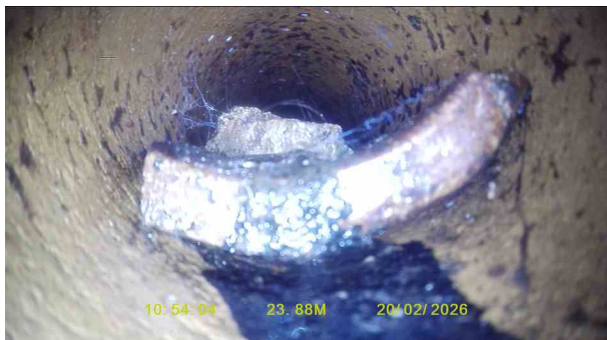
UNKNOWNX\_ee8bb757-b272-4aac-8351-86a90515e417\_20260309\_151006\_881.jpg, 00:02:53, 23.88 m  
Settled deposits, coarse, 50% cross-sectional area loss

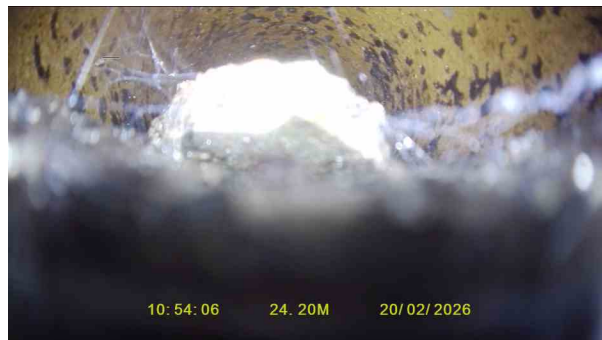
UNKNOWNX\_c0d73047-4b10-4f56-afd4-2bcc42f0deb9\_20260309\_151038\_481.jpg, 00:02:56, 24.20 m  
Survey abandoned, S/A - UNABLE TO PASS DEBRIS

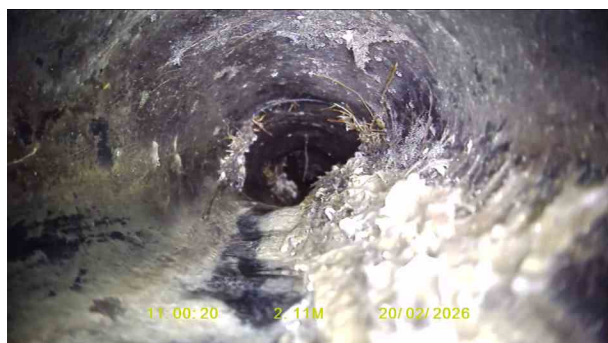
NEIGH  
MHX\_8c17c4af-3b21-4ba9-a9eb-daf083b01de2\_20260309\_1  
51444\_714.jpg, 00:00:34, 2.11 m  
Deformed drain or sewer, 20%

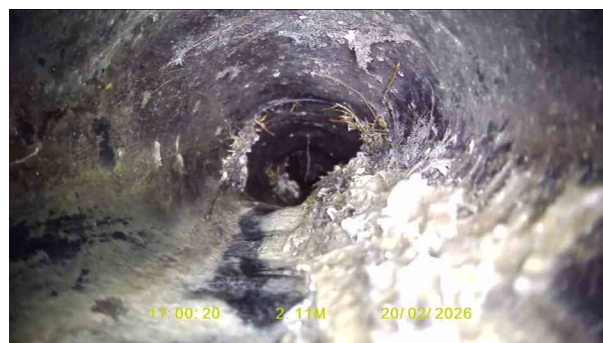
NEIGH  
MHX\_f2197242-dbd2-46cd-88c3-e7852d7478fe\_20260309\_1  
51452\_767.jpg, 00:00:34, 2.11 m  
Roots, fine

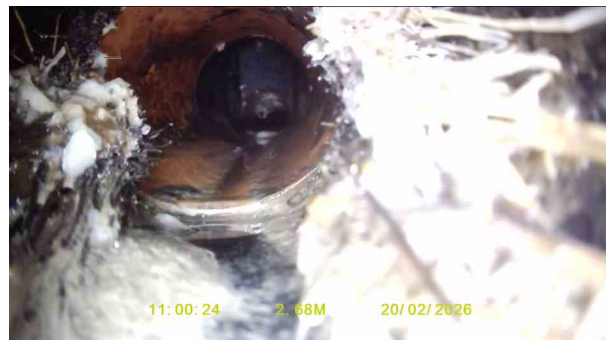
NEIGH  
MHX\_98e14b0c-5078-47af-9d1d-c4fecb05a7b2\_20260309\_1  
51545\_215.jpg, 00:00:38, 2.68 m  
Material changes to polyvinyl chloride

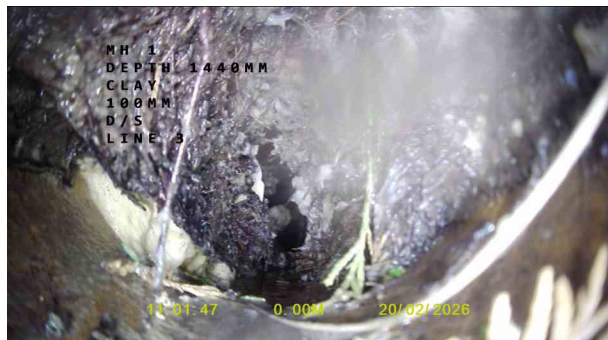
MH1X\_adaec02f-18b5-4ac4-94d2-7f08acbe9c62\_20260309\_1  
51823\_216.jpg, 00:00:07, 0.00 m  
Start node, manhole, reference: MANHOLE 1 (MH1)

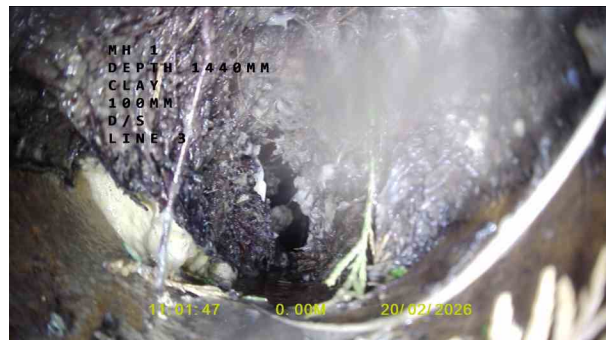
MH1X\_0e4f395e-c661-44f3-bef8-d5092db76894\_20260309\_1  
51829\_347.jpg, 00:00:07, 0.00 m  
Water level, 0% of the vertical dimension

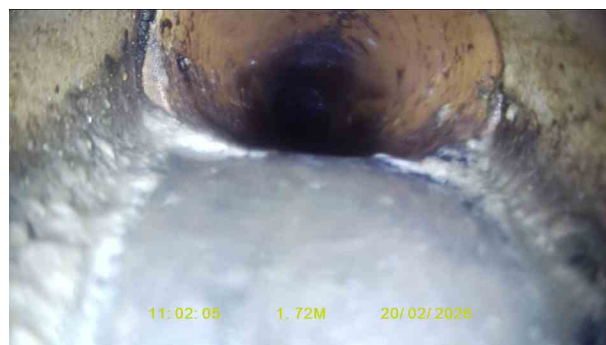
MH1X\_87134125-87be-4706-885c-f264c308d8d2\_20260309\_1  
152055\_841.jpg, 00:00:25, 1.72 m  
Attached deposits, encrustation at joint from 4 o'clock to 8 o'clock, 20% cross-sectional area loss

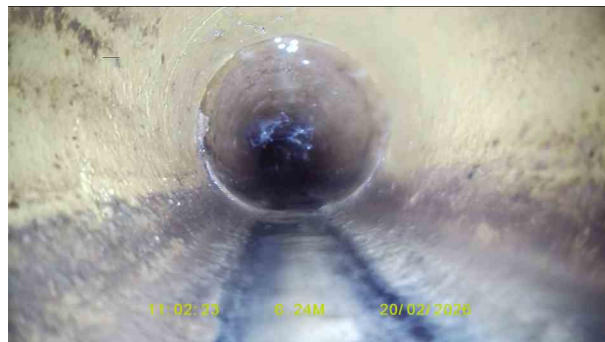
| Scale: | 1:64 | Position [m] | Code | Observation | MPEG | Photo | Grade |
|---|---|---|---|---|---|---|---|
| | | 6.24 | CCJ | Crack, circumferential at joint from 8 o'clock to 12 o'clock | 00:00:43 | MH1X_b7<br>e21036-a7<br>85-4a45-a | 2 |

MH1X\_b7e21036-a785-4a45-a376-16d1e7c6e280\_20260309\_152237\_006.jpg, 00:00:43, 6.24 m  
Crack, circumferential at joint from 8 o'clock to 12 o'clock

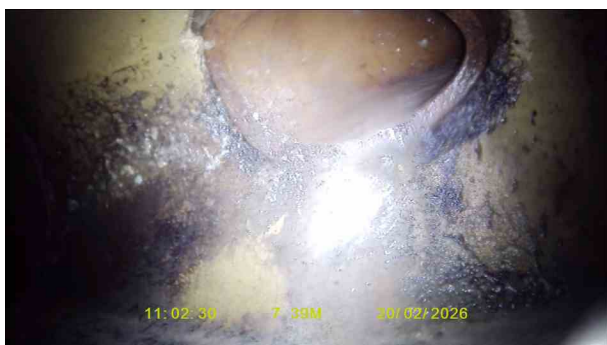
MH1X\_0cc10ae4-ed45-402d-be3a-c95dfc9df374\_20260309\_152253\_760.jpg, 00:00:51, 7.39 m  
Finish node, manhole, reference: MAIN SEWER
