### Climping Mill, Climping, West Sussex

- Preliminary Ecological Appraisal Survey
- Day-time Bat Roost Assessment

| Document Reference | LLD1260 |

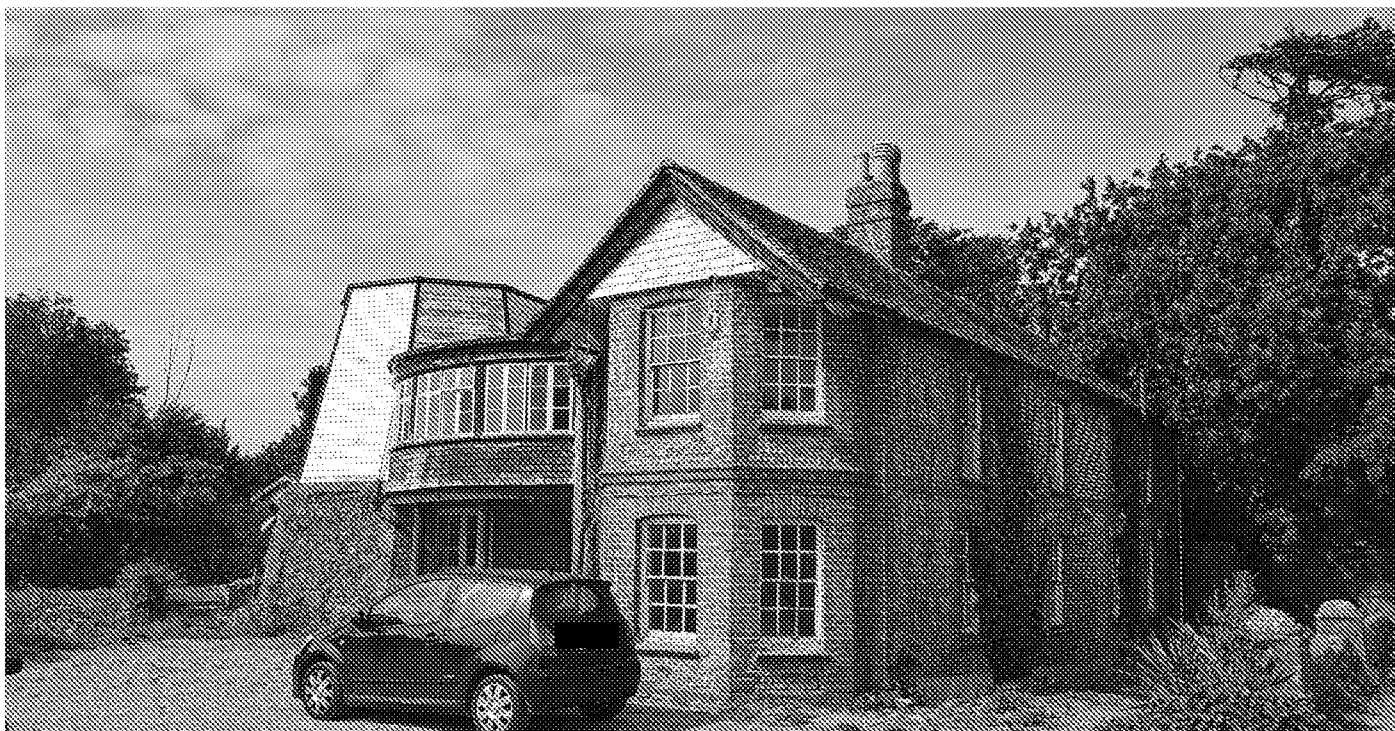
- 4.3.2 A large building of flint and brick construction which appears to have been extended numerous times over the years. The old windmill is still present, albeit with the top section and sails removed, and is attached to the main building via a flat roofed 'sun room'. The main section of building then extends along a north-south axis with a double gable roof, one section of which is clad in clay tile while the other is slate. The northern-most end of the building appears to be most recently constructed being an 'L' shape building of brick construction with tile roof.

- 4.3.3 Internally the building contains 3 no. open roof voids. Void no. 01 measures approximately 12m x 2.5m with a height to the ridge of c. 1.5m. The void is of traditional rafter construction with a mixture of BRM and bitumen roofing felt. Numerous rat and mouse droppings were recorded throughout. A small number of brown long-eared bat and pipistrelle sp. droppings were recorded at the point where the sun room joins adjoins this area. Void no. 02 measures approximately 16m x 3m with a height to the ridge of c. 1.5m. The void was similar in construction to void no. 01. A small number of pipistrelle droppings were recorded to the south and west of the central chimney. Void no. 03 was 'L-shaped' with a height to the ridge of c. 3m. Wooden sarking was present throughout. A small number of BLE droppings were recorded to the western section of the void.

| <b>Ref.</b> | <b>External Assessment</b> | <b>Internal Assessment</b> | <b>Suitability</b> |
|---|---|---|---|
| B1 | Warped/slipped/damaged roof tiles could provide access. Some missing mortar beneath ridge tiles. Small areas of lifted lead flashing. | Small number of pip sp. & Plecotus sp. droppings in void 1, Small numbers of pip sp. droppings in void 2 & 3. | <b>High</b> |

Photograph No. 1 - View of Building B1, assessed as providing High bat roost suitability.

- 5.5 Buildings B1 and B2 have both been assessed as providing bat roost suitability. Although these buildings will not be directly impacted upon by the construction of the new dwelling, refurbishment of these buildings has the potential to disturb/damage a bat roost (*should one be present*) through noise, vibration or blocking access points. Full bat surveys of these buildings are recommended before any works such as roof repair/replacement, repair/replacement of ceilings (which form the base of the loft void), erection of scaffolding which may block access points, demolition of walls etc takes place.

- 6.2 Refurbishment of Building B1 and B2 has the potential to impact upon a bat roost (*should one be present*). Before any works which may affect the roof/void of these buildings (*including erection of scaffolding, works to upstairs ceilings, re-roofing, extensive upstairs wall removal etc*) a full bat survey will be required. Building B1 should be subject to 3 no. survey visits while Building B2 will require 2 no. survey visits. Survey visits should be undertaken during the optimal survey season (*May-September, with at least 2 no. surveys for Building B1 and 1 no. survey for Building B2 undertaken during the peak months of May-August*) and in optimal weather conditions (*+10°C, calm, dry*) in accordance with best practice guidelines (*Bat Surveys for Professional Ecologists: Good Practice Guidelines (BCT, 2016)*).
