Bat Survey Report

Rigates Home Farm

**Climping Street
Climping
West Sussex
BN17 5RQ**

24-038
April 2025

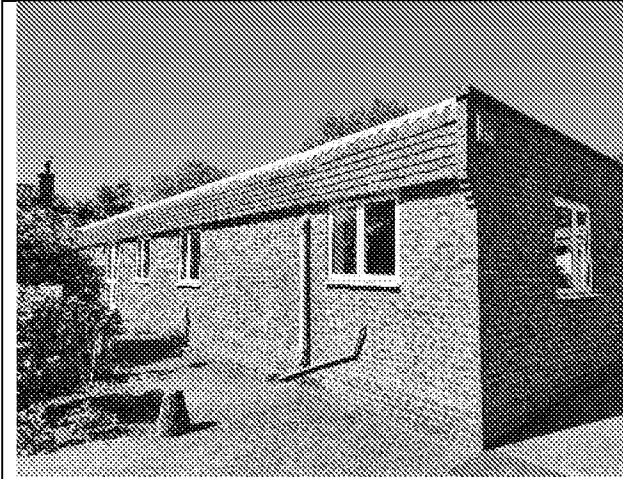
- 4.5 The residential flat is a single storey brick-built building with a flat roof covered by bituminous felt. There is a small timber extension at the southeast corner. Internally there is no enclosed roof void.

Photograph 1 – the residential flat viewed from the southern corner.
