**From:** Amanda Scholes on behalf of Planning.Responses  
**Sent:** 21 September 2018 08:17  
**To:** Planning Scanning  
**Subject:** FW: CM/16/18/PL Dementia Care Centre, rear Bairds Farm Shop, Climping, Littlehampton  
**Attachments:** 2868-BCH-ICS-PH1-XX-DR-C-025-P7-S2 - Highway Improvements[4].pdf; Bairds Farm Revised scheme Stage 1 - ICS Designers Response[3].pdf

## Road Safety Audit Stage 1

Location: Bairds Farm Shop / New Care  
Home Access A259 Crookthorn Lane,  
Littlehampton  
Section 278 Highway works with extra  
shared pedestrian/cycle paths

**Report Title:** Stage 1 Road Safety Audit  
Section 278 Highway Works with pedestrian /cycle paths

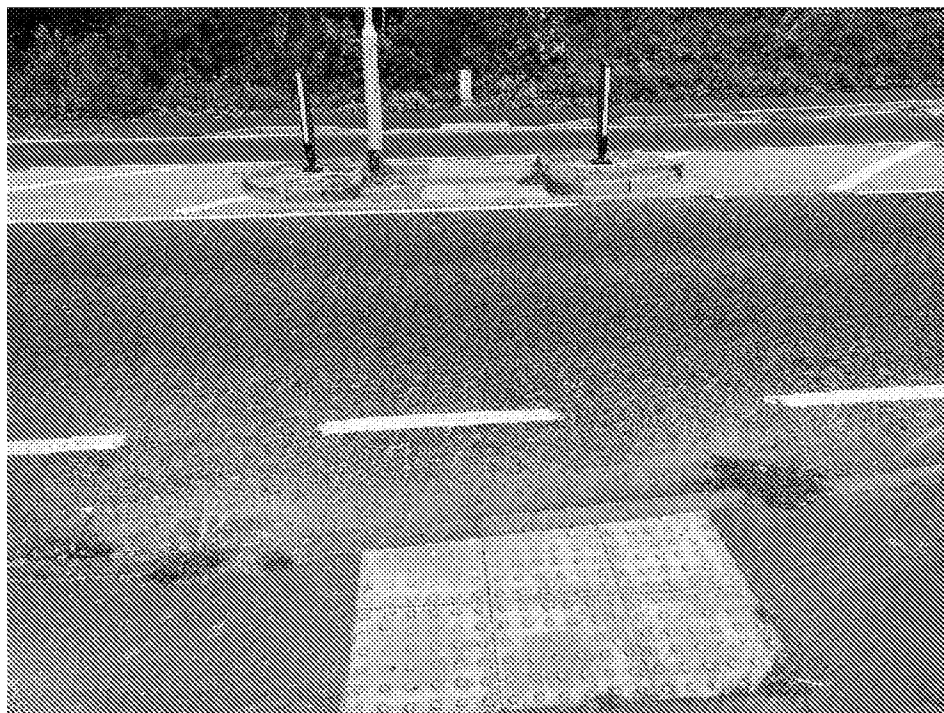
## 8.5 \*Problem\* (item A4.3)

Location: A259 Refuge island

Summary: Inadequate size refuge island for cycles to cross

Description: A new shared use path is detailed along the southern side of A259. Cycles will have to use the existing inadequate size refuge island to cross over the road between cycle paths. This island needs to be increased in size to include a minimum of 2m width and 3m length standing area to cater for cycles

Type of conflict/collision: Cycles unable to wait safely in middle refuge island

**Recommendation: Increase size of refuge island to cater for cycles.**

| <p style="text-align: center;"><b>Stage Road Safety Audit</b></p> <p style="text-align: center;"><b>SAFETY AUDIT EXCEPTION RESPONSE</b></p> | | |
|---|---|---|
| 8.5 | Inadequate size refuge island for cycles to cross | Refuge within both islands increased |

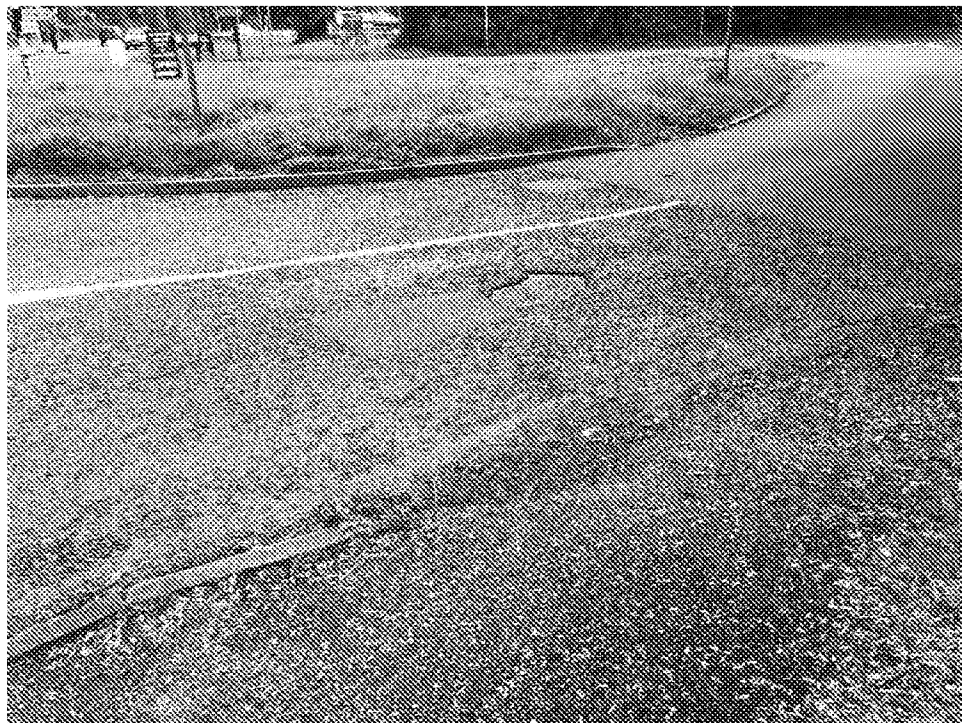
## 8.6 \*Problem\* (item A4.3)

Location: Climping Street western leg at junction

Summary: Poor surfacing inline of proposed crossing point

Description: A new footway and pedestrian crossing point is detailed across Climping Street. The existing carriageway surfacing is in poor condition and has potholes in line with the new crossing point that will be a trip hazard to pedestrians. This surfacing needs to be repaired

Type of conflict/collision: Pedestrians tripping crossing road

**Recommendation: Fix potholes ( Local Authority responsibility ).**

| <p style="text-align: center;"><b>Stage Road Safety Audit</b></p> <p style="text-align: center;"><b>SAFETY AUDIT EXCEPTION RESPONSE</b></p> | | |
|---|---|---|
| 8.6 | Poor surfacing inline of proposed crossing point | No action. Highway maintenance issue |
