# River Condition Assessment Report of Ryebank Rife to the South-east of Bairds Business Park, Grevatt's Lane, Littlehampton, BN17 5RE.

| <b>Site</b> | Bairds Business Park, Grevatt's Lane, Littlehampton, BN17 5RE.<br>Approx. grid reference SU9951401189. |
| <b>Survey Date</b> | 2.3.26 |

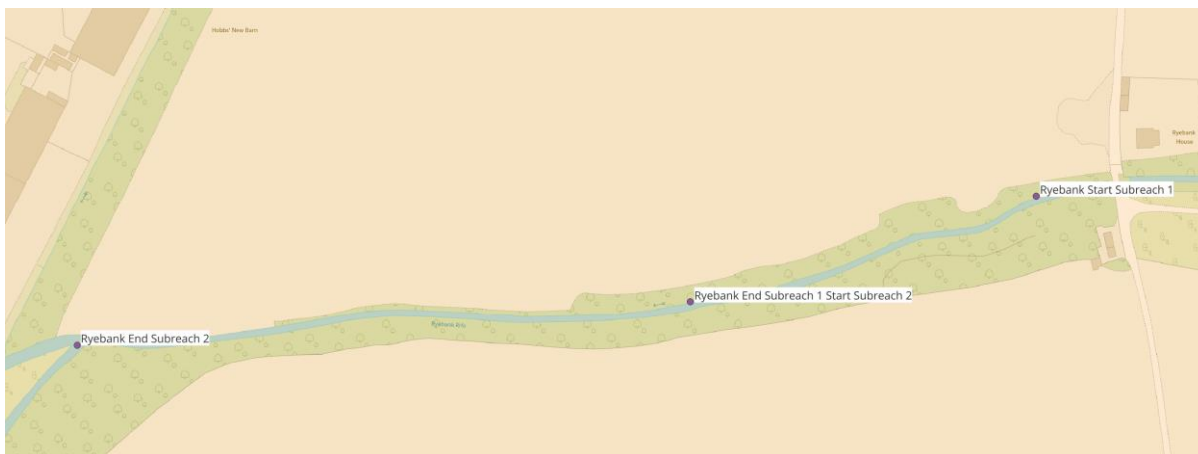
Fig 1 Map of Ryebank Rife Subreaches (Contains OS data © Crown Copyright and database right 2026)

- **Subreach 1** covers the upstream length from the east boundary, defined by the river section opposite a gate over the track, characterised by historic embanking on both of the river banks. This section also has natural 10m riparian zones.
- **Subreach 2** covers the downstream length from the end of the embanked river banks, extending downstream to the outflow on the left bank leading to the sea. This

includes a bridge culvert, and weirs created by log rounds. This section has minor encroachment by arable agriculture of the riparian zone.
