## **MR GARY LOVE**

### **Climping Mill, Climping, West Sussex**

- Preliminary Ecological Appraisal Survey
- Day-time Bat Roost Assessment

| Document Reference | LLD1260 |

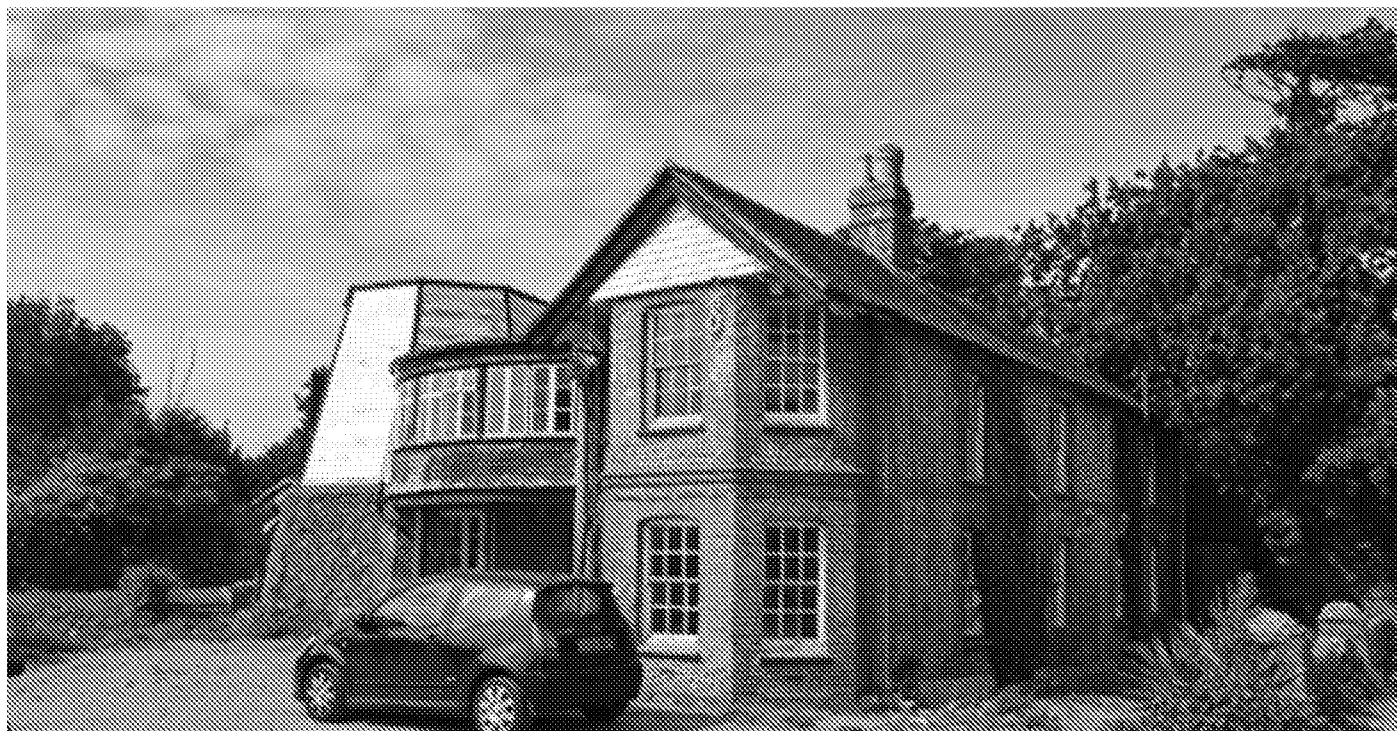
- 4.3.2 A large building of flint and brick construction which appears to have been extended numerous times over the years. The old windmill is still present, albeit with the top section and sails removed, and is attached to the main building via a flat roofed 'sun room'. The main section of building then extends along a north-south axis with a double gable roof, one section of which is clad in clay tile while the other is slate. The northern-most end of the building appears to be most recently constructed being an 'L' shape building of brick construction with tile roof.

- 4.3.3 Internally the building contains 3 no. open roof voids. Void no. 01 measures approximately 12m x 2.5m with a height to the ridge of c. 1.5m. The void is of traditional rafter construction with a mixture of BRM and bitumen roofing felt. Numerous rat and mouse droppings were recorded throughout. A small number of brown long-eared bat and pipistrelle sp. droppings were recorded at the point where the sun room joins adjoins this area. Void no. 02 measures approximately 16m x 3m with a height to the ridge of c. 1.5m. The void was similar in construction to void no. 01. A small number of pipistrelle droppings were recorded to the south and west of the central chimney. Void no. 03 was 'L-shaped' with a height to the ridge of c. 3m. Wooden sarking was present throughout. A small number of BLE droppings were recorded to the western section of the void. The evidence found suggests that the building supports only a low number of common species (if any at all) and that any roost present is of low conservation significance.

| <b>Ref.</b> | <b>External Assessment</b> | <b>Internal Assessment</b> | <b>Suitability</b> |
|---|---|---|---|
| B1 | Warped/slipped/damaged roof tiles could provide access. Some missing mortar beneath ridge tiles. Small areas of lifted lead flashing. | Small number of pip sp. & Plecotus sp. droppings in void 1, Small numbers of pip sp. droppings in void 2 & 3. | <b>High</b> |

Photograph No. 1 - View of Building B1, assessed as providing High bat roost suitability.

- 5.5 Buildings B1 and B2 have both been assessed as providing bat roost suitability. Although these buildings will not be directly impacted upon by the construction of the new dwelling, refurbishment of these buildings has the potential to disturb/damage a bat roost (*should one be present*) though noise, vibration or blocking access points.

- 5.6 Full bat surveys of these buildings are recommended before any works such as roof repair/replacement, repair/replacement of ceilings (which form the base of the loft void), erection of scaffolding which may block access points, demolition of walls etc takes place. Neither of these buildings are suggested to support a roost of high conservation value (*if at all*) and, subject to survey results, suitable mitigation measures could easily be incorporated into the scheme at a later date.

- 6.3 Building B1 should be subject to 3 no. survey visits while Building B2 will require 2 no. survey visits. Survey visits should be undertaken during the optimal survey season (*May-September, with at least 2 no. surveys for Building B1 and 1 no. survey for Building B2 undertaken during the peak months of May-August*) and in optimal weather conditions (*+10°C, calm, dry*) in accordance with best practice guidelines (*Bat Surveys for Professional Ecologists: Good Practice Guidelines (BCT, 2016)*).

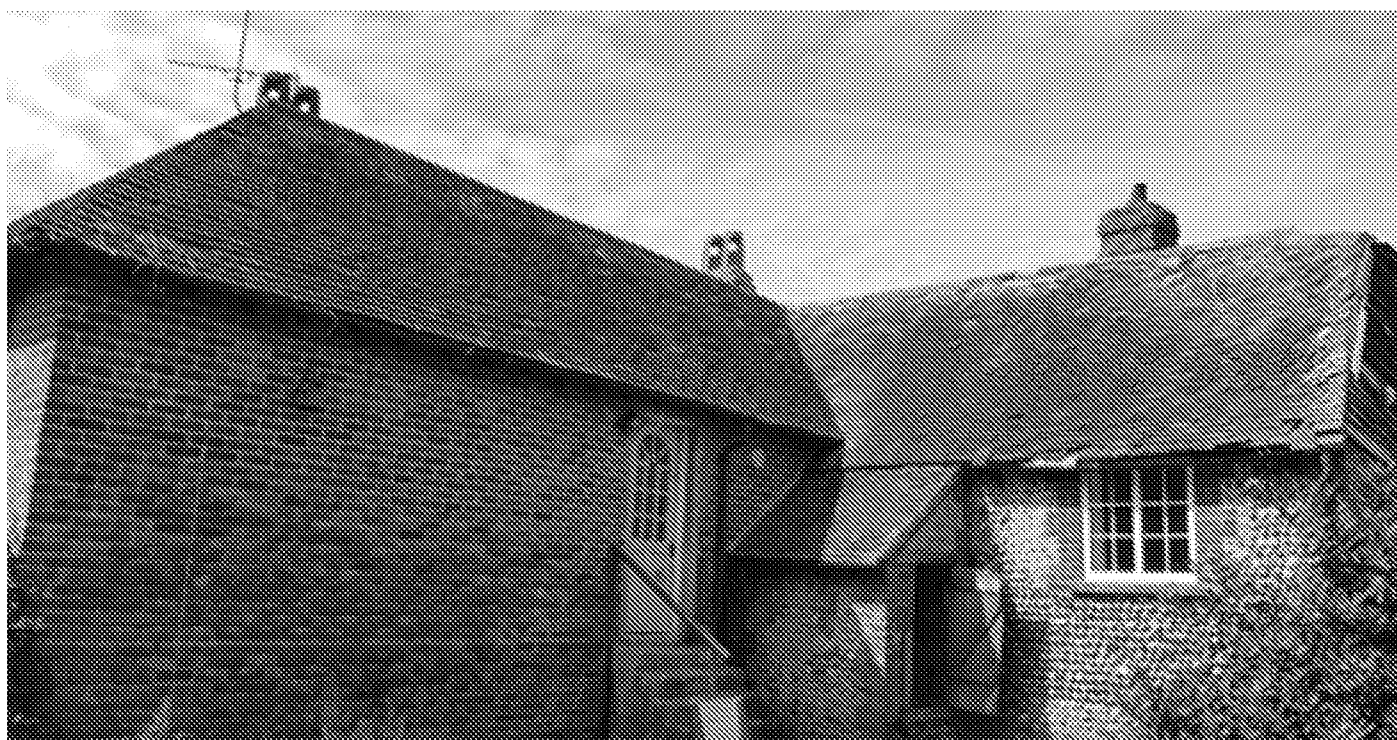
- 4.3.4 A small single-storey flint and brick cottage with clay tile roof. The roof is in poor condition with numerous slipped/broken tiles recorded throughout. Internally, the roof void contained a moderate amount of cobwebs as well as mouse droppings. No roofing membrane was present resulting in large amounts of debris within the void. Access was limited however a small number of droppings of a size and shape characteristic of pipistrelle sp. were recorded around the loft hatch. Similarly to Building B1, the evidence found suggests that any roost present is of low conservation significance.

| <b>Ref.</b> | <b>External Assessment</b> | <b>Internal Assessment</b> | <b>Suitability</b> |
|---|---|---|---|
| B2 | Numerous warped/missing/lifted roof tiles. | No roof membrane. Limited access into the roof void; small number of pipistrellus sp. droppings recorded near the roof hatch. | <b>Moderate</b> |

Photograph No. 2 - Building B2, assessed as providing moderate bat roost suitability.

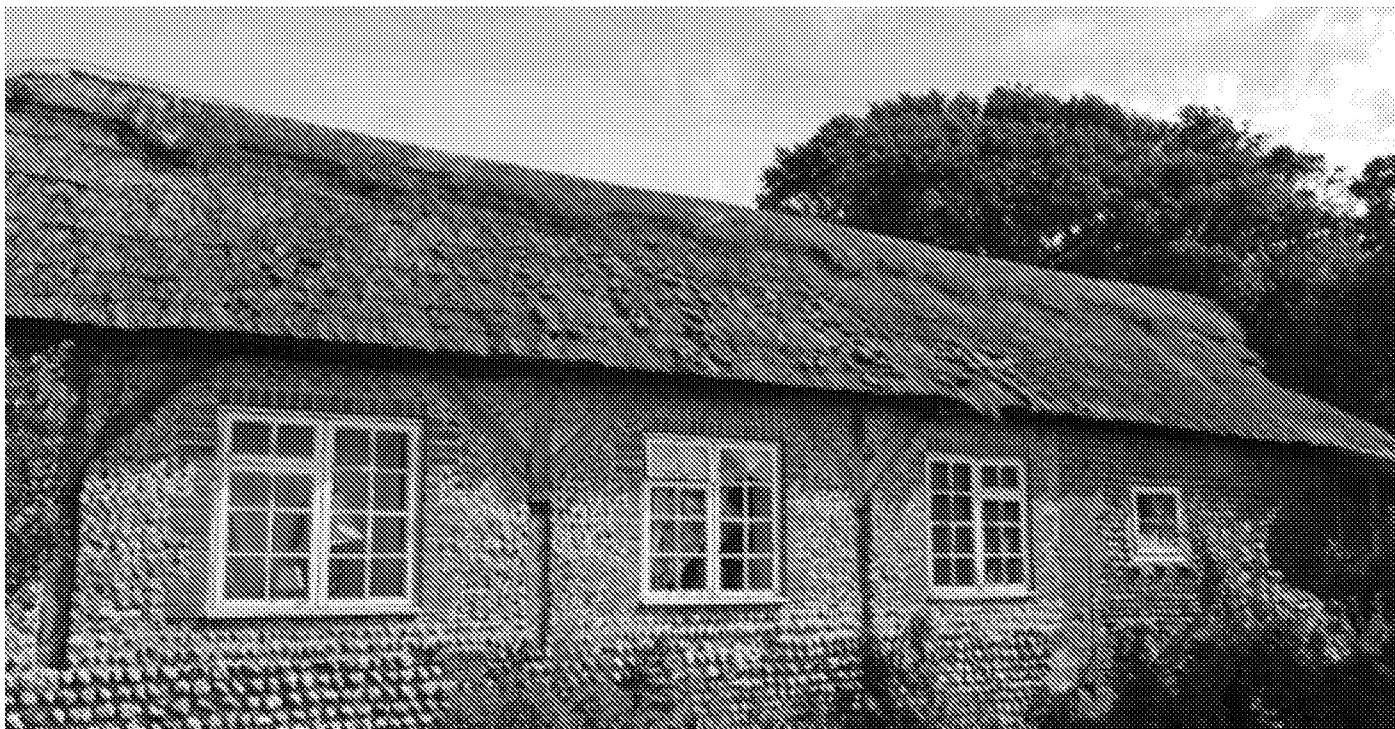
- 4.3.5 A single storey flint cottage with thatch roof in poor condition. Deterioration of the thatch has resulted in reasonably high light levels within the roof void. Dense cobwebs were noted throughout as well as ivy ingress. No evidence of bats was recorded internally/externally.

| <b>Ref.</b> | <b>External Assessment</b> | <b>Internal Assessment</b> | <b>Suitability</b> |
|---|---|---|---|
| B3 | Potential access at the eaves. | No evidence internally. Void considered too light to support a roost. No potential for crevice dwellers in the thatch. | <b>Negligible</b> |

Photograph No. 3 - Building B3, assessed as providing negligible bat roost suitability.

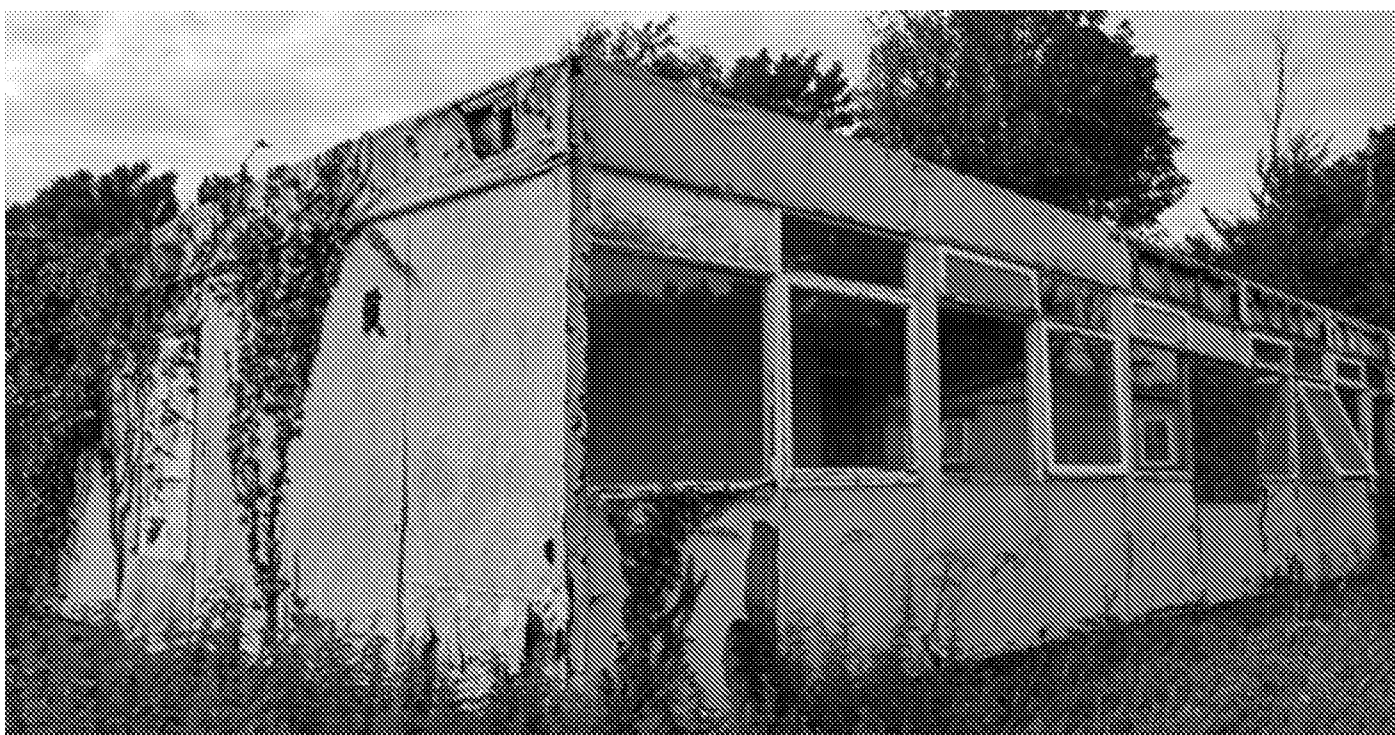
- 4.3.6 Building B4 was formerly utilised by the private school which used to own the site. The large pre-fabricated flat roofed building has fallen into a state of disrepair and now has numerous missing windows, collapsed ceilings and holes in the roof. In its current state the building is considered to be too damp, draughty and light to support a bat roost.

| <b>Ref.</b> | <b>External Assessment</b> | <b>Internal Assessment</b> | <b>Suitability</b> |
|---|---|---|---|
| B4 | In very poor condition, damp and draughty throughout. | No roof void. | <b>Negligible</b> |

Photograph No. 4 - Building B4, assessed as providing 'negligible' bat roost potential.

- 6.4 Buildings B4 and B5 have been assessed as offering '*negligible*' bat roost suitability. The demolition of these buildings to facilitate the construction of the new dwelling on site is considered unlikely to contravene *The Conservation of Habitats and Species Regulations 2010*. No further survey work of these buildings is recommended.
