**Scyld, Horsemere Green Lane, Climping**

- Preliminary Ecological Appraisal Report
- Preliminary Bat Roost Assessment

**Planning Issue**

| Project Reference | LLD1488 |

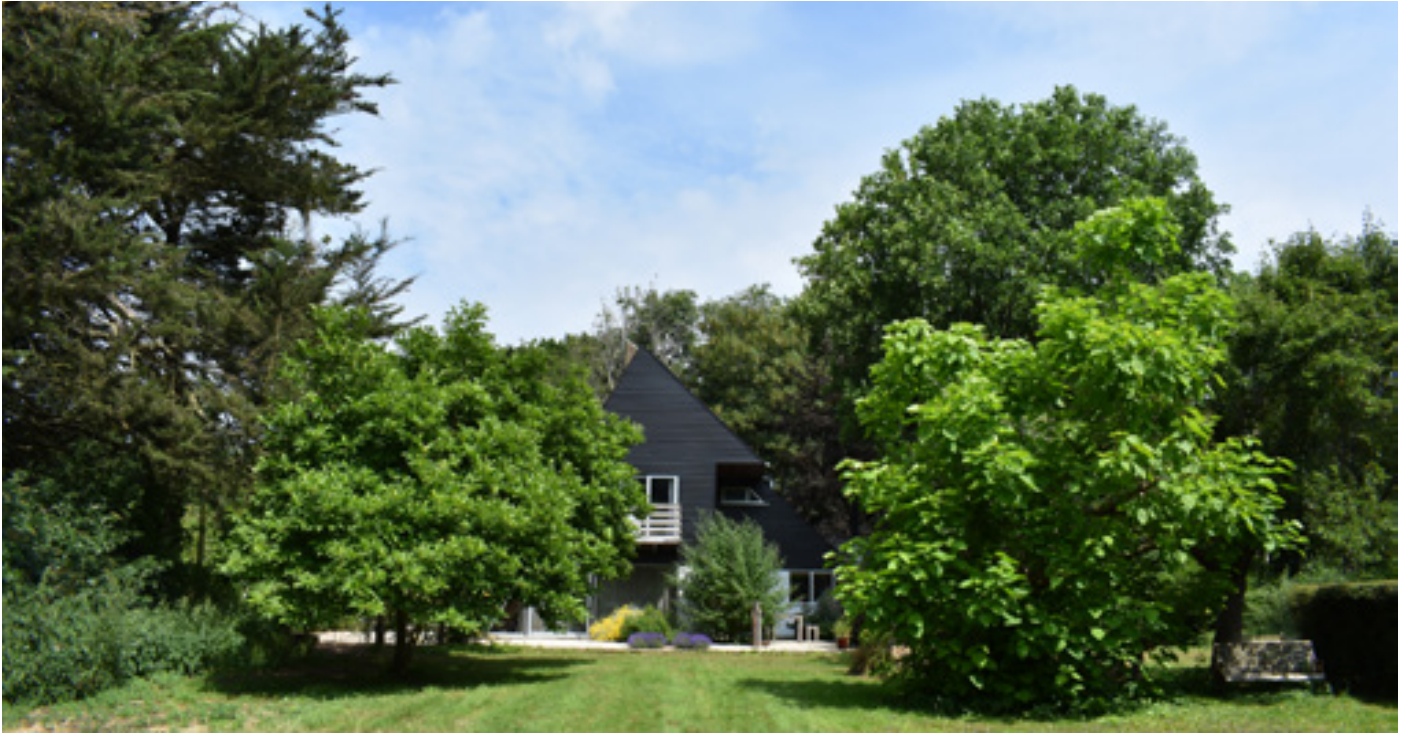
**Photograph No. 01 - Southern aspect of the existing residential property with adjacent amenity lawn, surrounding introduced shrubs and scattered trees, including magnolia (*Magnolia sp.*), indian bean (*Catalpa sp.*) and tulip tree (*Liriodendron sp.*).**

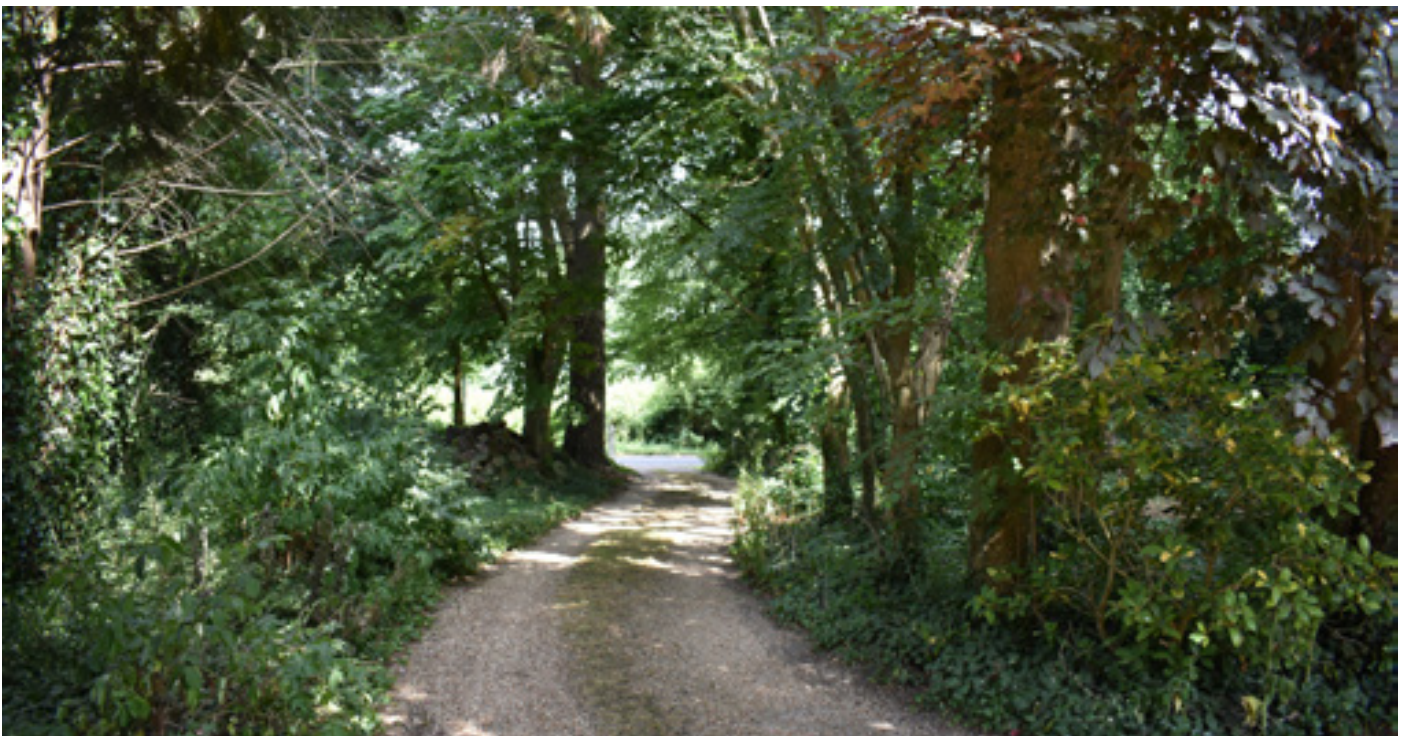
**Photograph No. 02 - Wooded driveway from the existing property, leading north towards the top of the property line and Horsemere Green Lane running parallel with the site.**

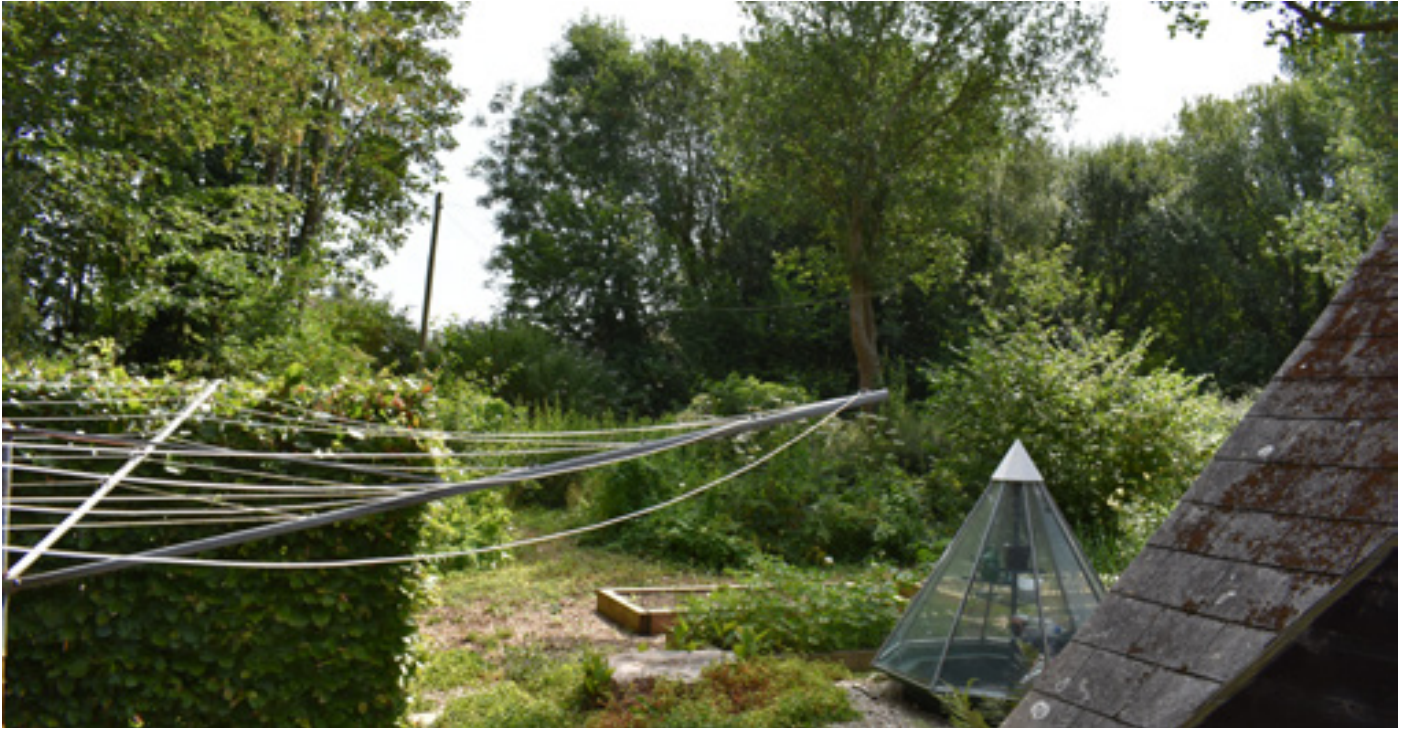
**Photograph No. 03 - A mixture of habitat parcels between the existing property and eastern border, including introduced shrubs, tall ruderal vegetation and wooded edge.**

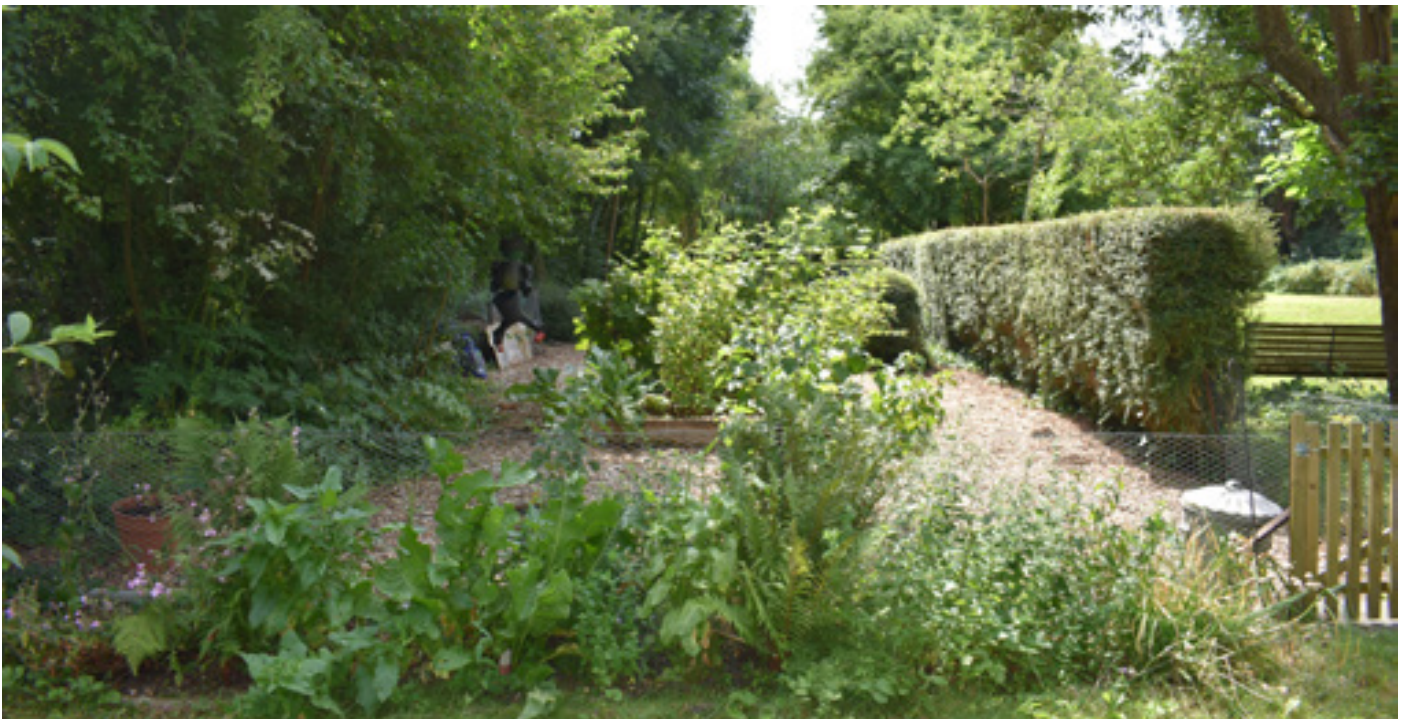
**Photograph No. 04 - A vegetable garden with introduced plant species including, Raspberry (*Rubus idaeus*), Rhubarb (*Rheum rhabarbarum*) and Gooseberry (*Ribes uva-crispa*).**

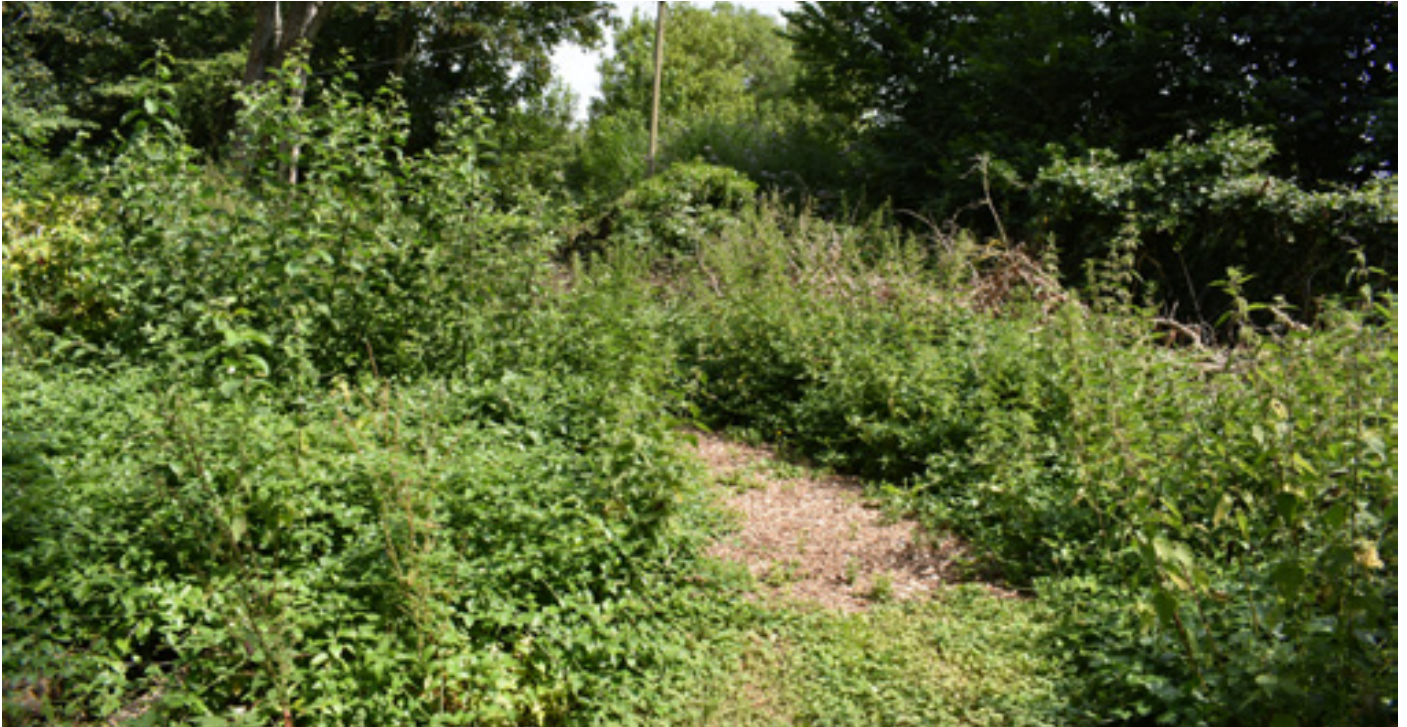
**Photograph No. 05 - The tall ruderal adjacent to the property on the eastern edge, provides good reptilian habitat, this provides similar benefits as the tall ruderal found on the southern boundary line.**

- 7.3 Due to the presence of suitable habitat on site, a full reptile survey is recommended to ascertain the presence / absence of reptiles on site. The survey should include 7 no. survey visits in suitable weather conditions (9-18°C, sunny, dry) during the optimal survey season (*mid-March – October with April June and September – October being peak months*).

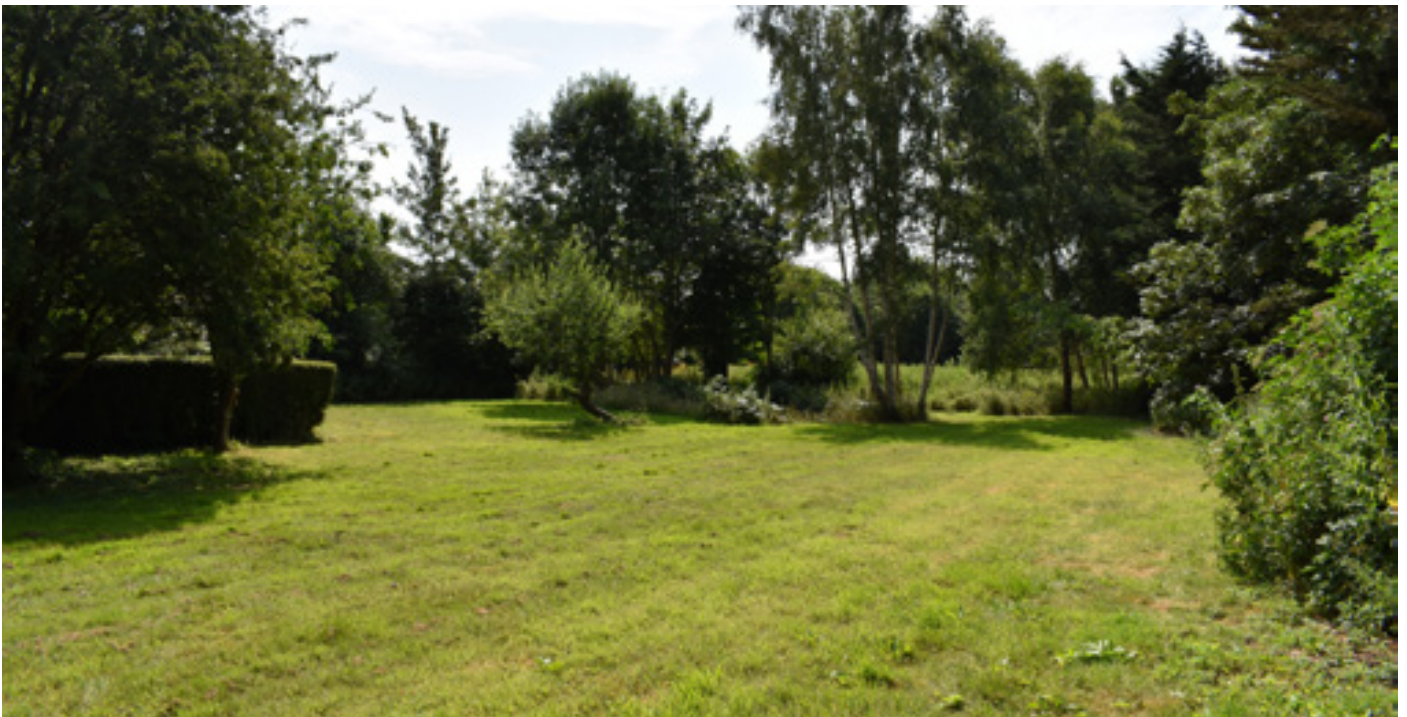
**Photograph No. 06 - The amenity grassland species composition is typical of its type, dominated by Perennial Rye-grass (*Lolium perenne*) and Yorkshire Fog (*Holcus lanatus*), interspersed with occasional Clover (*Trifolium repens*)**

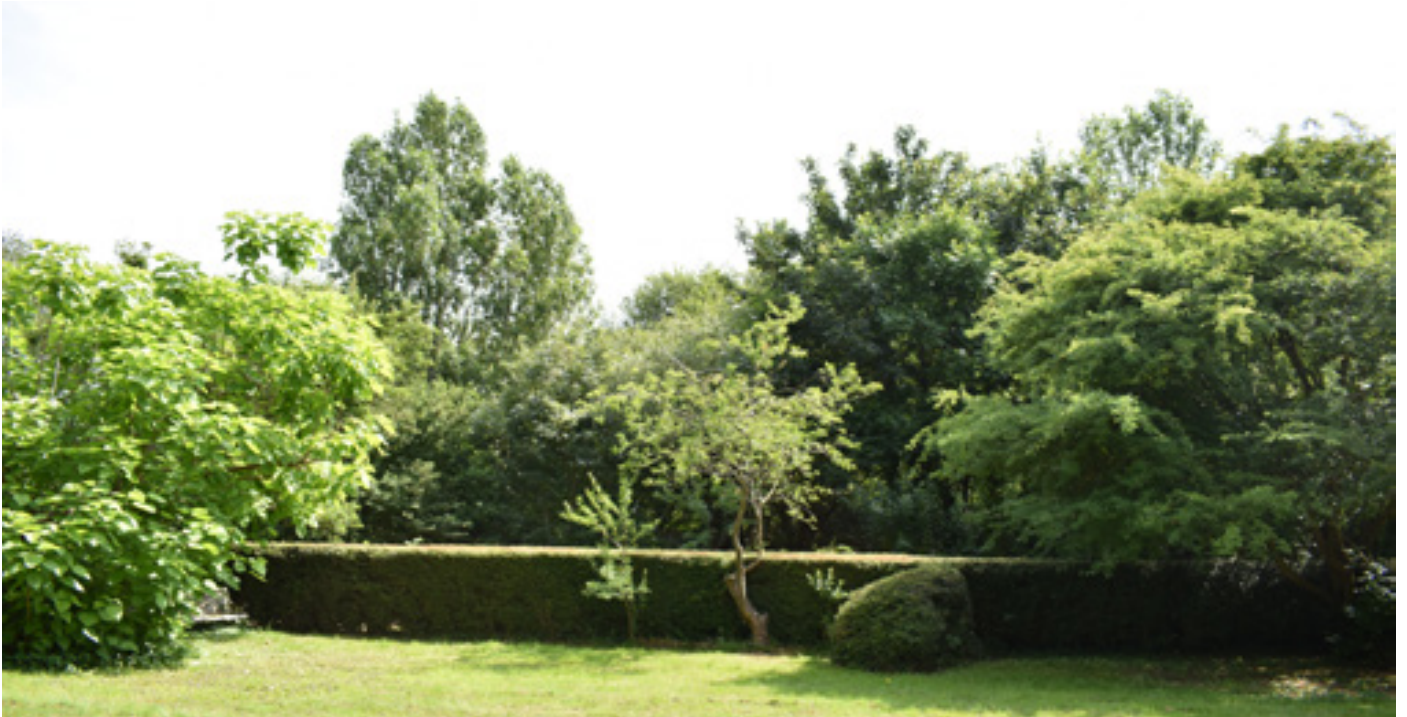
**Photograph No. 07 - Cotoneaster (*Cotoneaster sp.*) hedge border between the vegetable garden and eastern boundary.**

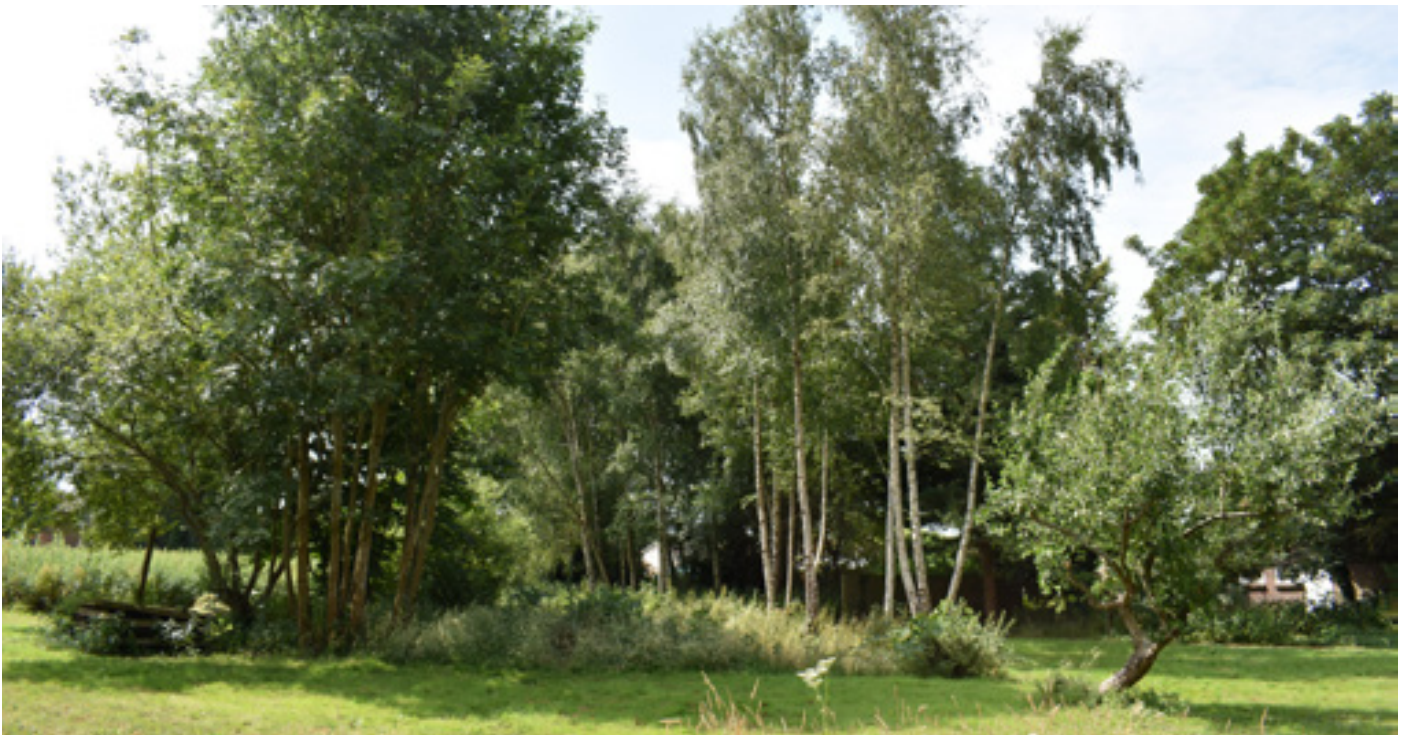
**Photograph No. 08 - Scattered tree line located between the amenity lawn and tall ruderal habitats, near to the southern boundary with a stack of wooden pallets providing suitable reptilian habitat.**

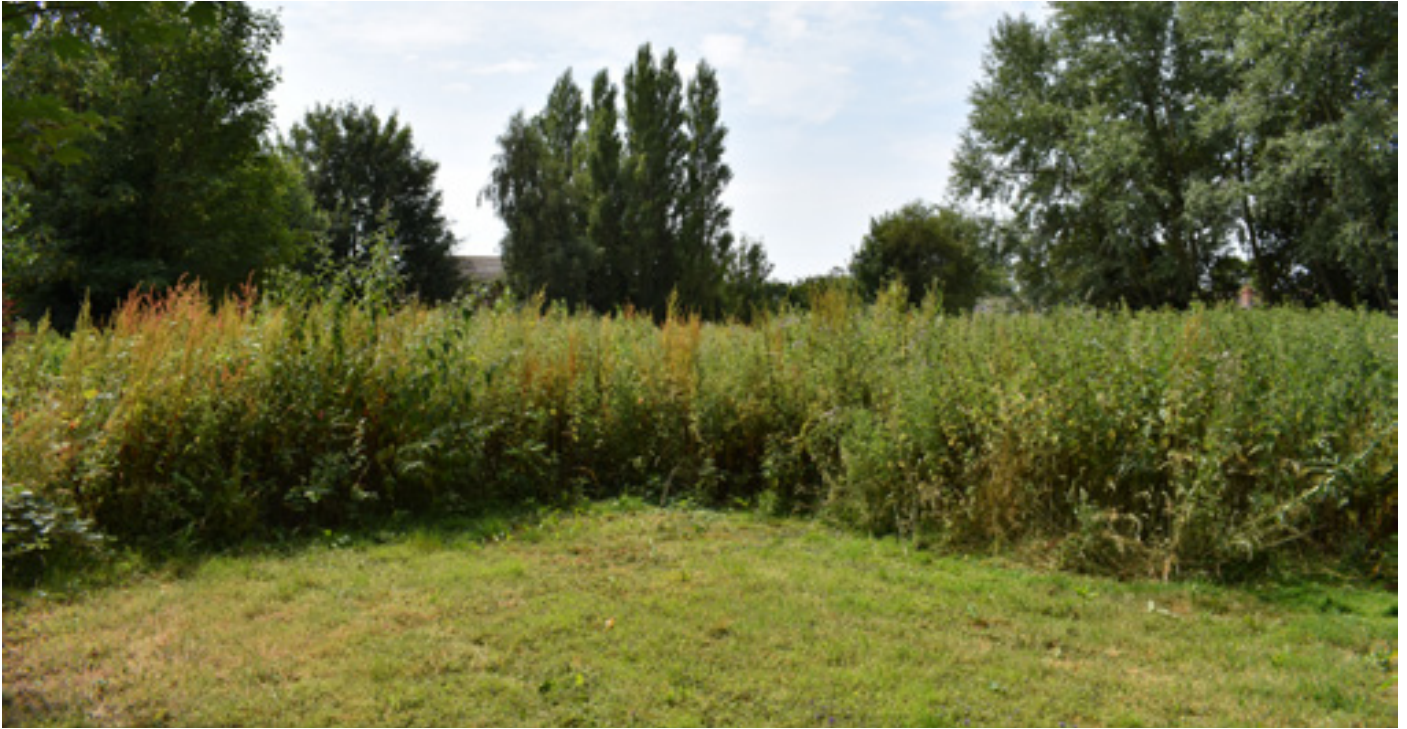
**Photograph No. 09 - Tall ruderal located on the southern boundary, surrounded by a tree lined border and neighbouring gardens beyond the site.**

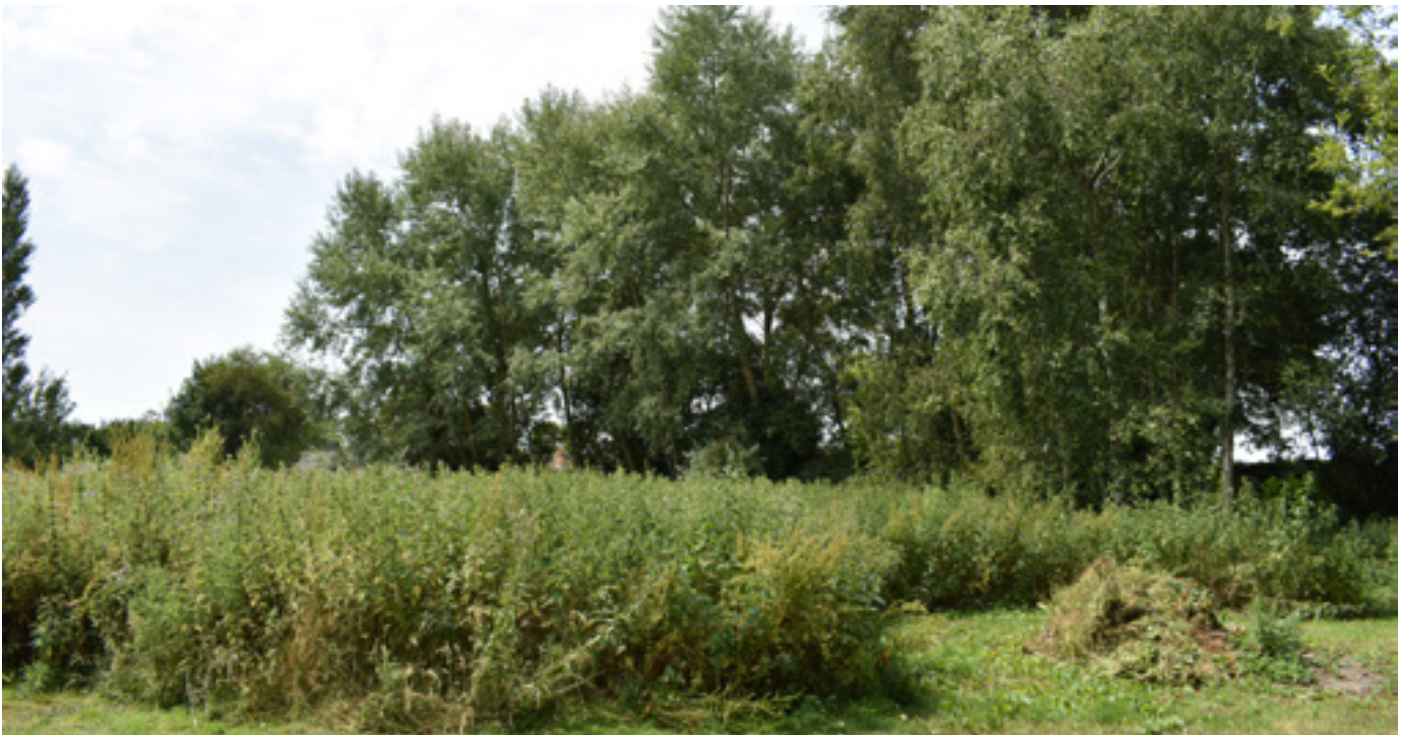
**Photograph No. 10 - Tall ruderal with dominating Nettles (*Urtica dioica*) and Broadleaved Dock (*Rumex obtusifolius*) forming a suitable reptilian habitat.**

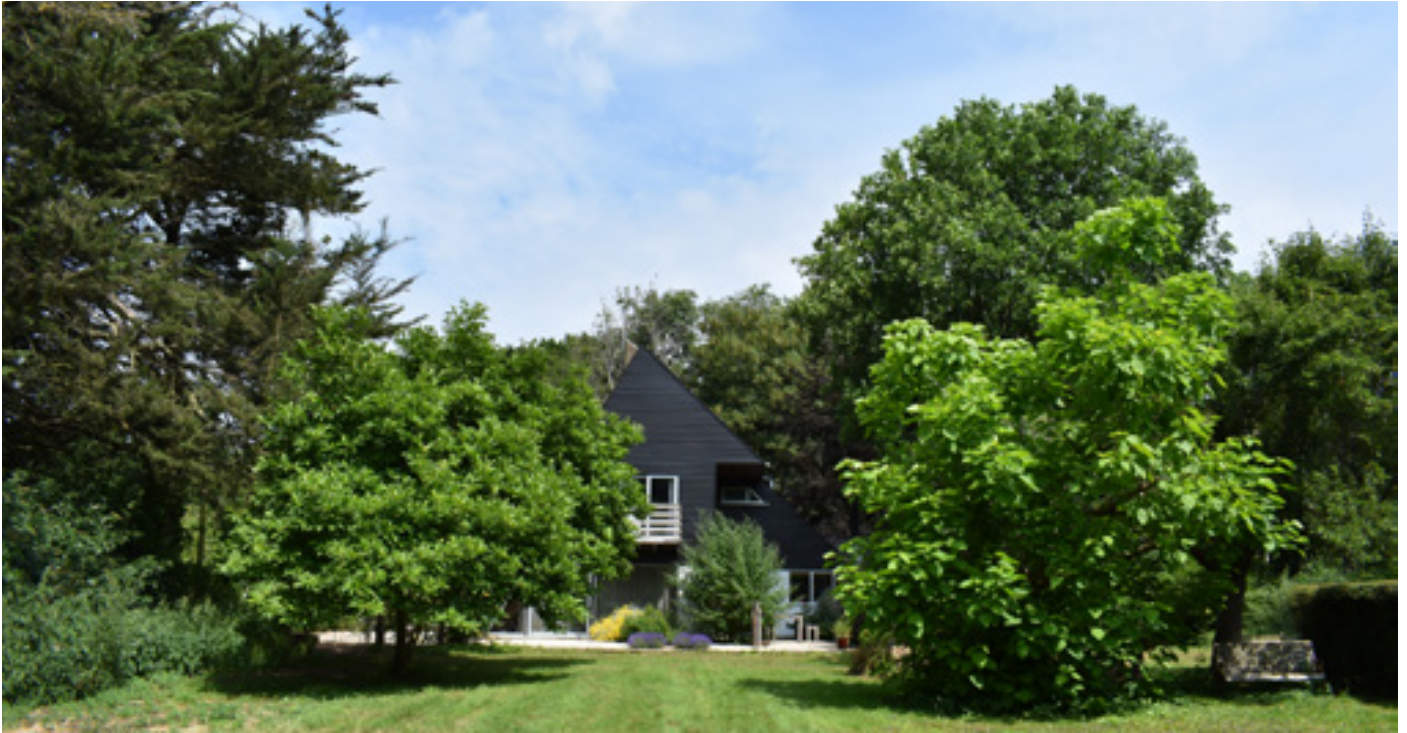
**Photograph No. 01 - Southern aspect of the existing residential property with adjacent amenity lawn and scattered trees, the building is of a bespoke architectural design.**

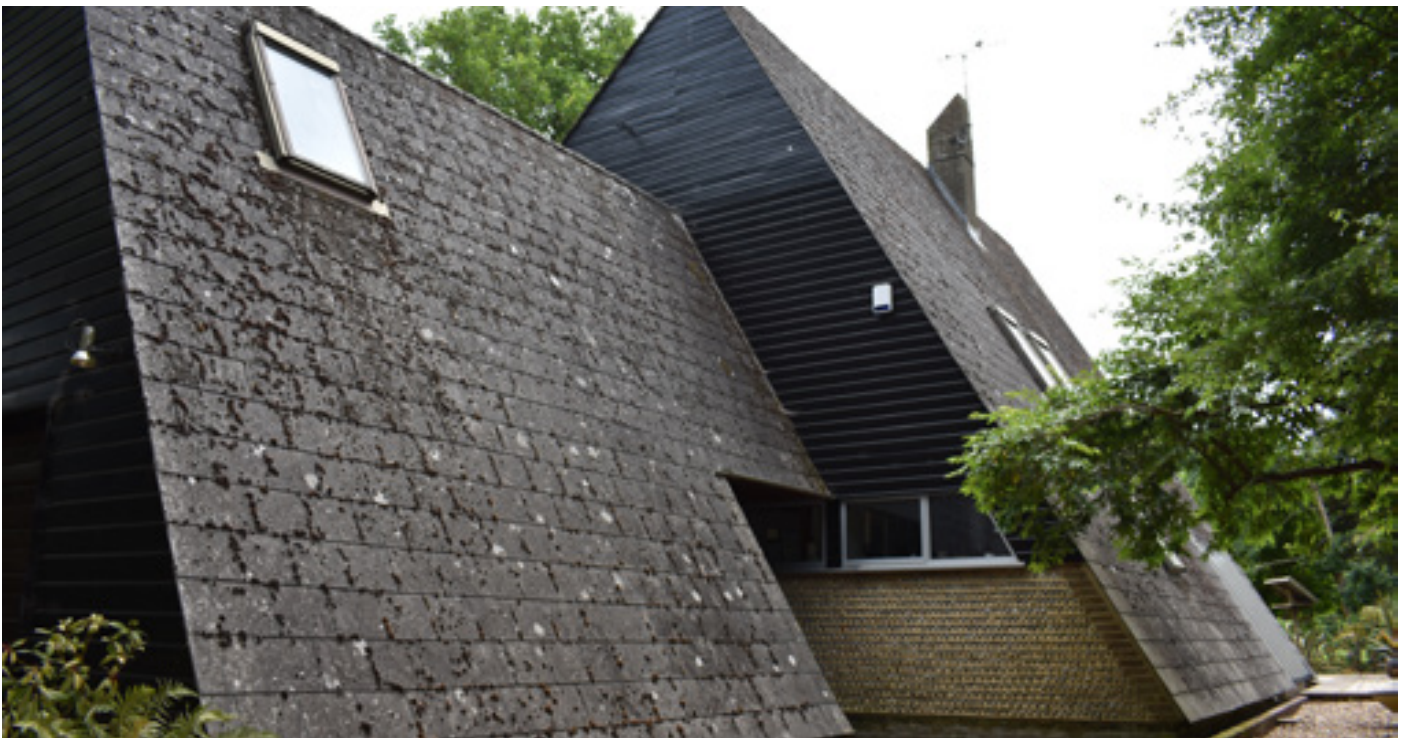
**Photograph No. 02 - Formed of 2 no. triangular structures linked via the garage and main building. On the Eastern aspect (*shown*), the roof runs the entire length of the building, and sits within 10 cm of the ground.**

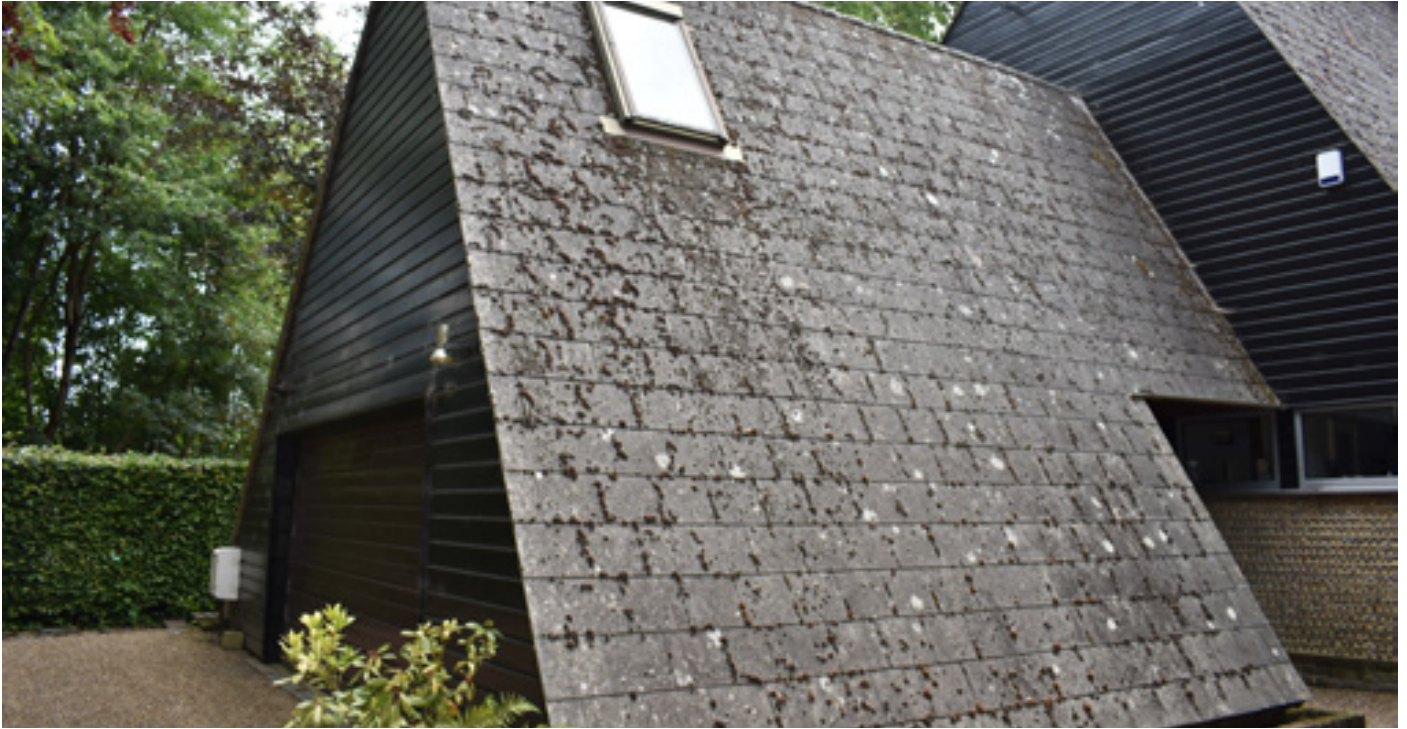
- 6.3 The existing building on site was extensively examined for any evidence of bats such as droppings, urine marks, feeding remains or grease stains; no evidence of bats was found. The thin concrete tiled roof construction and lack roof void reduce the suitability of the building for supporting a bat roost.

Photograph No. 03 - The tiles are made of thin concrete material with very little or no gaps between one another. The smaller (*garage*) structure contains; 1 no. window on the western side, tightly sealed into the roof and tiles with little or no gaps around it. The northern aspect consists of wood-  
en sidings and metal garage door.

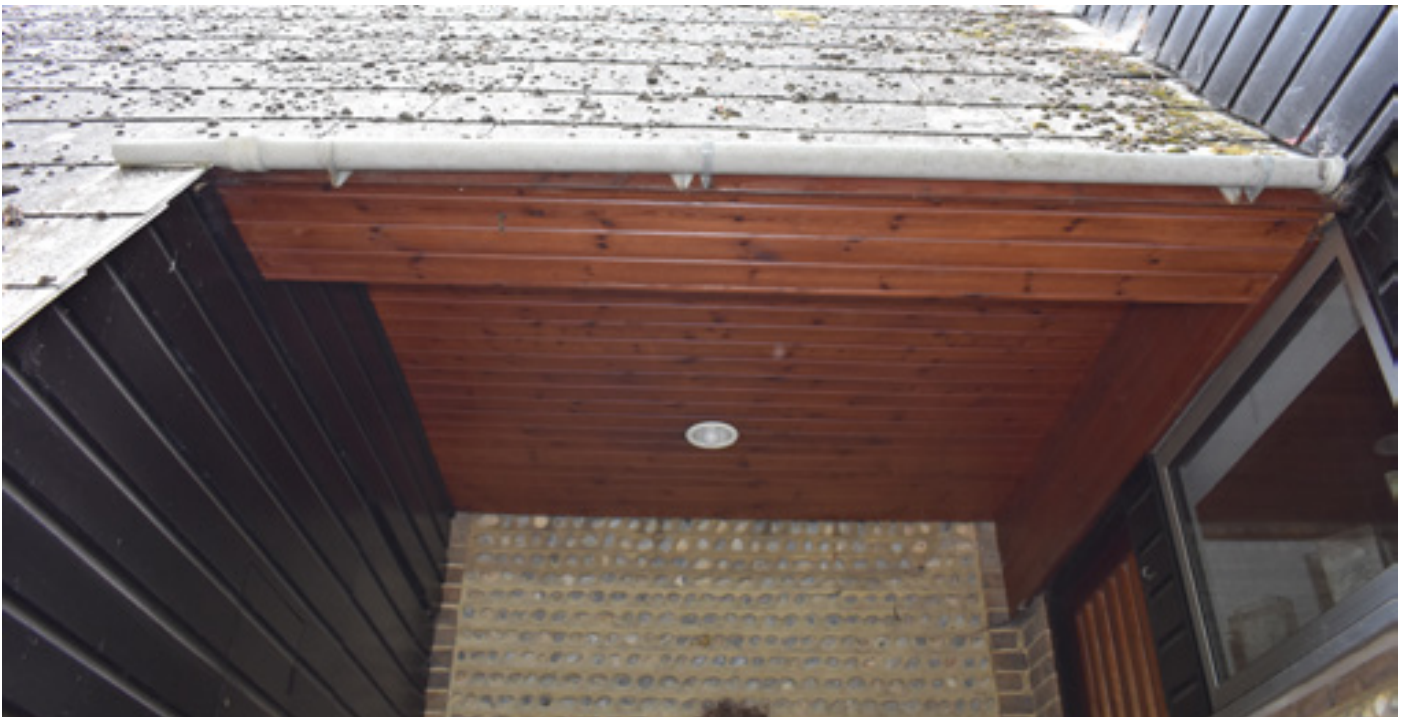
Photograph No. 04 - Connecting section between garage and main house, all materials sealing the wall and porch areas are aligned and tightly fitted into place against one another, no gaps are visible.

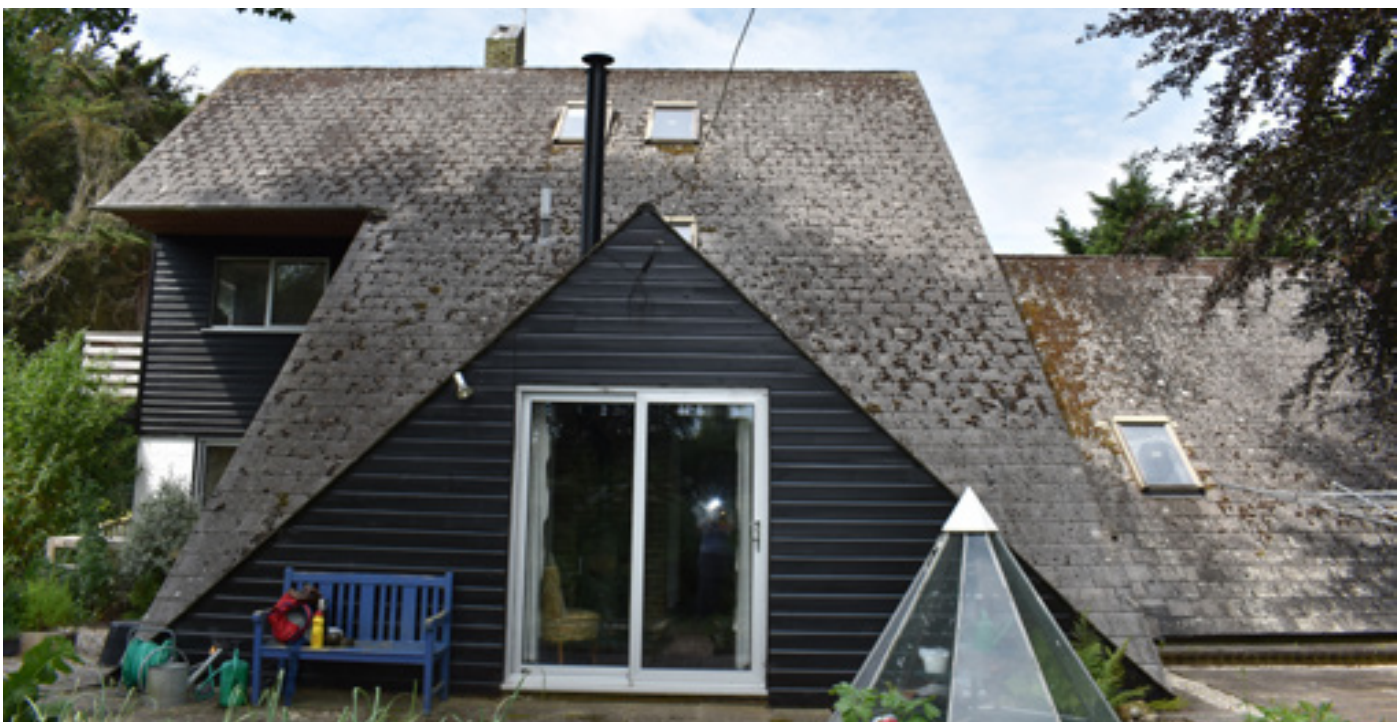
**Photograph No. 06 - The eastern aspect of the property is covered in mainly the concrete tiles, all windows and doors are fitted tightly into the roof and walls with no visible gaps suitable for bat roosting.**

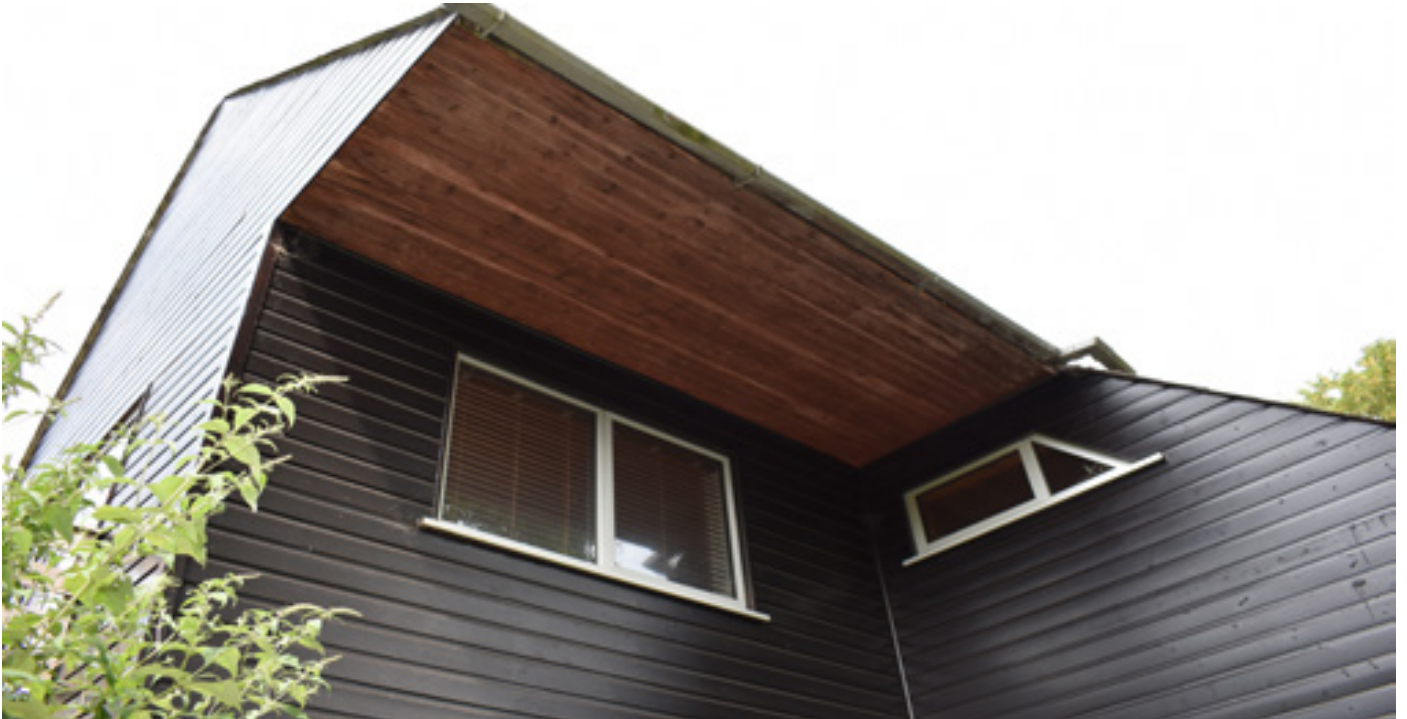
**Photograph No. 07 - The wooden sidings on the eastern aspect were also noted as tightly fitted with no visible gaps suitable for bat roosting.**

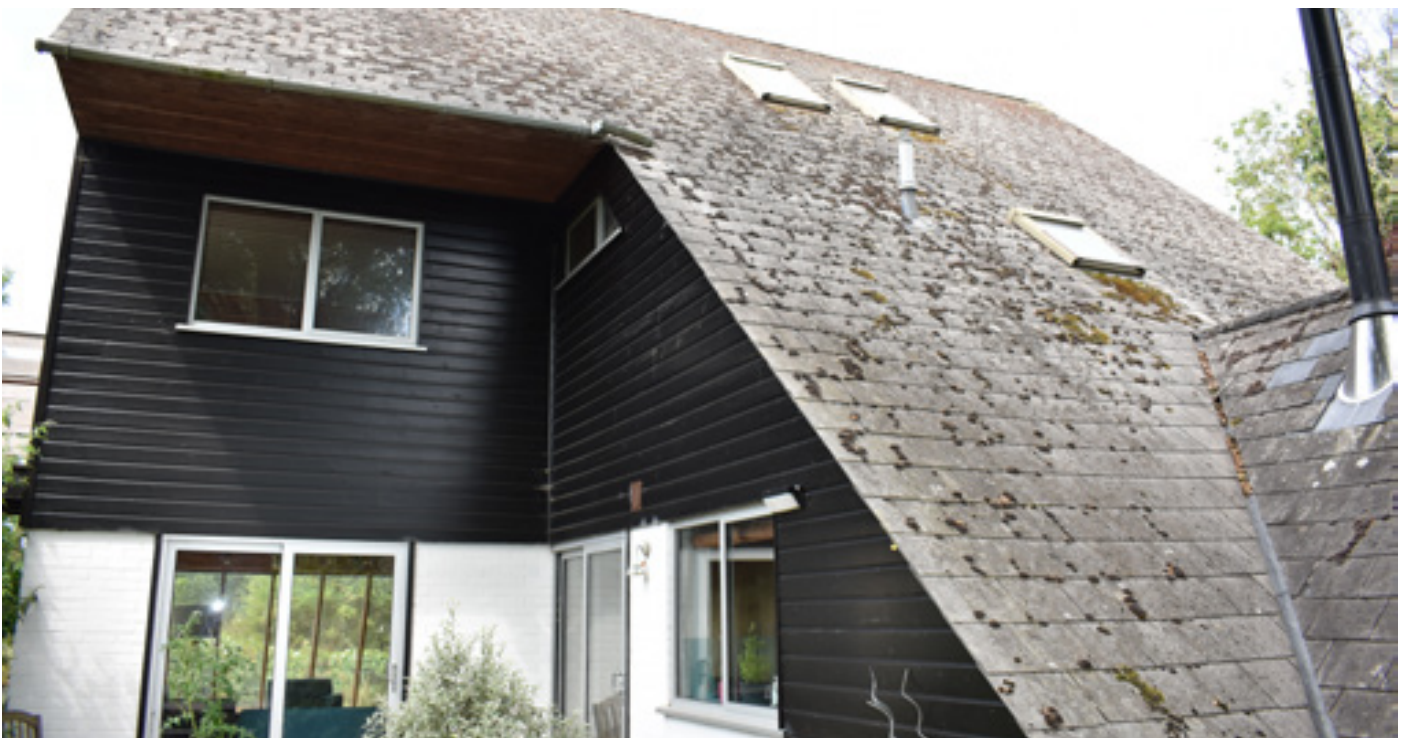
**Photograph No. 08 - The eastern aspect of the property covers many angles and edges, all have limited potential for bat roosts.**

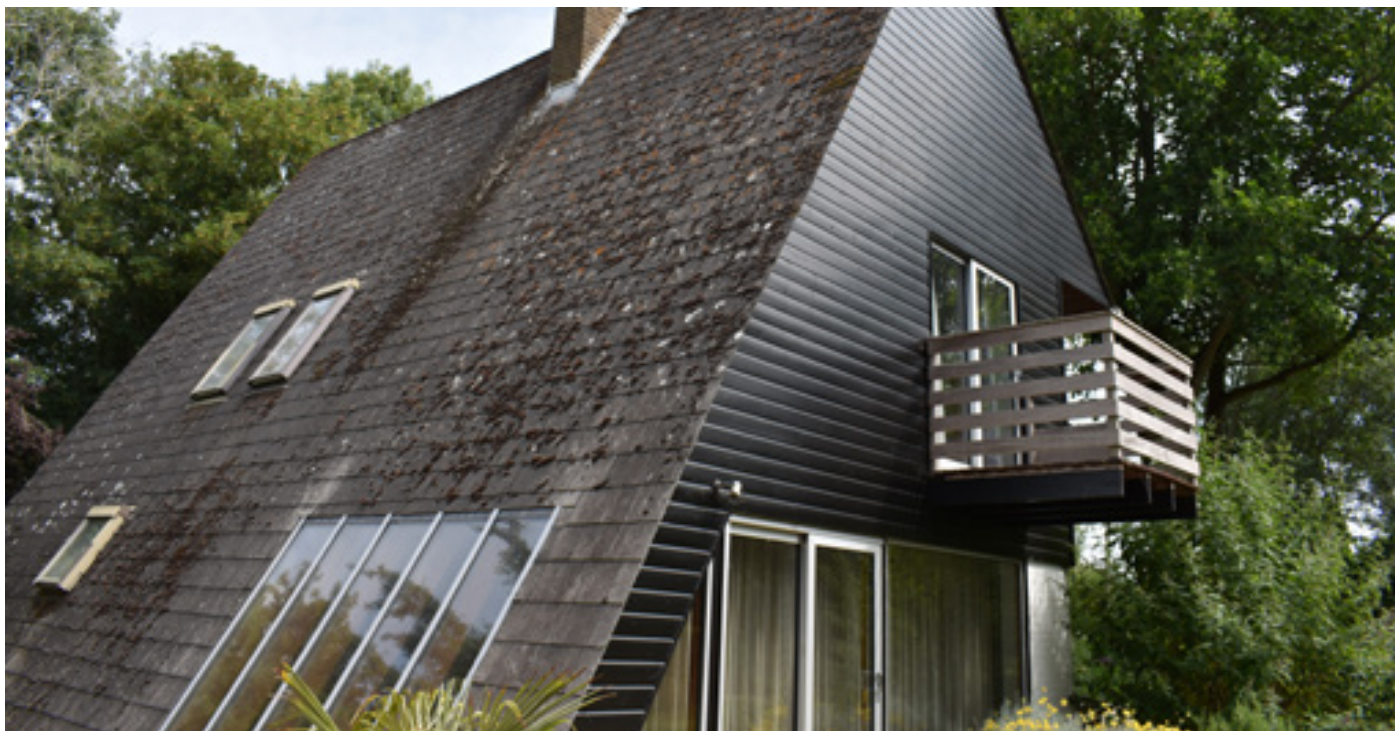
**Photograph No. 09 - The main house structure on the western aspect is covered in mainly concrete tiles, with 4 no. windows. All of the windows are fitted tightly into the roof with no visible gaps suitable for bat roosting.**

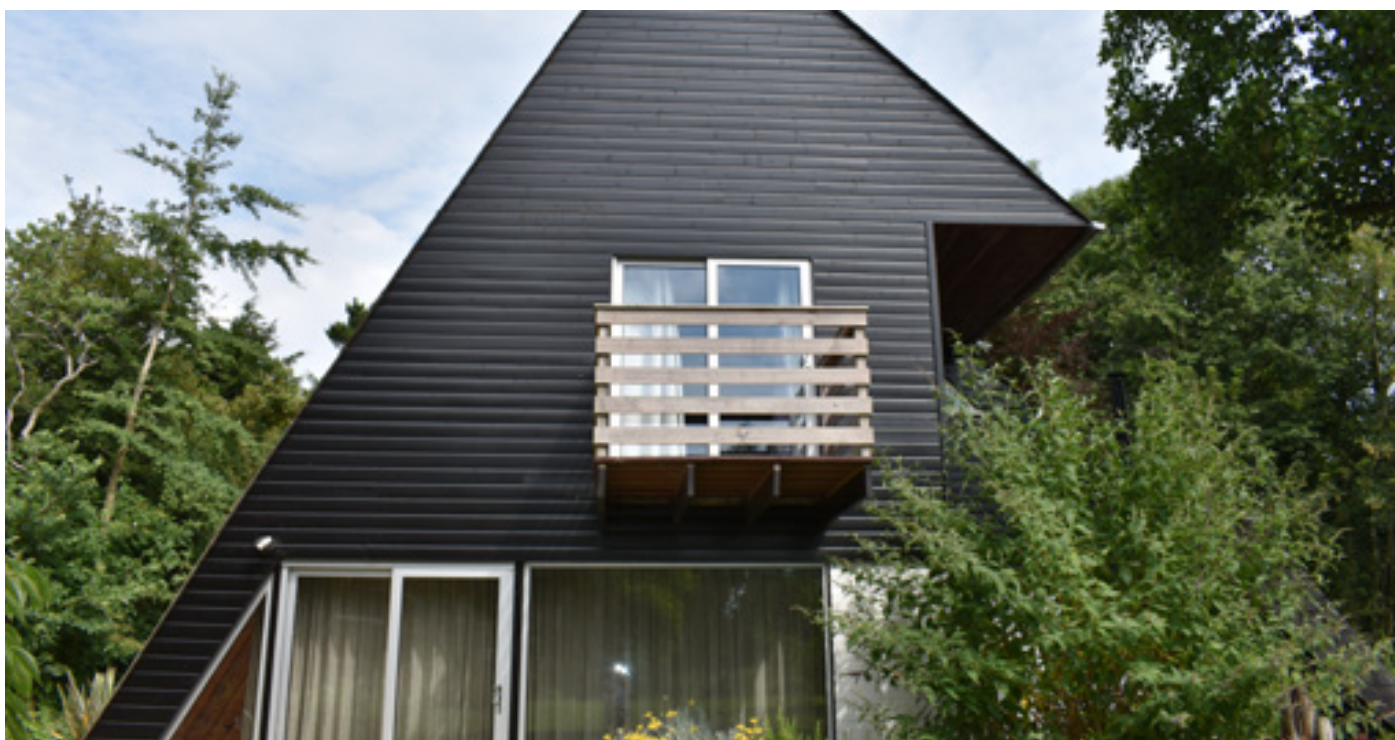
**Photograph No. 10 - The southern aspect is covered in wooden sidings with small balcony and patio doors fitted tightly against the wooden frames. No visible gaps suitable for bat roosts were noted.**

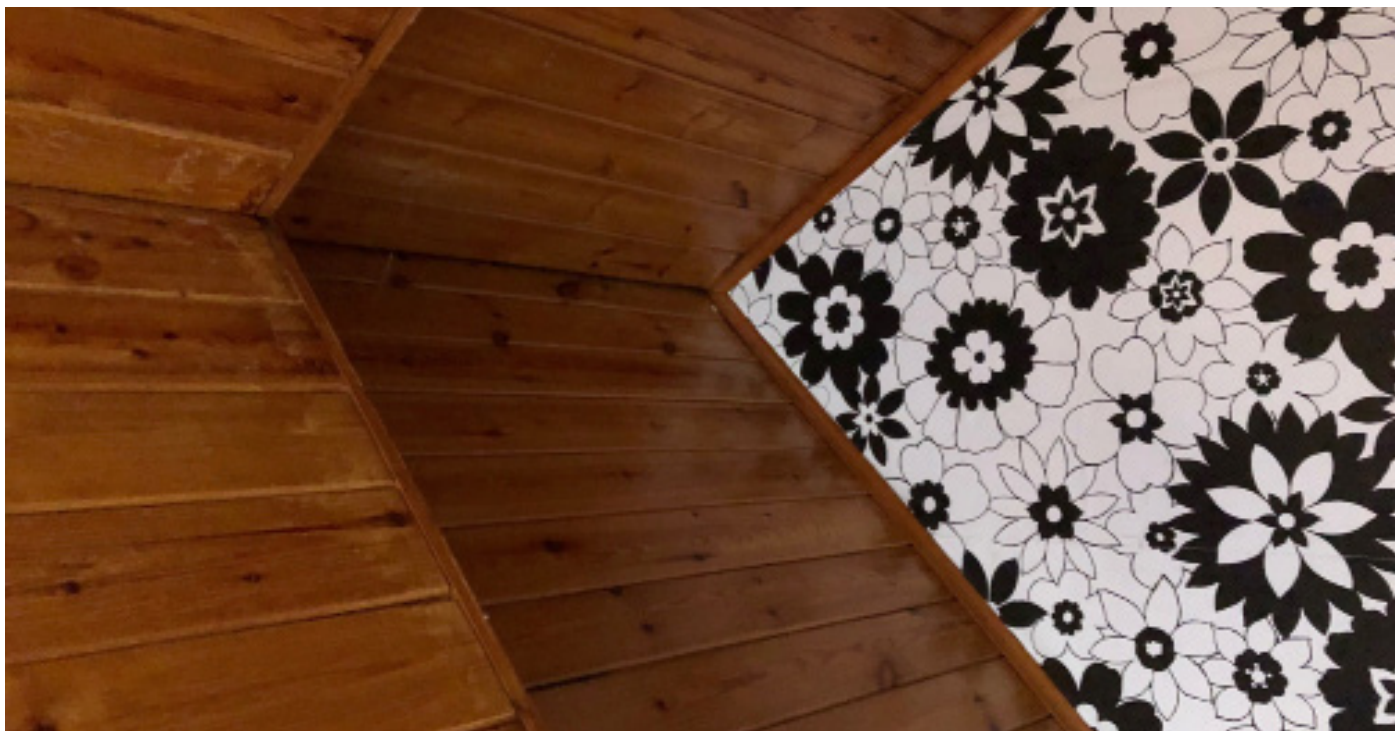
**Photograph No. 09 - All ceiling heights continue into the roof space. The apex of the property is open throughout the property.**

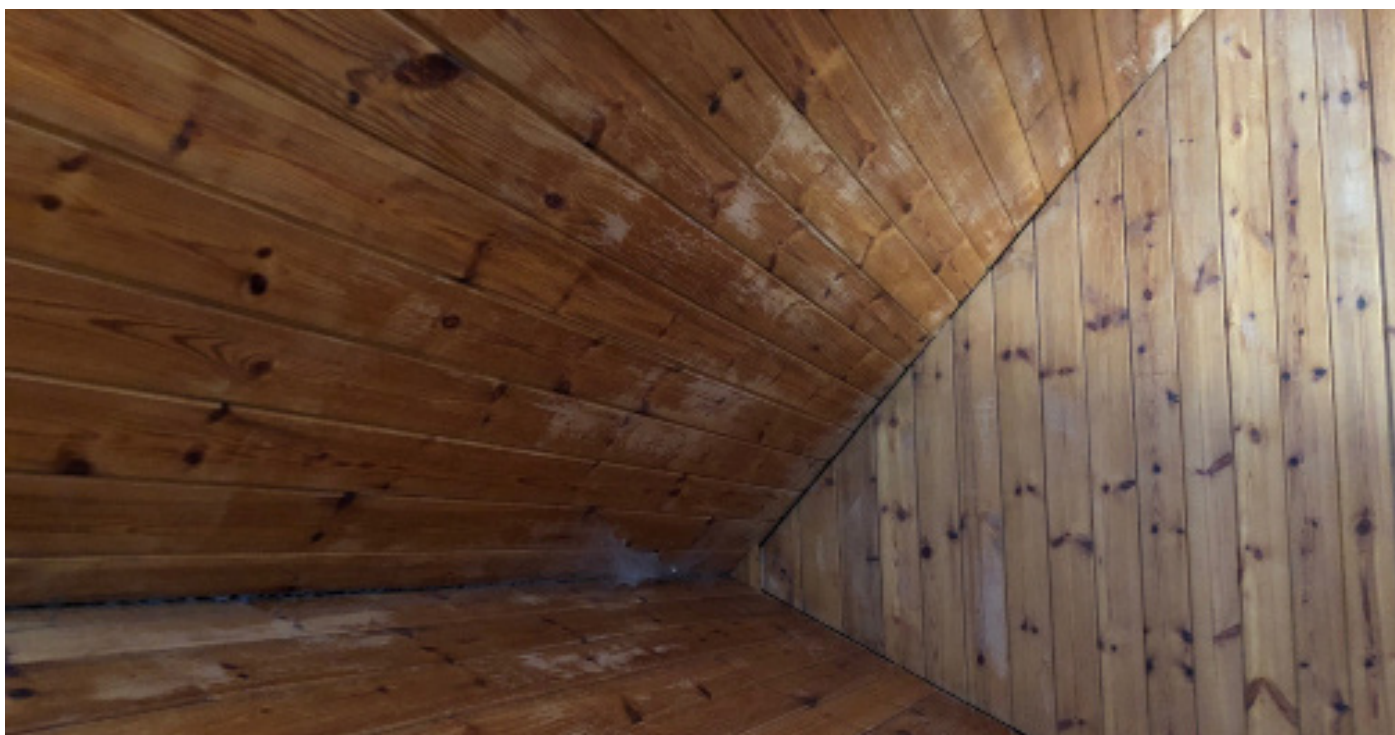
**Photograph No. 10 - Inside the property there is no loft void. the ceiling height continues into the otherwise roof space.**
