## MR GARY LOVE

### Climping Mill, Climping, West Sussex

- Preliminary Ecological Appraisal Survey
- Day-time Bat Roost Assessment

| Document Reference | LLD1260 |

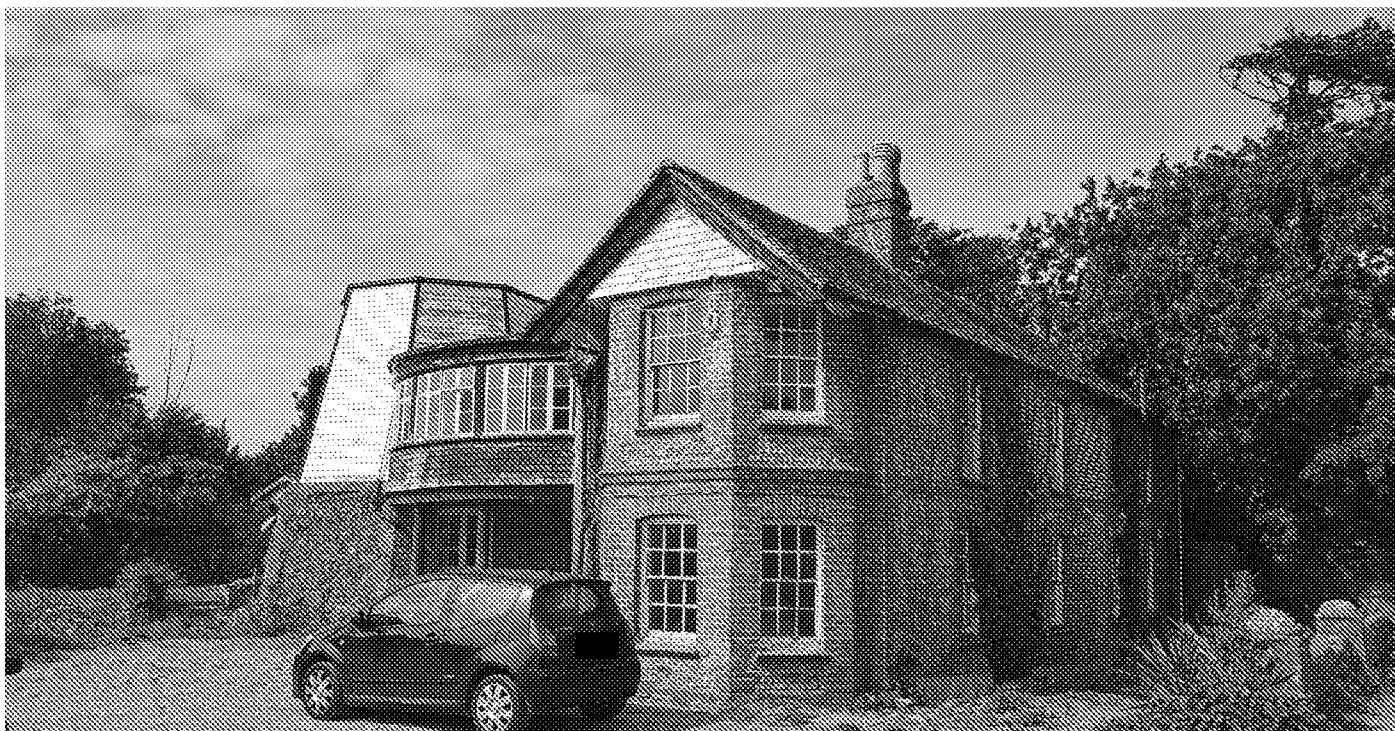
- 4.3.2 A large building of flint and brick construction which appears to have been extended numerous times over the years. The old windmill is still present, albeit with the top section and sails removed, and is attached to the main building via a flat roofed 'sun room'. The main section of building then extends along a north-south axis with a double gable roof, one section of which is clad in clay tile while the other is slate. The northern-most end of the building appears to be most recently constructed being an 'L' shape building of brick construction with tile roof.

- 4.3.3 Internally the building contains 3 no. open roof voids. Void no. 01 measures approximately 12m x 2.5m with a height to the ridge of c. 1.5m. The void is of traditional rafter construction with a mixture of BRM and bitumen roofing felt. Numerous rat and mouse droppings were recorded throughout. A small number of brown long-eared bat and pipistrelle sp. droppings were recorded at the point where the sun room joins adjoins this area. Void no. 02 measures approximately 16m x 3m with a height to the ridge of c. 1.5m. The void was similar in construction to void no. 01. A small number of pipistrelle droppings were recorded to the south and west of the central chimney. Void no. 03 was 'L-shaped' with a height to the ridge of c. 3m. Wooden sarking was present throughout. A small number of BLE droppings were recorded to the western section of the void.

| <b>Ref.</b> | <b>External Assessment</b> | <b>Internal Assessment</b> | <b>Suitability</b> |
|---|---|---|---|
| B1 | Warped/slipped/damaged roof tiles could provide access. Some missing mortar beneath ridge tiles. Small areas of lifted lead flashing. | Small number of pip sp. & Plecotus sp. droppings in void 1, Small numbers of pip sp. droppings in void 2 & 3. | <b>High</b> |

Photograph No. 1 - View of Building B1, assessed as providing High bat roost suitability.

- 6.2 Refurbishment of Building B1 and B2 has the potential to impact upon a bat roost (*should one be present*). Before any works which may affect the roof/void of these buildings (*including erection of scaffolding, works to upstairs ceilings, re-roofing, extensive upstairs wall removal etc*) a full bat survey will be required. Building B1 should be subject to 3 no. survey visits while Building B2 will require 2 no. survey visits. Survey visits should be undertaken during the optimal survey season (*May-September, with at least 2 no. surveys for Building B1 and 1 no. survey for Building B2 undertaken during the peak months of May-August*) and in optimal weather conditions (*+10°C, calm, dry*) in accordance with best practice guidelines (*Bat Surveys for Professional Ecologists: Good Practice Guidelines (BCT, 2016)*).

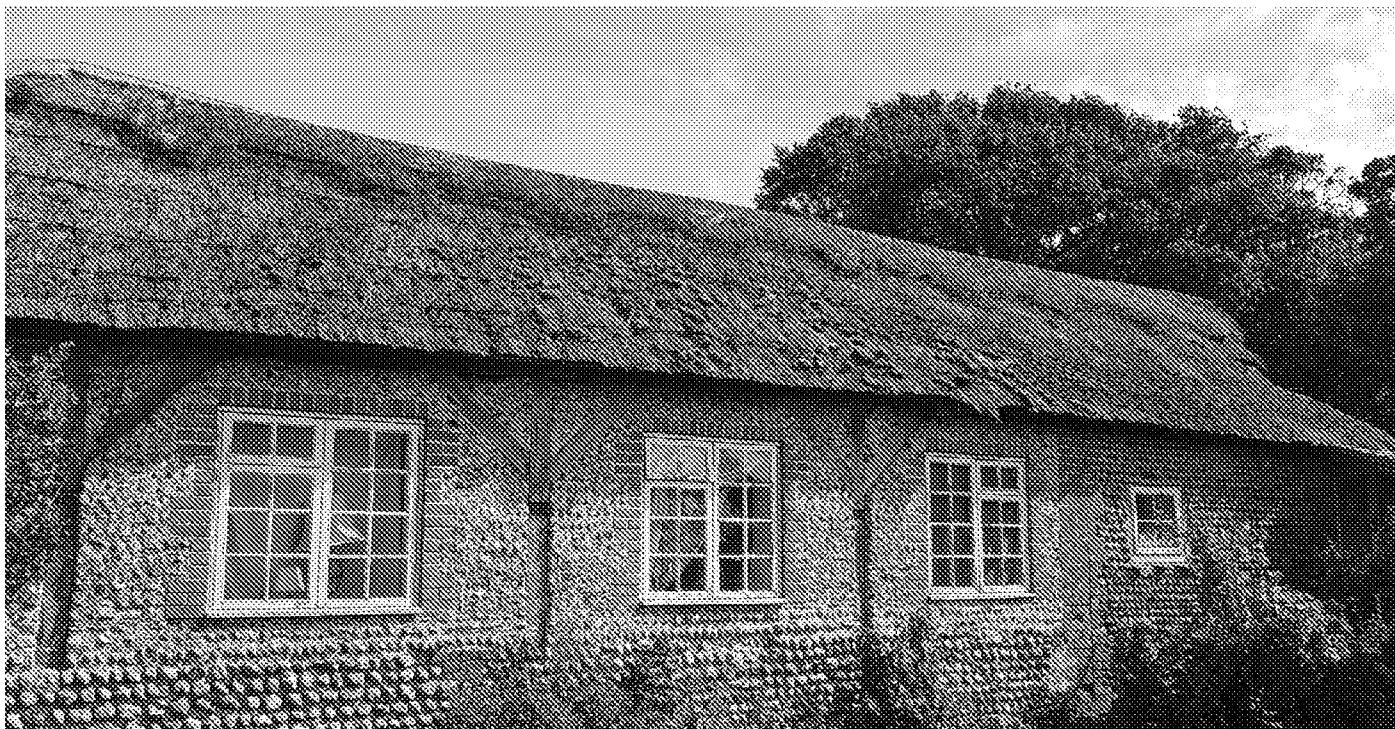
- 4.3.5 A single storey flint cottage with thatch roof in poor condition. Deterioration of the thatch has resulted in reasonably high light levels within the roof void. Dense cobwebs were noted throughout as well as ivy ingress. No evidence of bats was recorded internally/externally.

| <b>Ref.</b> | <b>External Assessment</b> | <b>Internal Assessment</b> | <b>Suitability</b> |
|---|---|---|---|
| B3 | Potential access at the eaves. | No evidence internally. Void considered too light to support a roost. No potential for crevice dwellers in the thatch. | <b>Negligible</b> |

Photograph No. 3 - Building B3, assessed as providing negligible bat roost suitability.

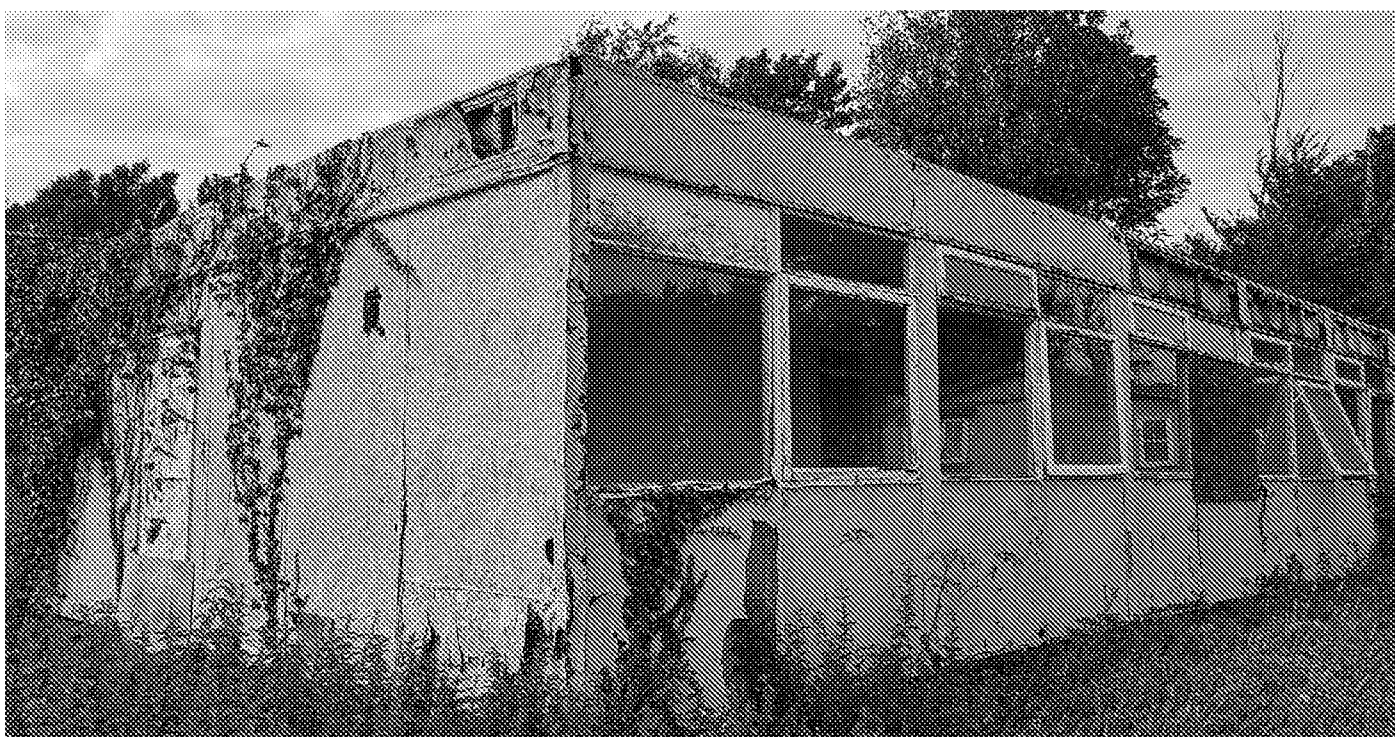
- 4.3.6 Building B4 was formerly utilised by the private school which used to own the site. The large pre-fabricated flat roofed building has fallen into a state of disrepair and now has numerous missing windows, collapsed ceilings and holes in the roof. In its current state the building is considered to be too damp, draughty and light to support a bat roost.

| <b>Ref.</b> | <b>External Assessment</b> | <b>Internal Assessment</b> | <b>Suitability</b> |
|---|---|---|---|
| B4 | In very poor condition, damp and draughty throughout. | No roof void. | <b>Negligible</b> |

Photograph No. 4 - Building B4, assessed as providing 'negligible' bat roost potential.

- 6.3 Buildings B4 and B5 have been assessed as offering '*negligible*' bat roost suitability. The demolition of these buildings to facilitate the construction of the new dwelling on site is considered unlikely to contravene *The Conservation of Habitats and Species Regulations 2010*.

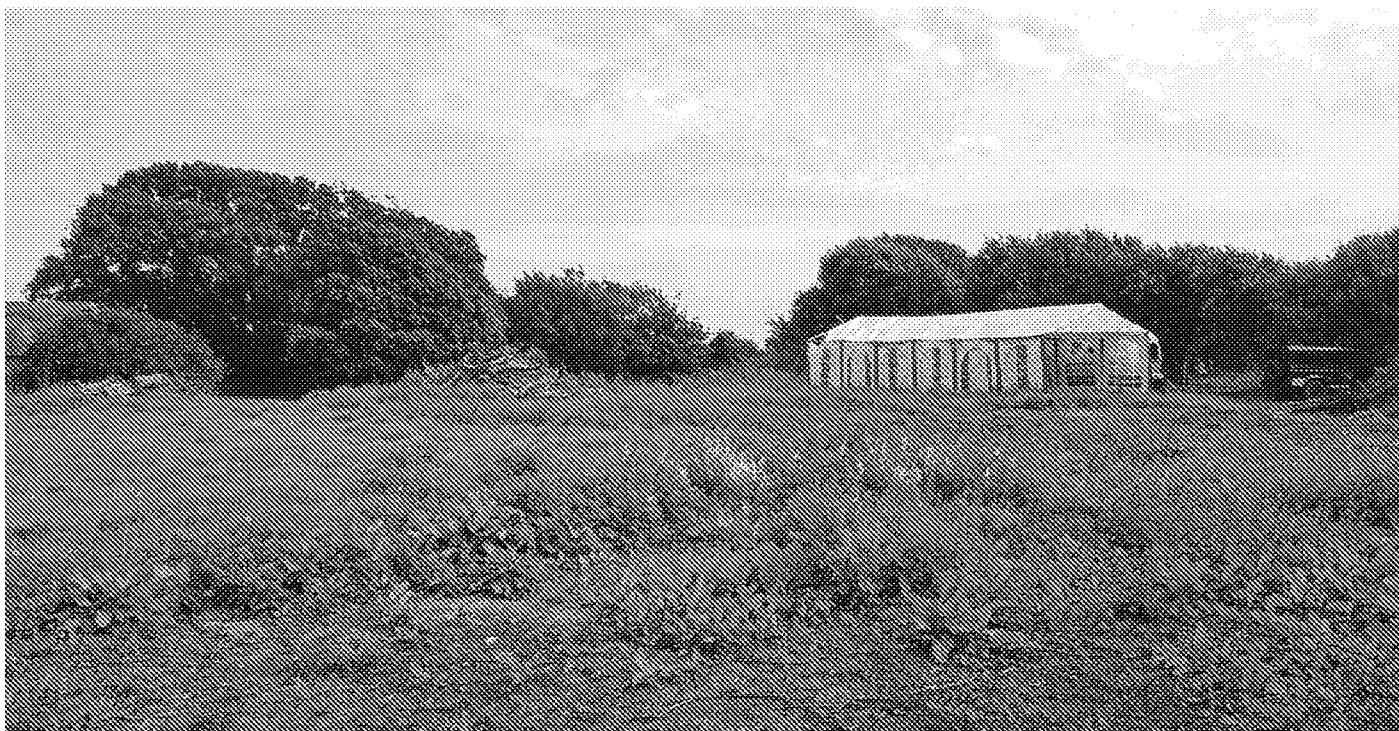
4.2.7 Large sections to the western sections of the site appear to have been recently cleared, resulting in bare ground which is beginning to be re-colonised.

Photograph No. 7 - View across the western section of the site looking towards the south-east.

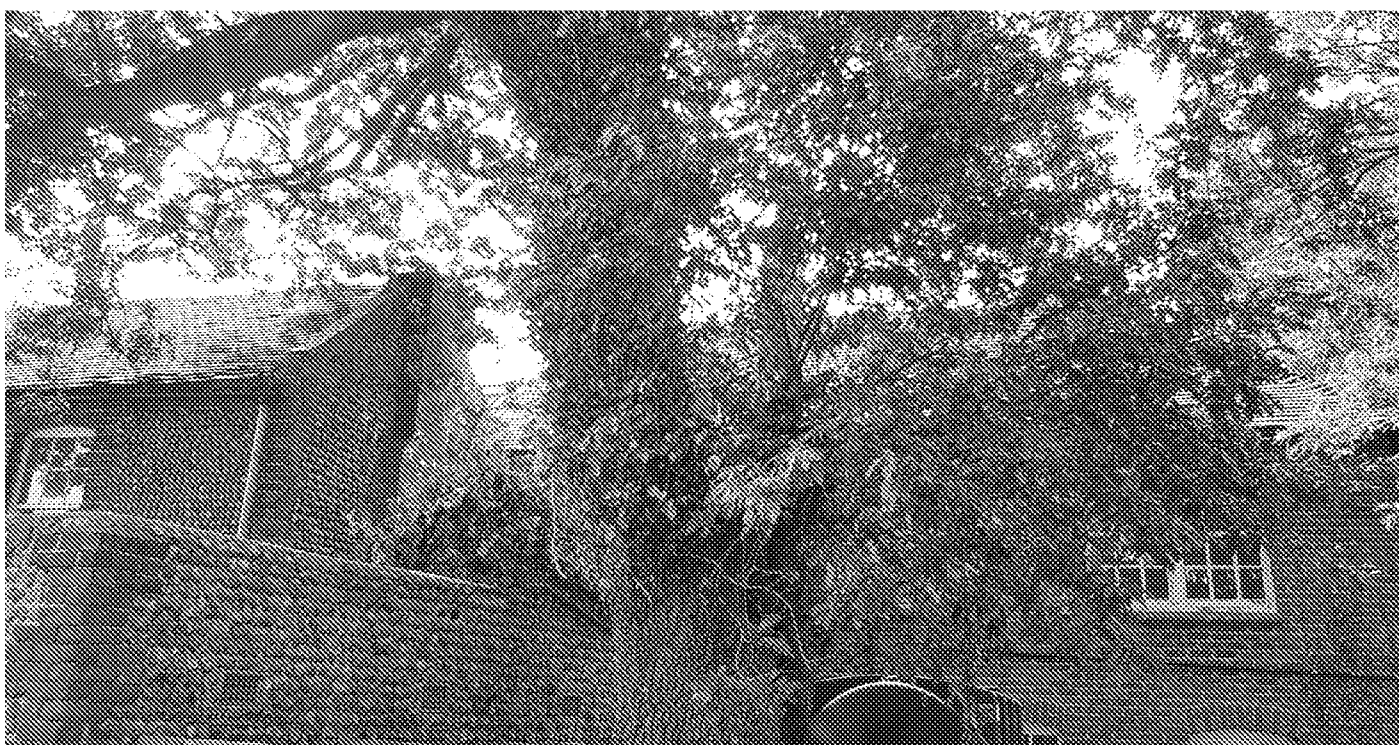
- 4.4.1 Trees which may be impacted by the development were fully assessed during the course of this survey. The majority of the trees on site are semi-mature specimens and offer no discernible bat roost features.
- 4.4.2 A single large oak tree to the north-east of the site (*T01*) has been assessed as providing '*low*' bat roost suitability. This tree holds ivy cover throughout while a large tear-out was recorded at c. 2.0m height. No direct evidence of bats was recorded.

Photograph No. 8 - Tree T01 which was assessed as providing 'low' bat roost suitability.

- 5.6 A single tree (*T01*) has been assessed as providing some bat roost suitability. This tree has been assessed as providing 'low' bat roost suitability. This tree is recommended for retention; should removal be required the tree should be soft-felled under ecological supervision.
