**MJH EXECUTIVE HOMES LIMITED**

**LANGFORD, HORSEMERE GREEN LANE, CLIMPING**

**GROUND INVESTIGATION REPORT**

March 2020  
Report No. CCL03279.CL23

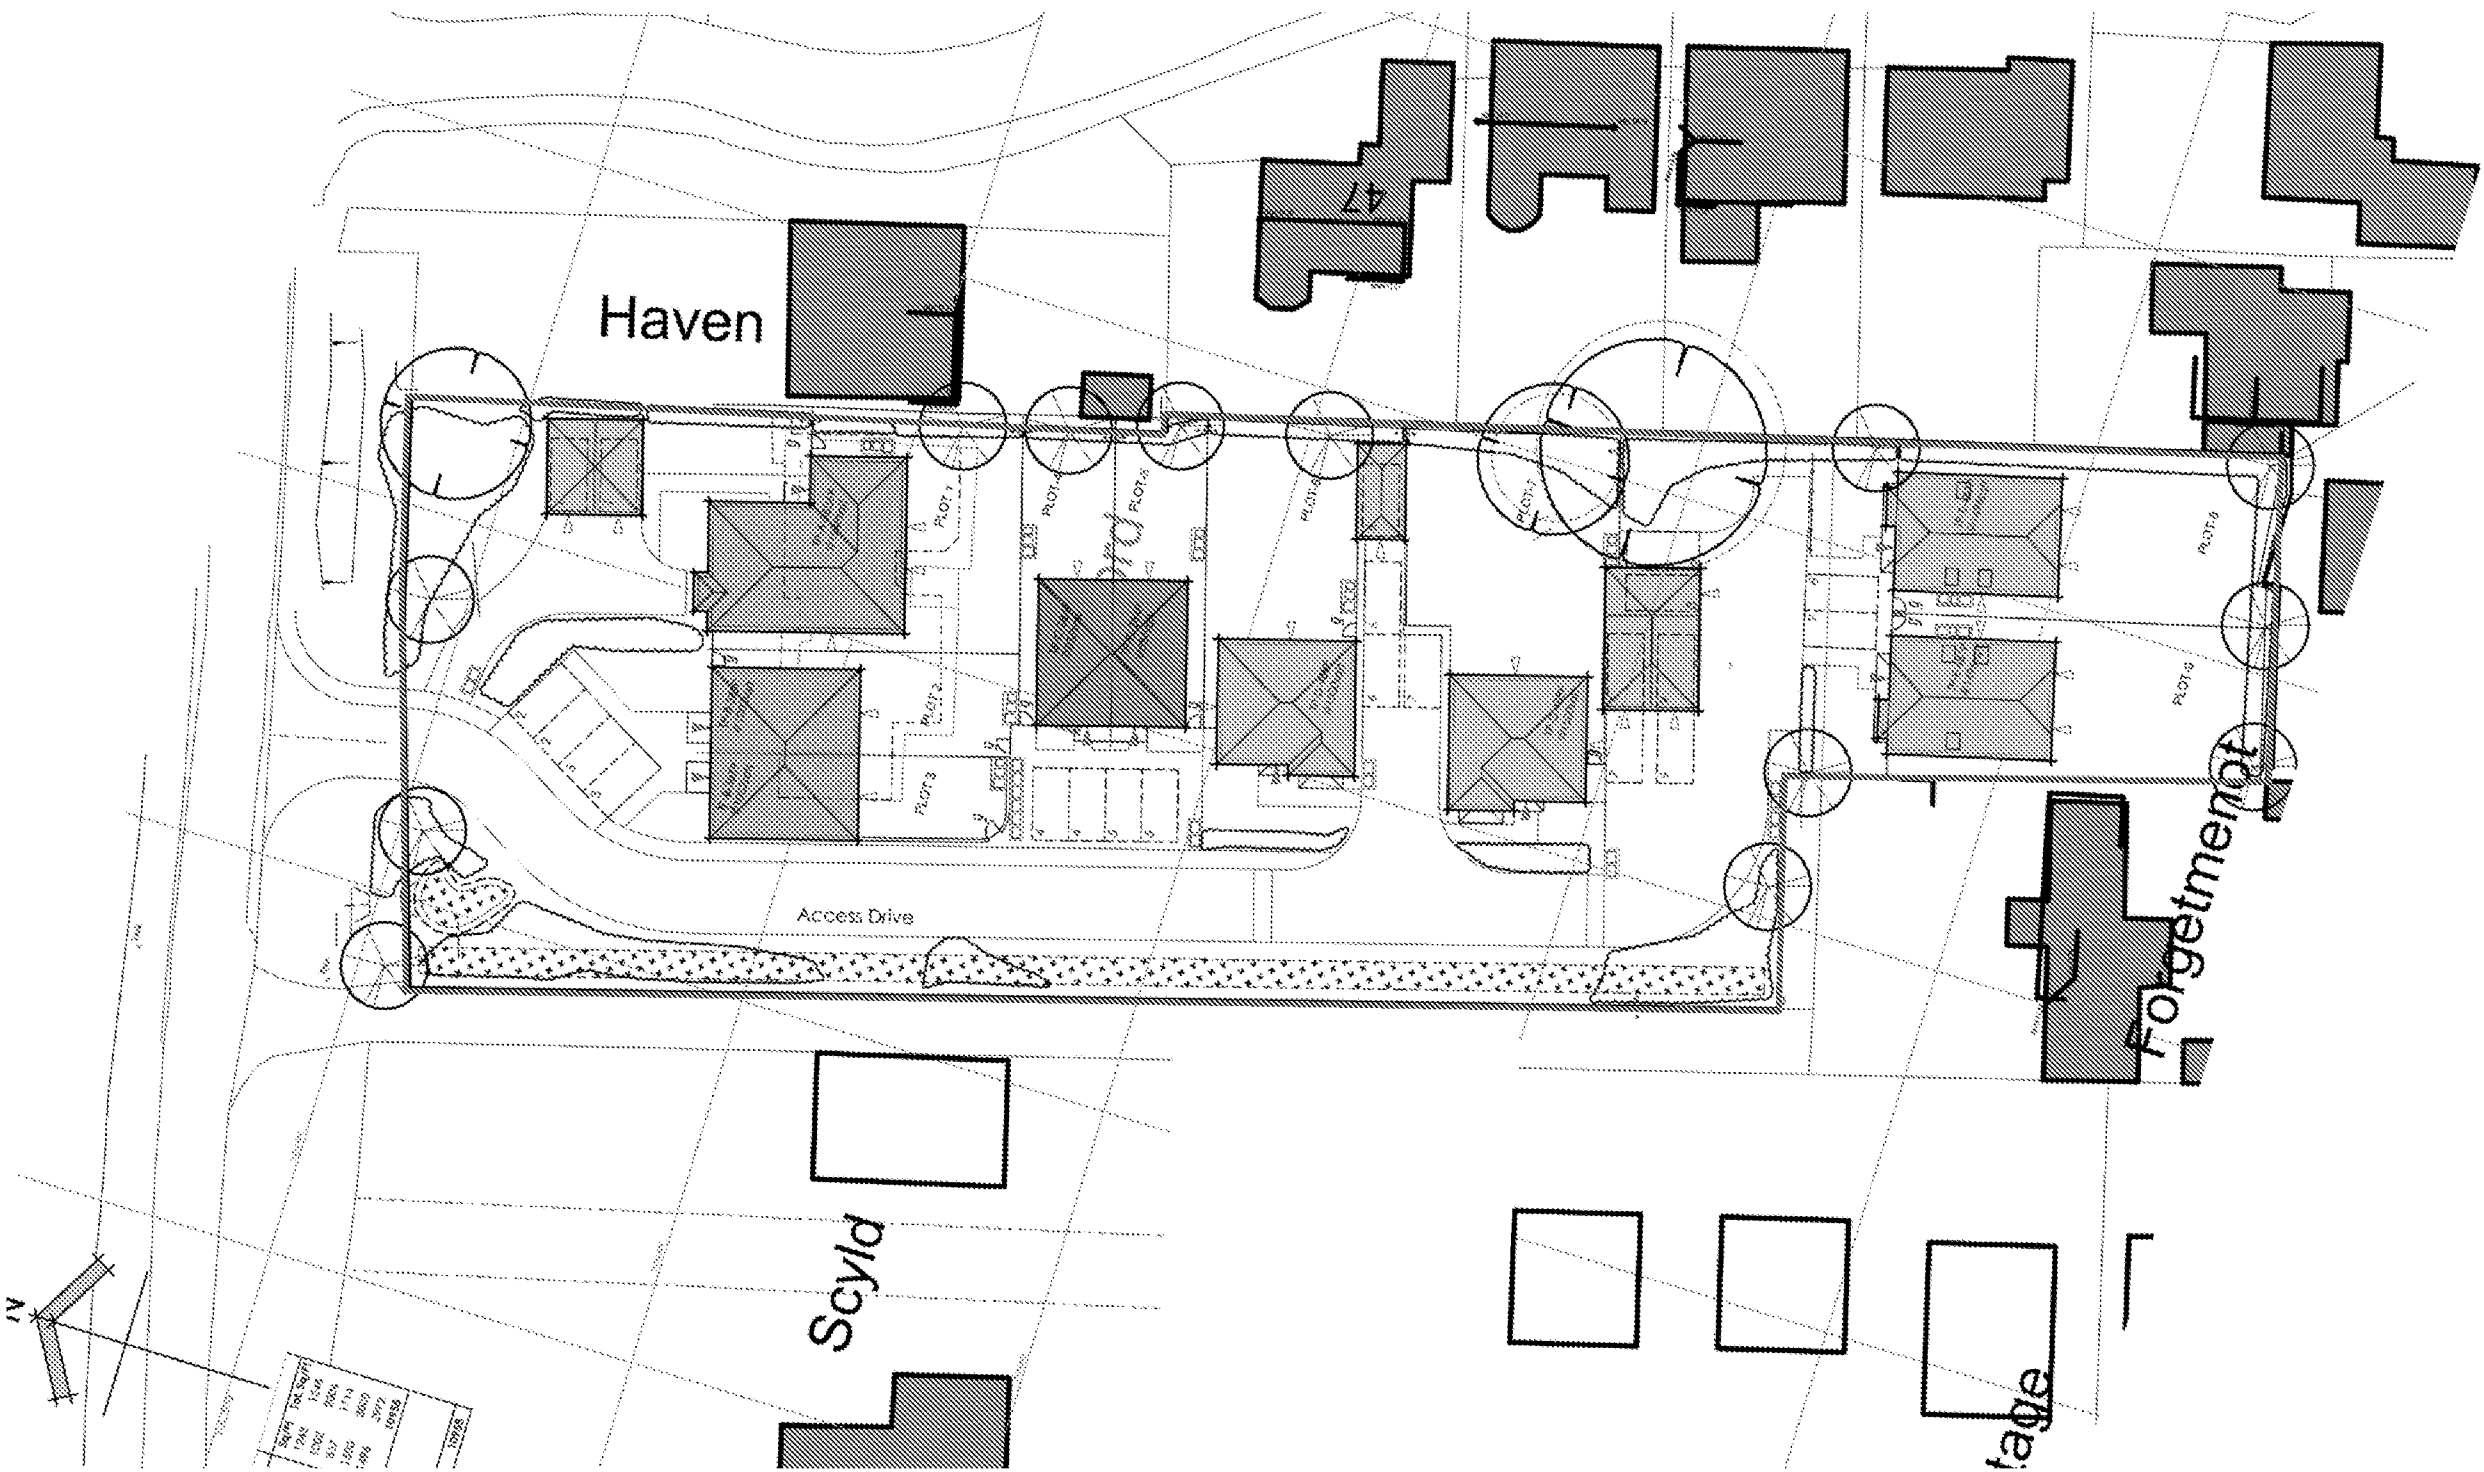
FIGURE 3

PROPOSED DEVELOPMENT PLAN  
Scale 1:500

Reproduced from the 1:500 scale Site Layout by Carlton Design Partnership dated 03/12/2019. Drg No. 190725/SL-01
