## MR GARY LOVE

### Climping Mill, Climping, West Sussex

- Preliminary Ecological Appraisal Survey
- Day-time Bat Roost Assessment

| Document Reference | LLD1260 |

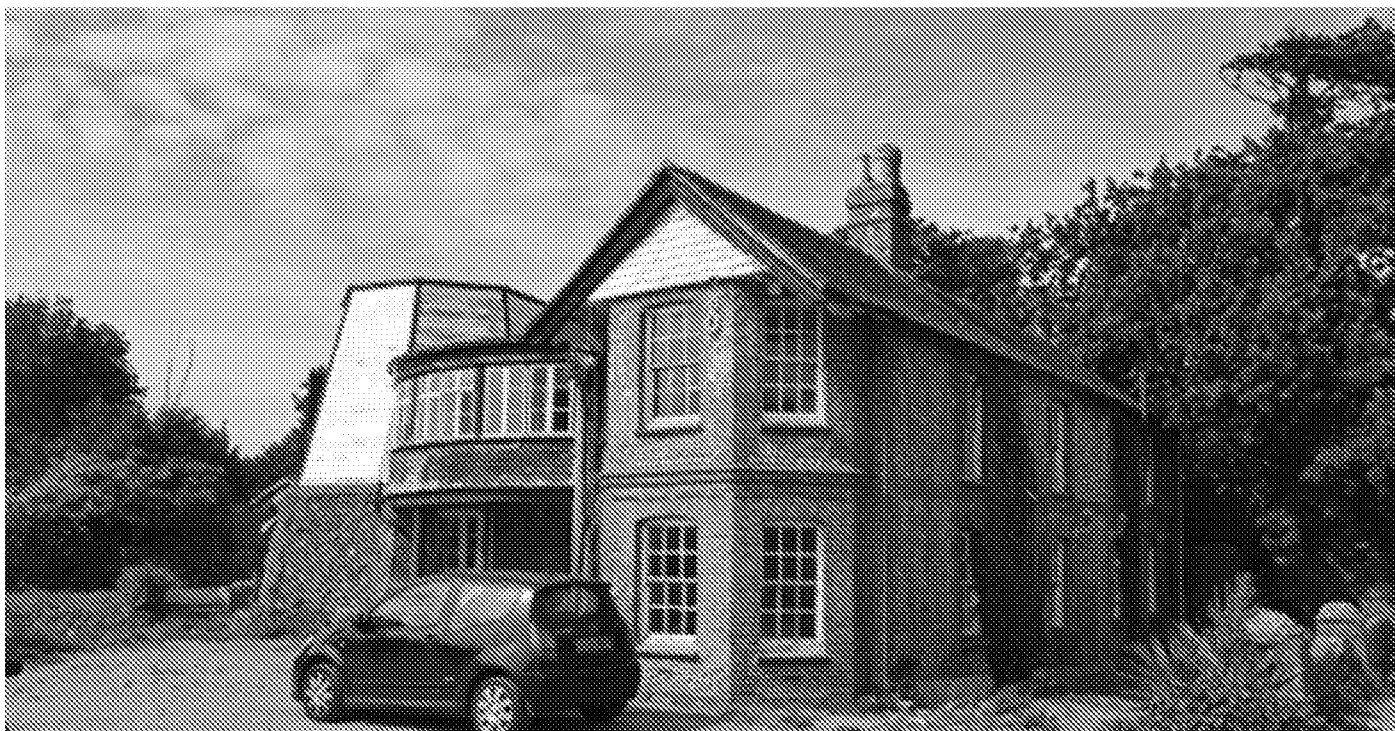
- 4.3.2 A large building of flint and brick construction which appears to have been extended numerous times over the years. The old windmill is still present, albeit with the top section and sails removed, and is attached to the main building via a flat roofed 'sun room'. The main section of building then extends along a north-south axis with a double gable roof, one section of which is clad in clay tile while the other is slate. The northern-most end of the building appears to be most recently constructed being an 'L' shape building of brick construction with tile roof.

- 4.3.3 Internally the building contains 3 no. open roof voids. Void no. 01 measures approximately 12m x 2.5m with a height to the ridge of c. 1.5m. The void is of traditional rafter construction with a mixture of BRM and bitumen roofing felt. Numerous rat and mouse droppings were recorded throughout. A small number of brown long-eared bat and pipistrelle sp. droppings were recorded at the point where the sun room joins adjoins this area. Void no. 02 measures approximately 16m x 3m with a height to the ridge of c. 1.5m. The void was similar in construction to void no. 01. A small number of pipistrelle droppings were recorded to the south and west of the central chimney. Void no. 03 was 'L-shaped' with a height to the ridge of c. 3m. Wooden sarking was present throughout. A small number of BLE droppings were recorded to the western section of the void. The evidence found suggests that the building supports only a low number of common species (if any at all) and that any roost present is of low conservation significance.

| <b>Ref.</b> | <b>External Assessment</b> | <b>Internal Assessment</b> | <b>Suitability</b> |
|---|---|---|---|
| B1 | Warped/slipped/damaged roof tiles could provide access. Some missing mortar beneath ridge tiles. Small areas of lifted lead flashing. | Small number of pip sp. & Plecotus sp. droppings in void 1, Small numbers of pip sp. droppings in void 2 & 3. | <b>High</b> |

Photograph No. 1 - View of Building B1, assessed as providing High bat roost suitability.

- 5.5 Buildings B1 and B2 have both been assessed as providing bat roost suitability. Although these buildings will not be directly impacted upon by the construction of the new dwelling, refurbishment of these buildings has the potential to disturb/damage a bat roost (*should one be present*) though noise, vibration or blocking access points.

- 5.6 Full bat surveys of these buildings are recommended before any works such as roof repair/replacement, repair/replacement of ceilings (which form the base of the loft void), erection of scaffolding which may block access points, demolition of walls etc takes place. Neither of these buildings are suggested to support a roost of high conservation value (*if at all*) and, subject to survey results, suitable mitigation measures could easily be incorporated into the scheme at a later date.

- 6.3 Building B1 should be subject to 3 no. survey visits while Building B2 will require 2 no. survey visits. Survey visits should be undertaken during the optimal survey season (*May-September, with at least 2 no. surveys for Building B1 and 1 no. survey for Building B2 undertaken during the peak months of May-August*) and in optimal weather conditions (*+10°C, calm, dry*) in accordance with best practice guidelines (*Bat Surveys for Professional Ecologists: Good Practice Guidelines (BCT, 2016)*).

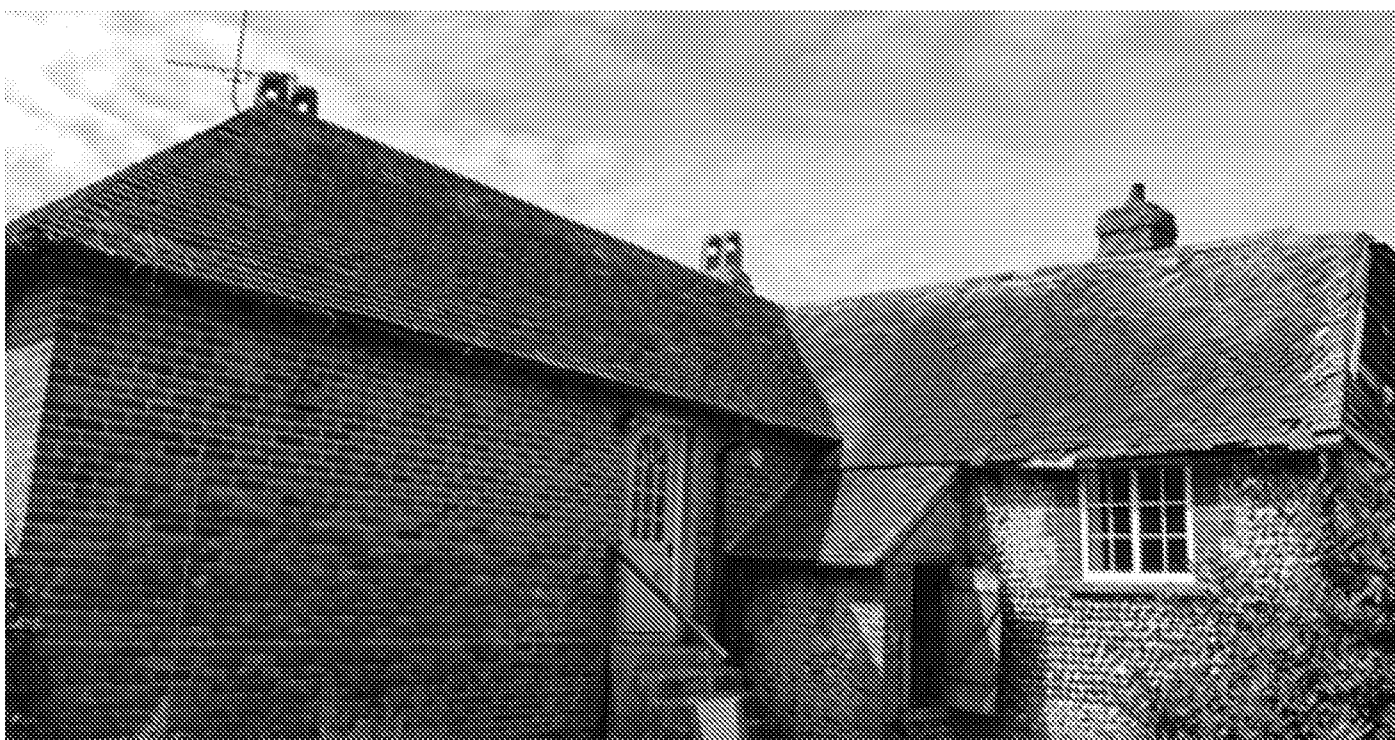
- 4.3.4 A small single-storey flint and brick cottage with clay tile roof. The roof is in poor condition with numerous slipped/broken tiles recorded throughout. Internally, the roof void contained a moderate amount of cobwebs as well as mouse droppings. No roofing membrane was present resulting in large amounts of debris within the void. Access was limited however a small number of droppings of a size and shape characteristic of pipistrelle sp. were recorded around the loft hatch. Similarly to Building B1, the evidence found suggests that any roost present is of low conservation significance.

| <b>Ref.</b> | <b>External Assessment</b> | <b>Internal Assessment</b> | <b>Suitability</b> |
|---|---|---|---|
| B2 | Numerous warped/missing/lifted roof tiles. | No roof membrane. Limited access into the roof void; small number of pipistrellus sp. droppings recorded near the roof hatch. | <b>Moderate</b> |

Photograph No. 2 - Building B2, assessed as providing moderate bat roost suitability.

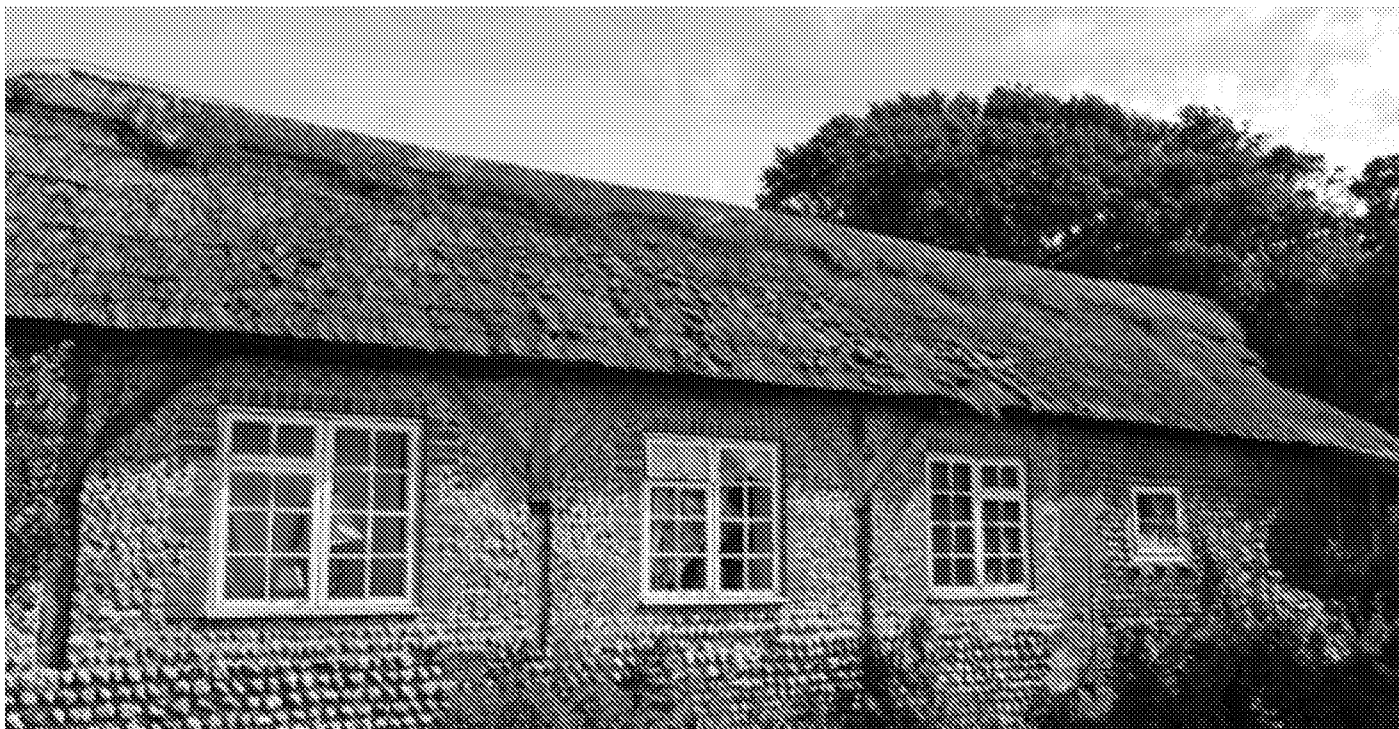
- 4.3.5 A single storey flint cottage with thatch roof in poor condition. Deterioration of the thatch has resulted in reasonably high light levels within the roof void. Dense cobwebs were noted throughout as well as ivy ingress. No evidence of bats was recorded internally/externally.

| <b>Ref.</b> | <b>External Assessment</b> | <b>Internal Assessment</b> | <b>Suitability</b> |
|---|---|---|---|
| B3 | Potential access at the eaves. | No evidence internally. Void considered too light to support a roost. No potential for crevice dwellers in the thatch. | <b>Negligible</b> |

Photograph No. 3 - Building B3, assessed as providing negligible bat roost suitability.

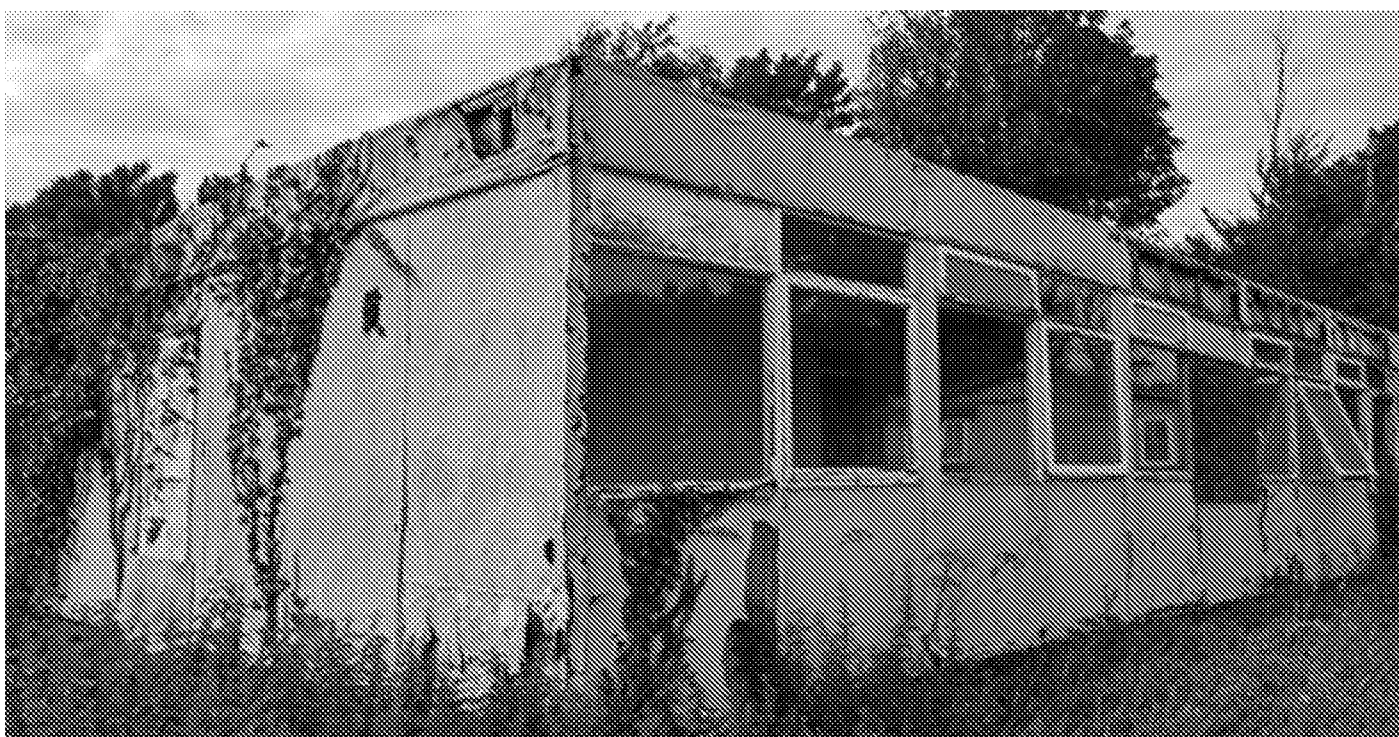
- 4.3.6 Building B4 was formerly utilised by the private school which used to own the site. The large pre-fabricated flat roofed building has fallen into a state of disrepair and now has numerous missing windows, collapsed ceilings and holes in the roof. In its current state the building is considered to be too damp, draughty and light to support a bat roost.

| <b>Ref.</b> | <b>External Assessment</b> | <b>Internal Assessment</b> | <b>Suitability</b> |
|---|---|---|---|
| B4 | In very poor condition, damp and draughty throughout. | No roof void. | <b>Negligible</b> |

Photograph No. 4 - Building B4, assessed as providing 'negligible' bat roost potential.

- 6.4 Buildings B4 and B5 have been assessed as offering '*negligible*' bat roost suitability. The demolition of these buildings to facilitate the construction of the new dwelling on site is considered unlikely to contravene *The Conservation of Habitats and Species Regulations 2010*. No further survey work of these buildings is recommended.

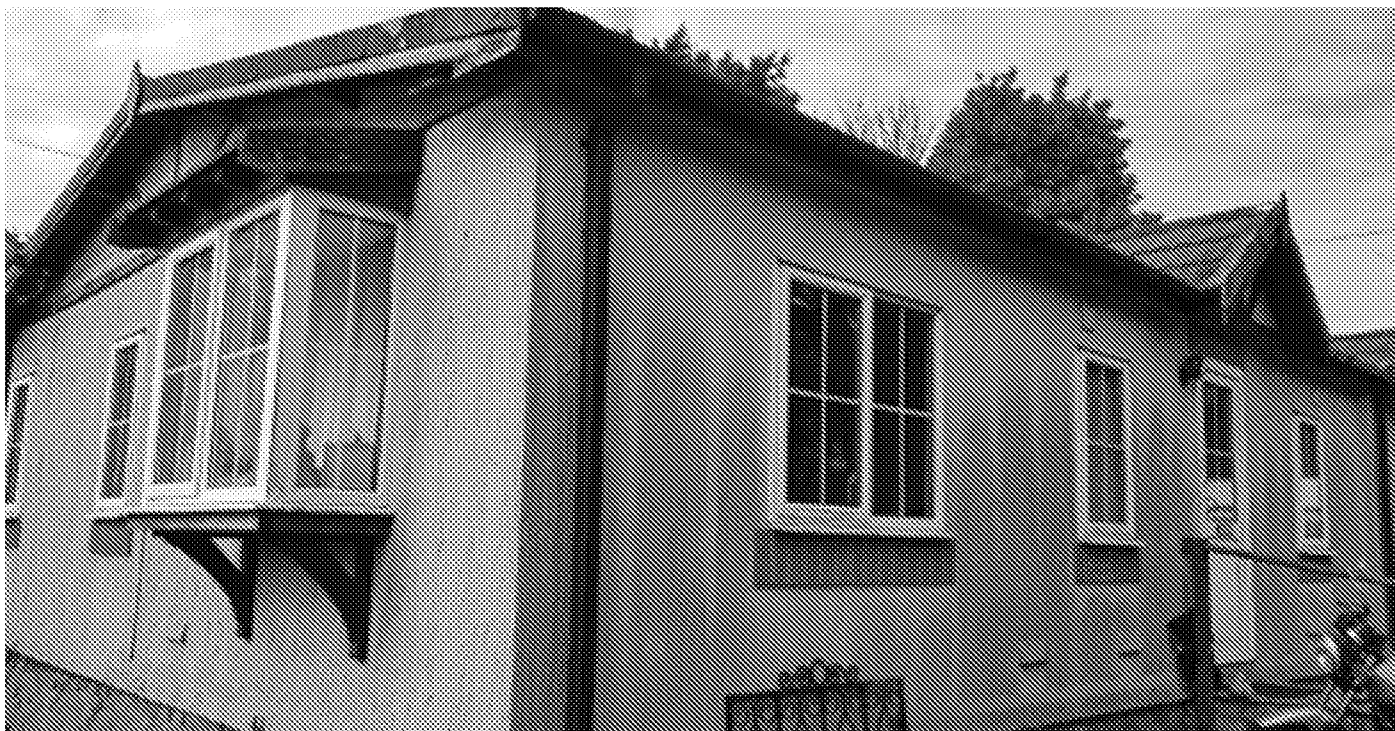
- 4.3.7 A large park home located to the north-western section of the site. The buildings is of modern construction with felt and tile roof which was in good condition. PVC windows were in good condition as were the wooden soffits and fascia; no potential access points were noted. No access was available internally.

| <b>Ref.</b> | <b>External Assessment</b> | <b>Internal Assessment</b> | <b>Suitability</b> |
|---|---|---|---|
| B5 | Recent construction, limited potential access points. These which were recorded were cobweb covered. | No internal access. | <b>Negligible</b> |

Photograph No. 5 - Building B5, assessed as providing 'negligible' bat roost potential.

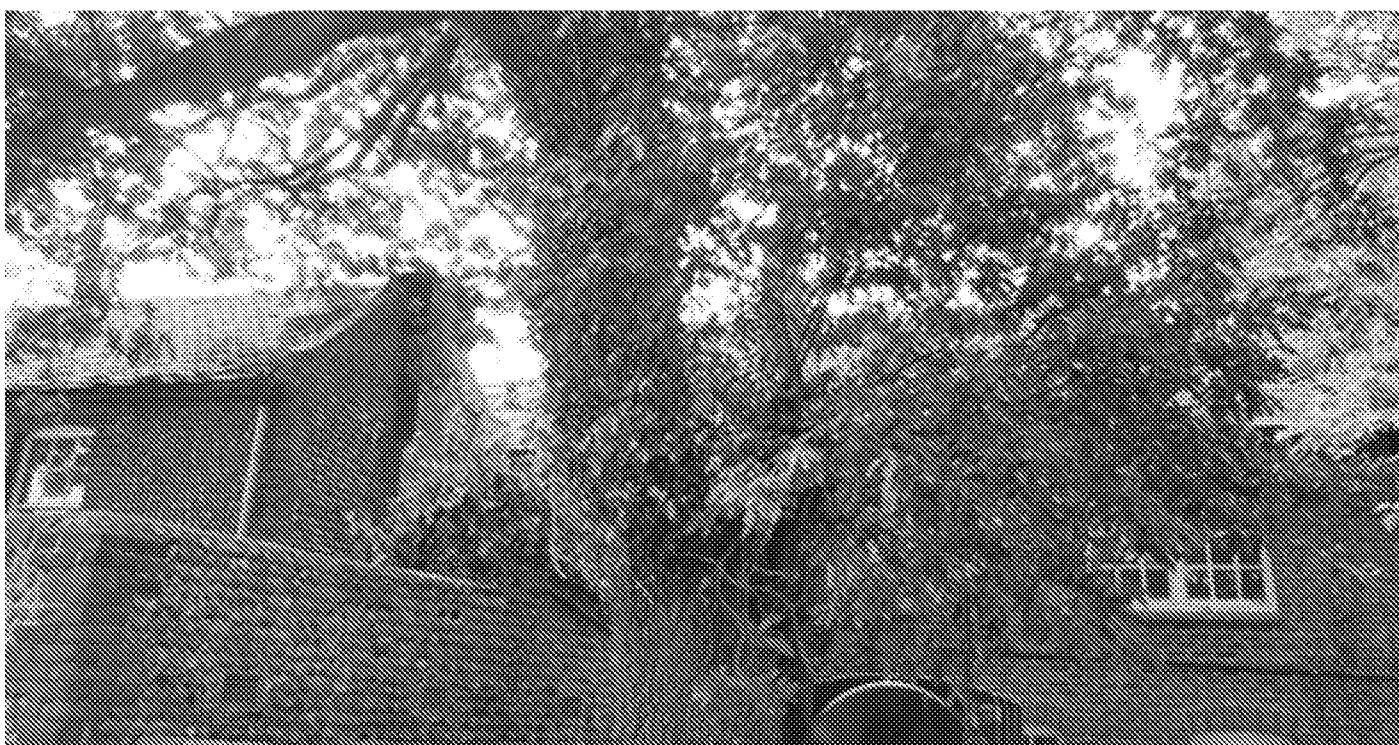
4.4.2 A single large oak tree to the north-east of the site (*T01*) has been assessed as providing 'low' bat roost suitability. This tree holds ivy cover throughout while a large tear-out was recorded at c. 2.0m height. No direct evidence of bats was recorded.

Photograph No. 8 - Tree T01 which was assessed as providing 'low' bat roost suitability.

- 5.7 A single tree (*T01*) has been assessed as providing some bat roost suitability. This tree has been assessed as providing 'low' bat roost suitability. This tree is recommended for retention; should removal be required the tree should be soft-felled under ecological supervision.
