**STRIPPING OUT PHOTOGRAPHIC APPENDICES**

**CLYMPING MILL, MILL COTTAGE & MILL THATCH**

Ref: DGC21815

Date of Issue: 16<sup>th</sup> February 2018

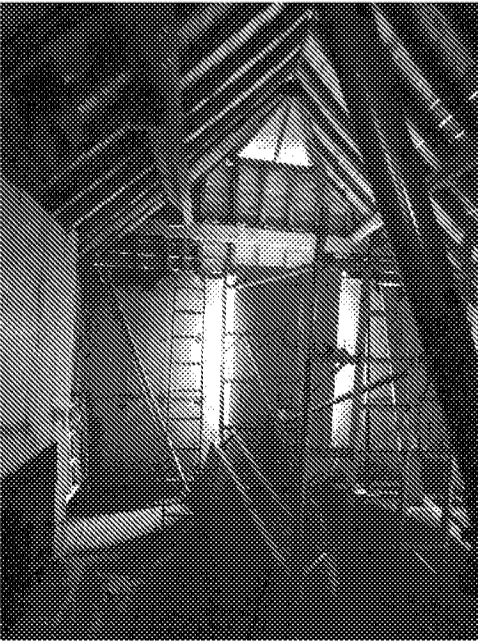
Photograph 1.01 Existing rafters taken down de-frassed and reinstated strengthened with sarking board and coach bolted purlins to Structural Engineers Details. High level collars still to be installed including formation of notching out to existing rafters to accommodate the new timber connection which is to be timber dowelled.

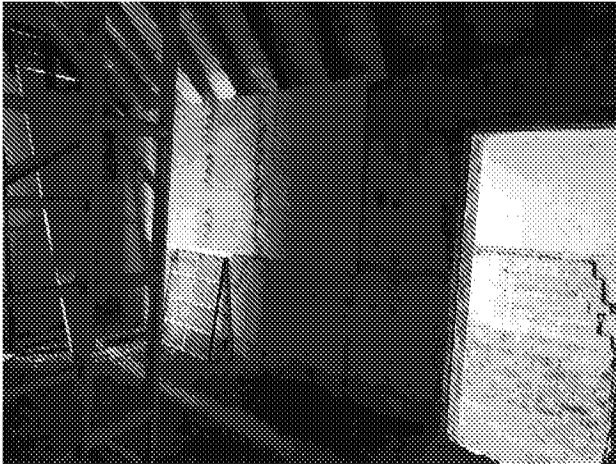
Photograph 1.02 Existing window opening boarded over, internal plastered finishes retained

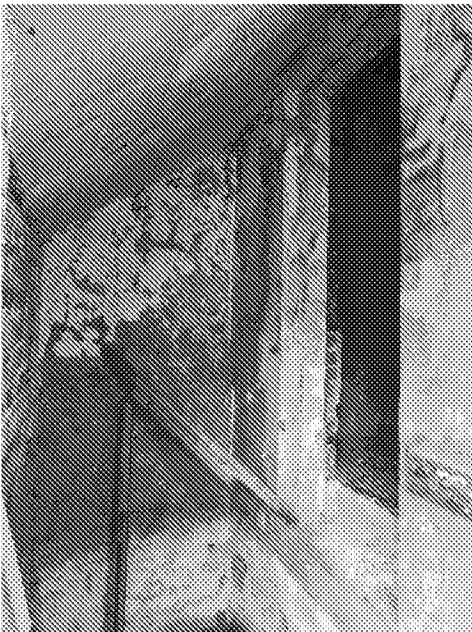
Photograph 2.01 Former opening between Living Room and lean-to infilled with blockwork. The masonry walls show a plastered finish.

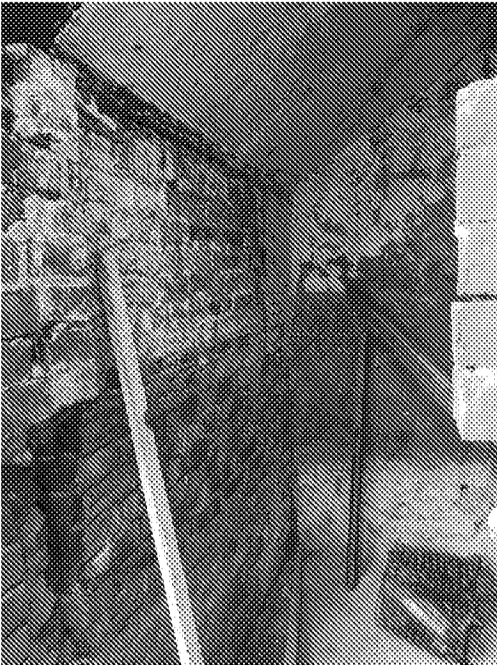
Photograph 2.02 The original floor has been replaced with a cementitious screed as part of a previous renovation and the inner wall finish is fair-faced brickwork and timber inserts.
