**STRIPPING OUT PHOTOGRAPHIC APPENDICES**

**CLYMPING MILL, MILL COTTAGE & MILL THATCH**

Ref: DGC21815

Date of Issue: 16<sup>th</sup> February 2018

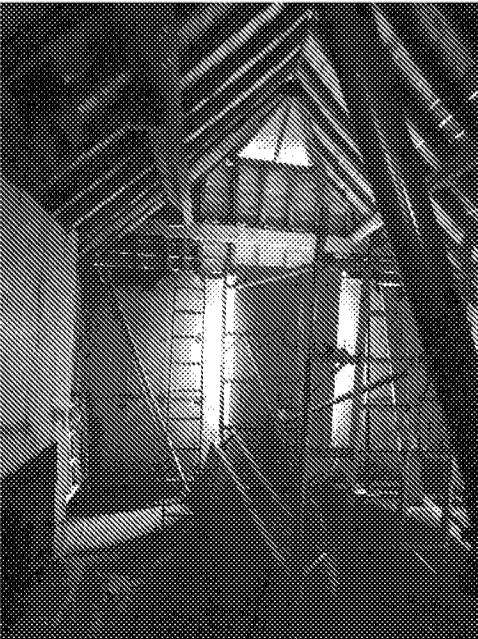
Photograph 1.01 Existing rafters taken down de-frassed and reinstated strengthened with sarking board and coach bolted purlins to Structural Engineers Details. High level collars still to be installed including formation of notching out to existing rafters to accommodate the new timber connection which is to be timber dowelled.

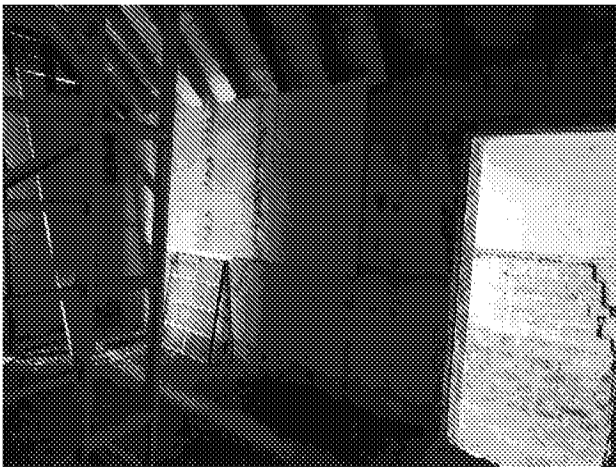
Photograph 1.02 Existing window opening boarded over, internal plastered finishes retained

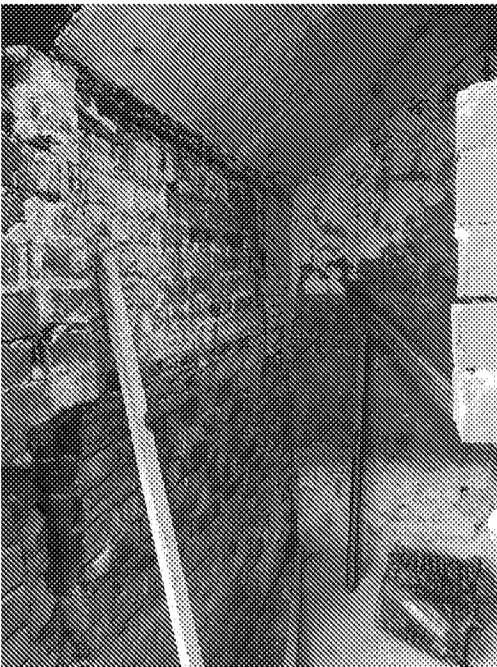
Photograph 2.02 The original floor has been replaced with a cementitious screed as part of a previous renovation and the inner wall finish is fair-faced brickwork and timber inserts.
