# Arboricultural Impact Assessment

Land at Climping

25<sup>th</sup> April 2022

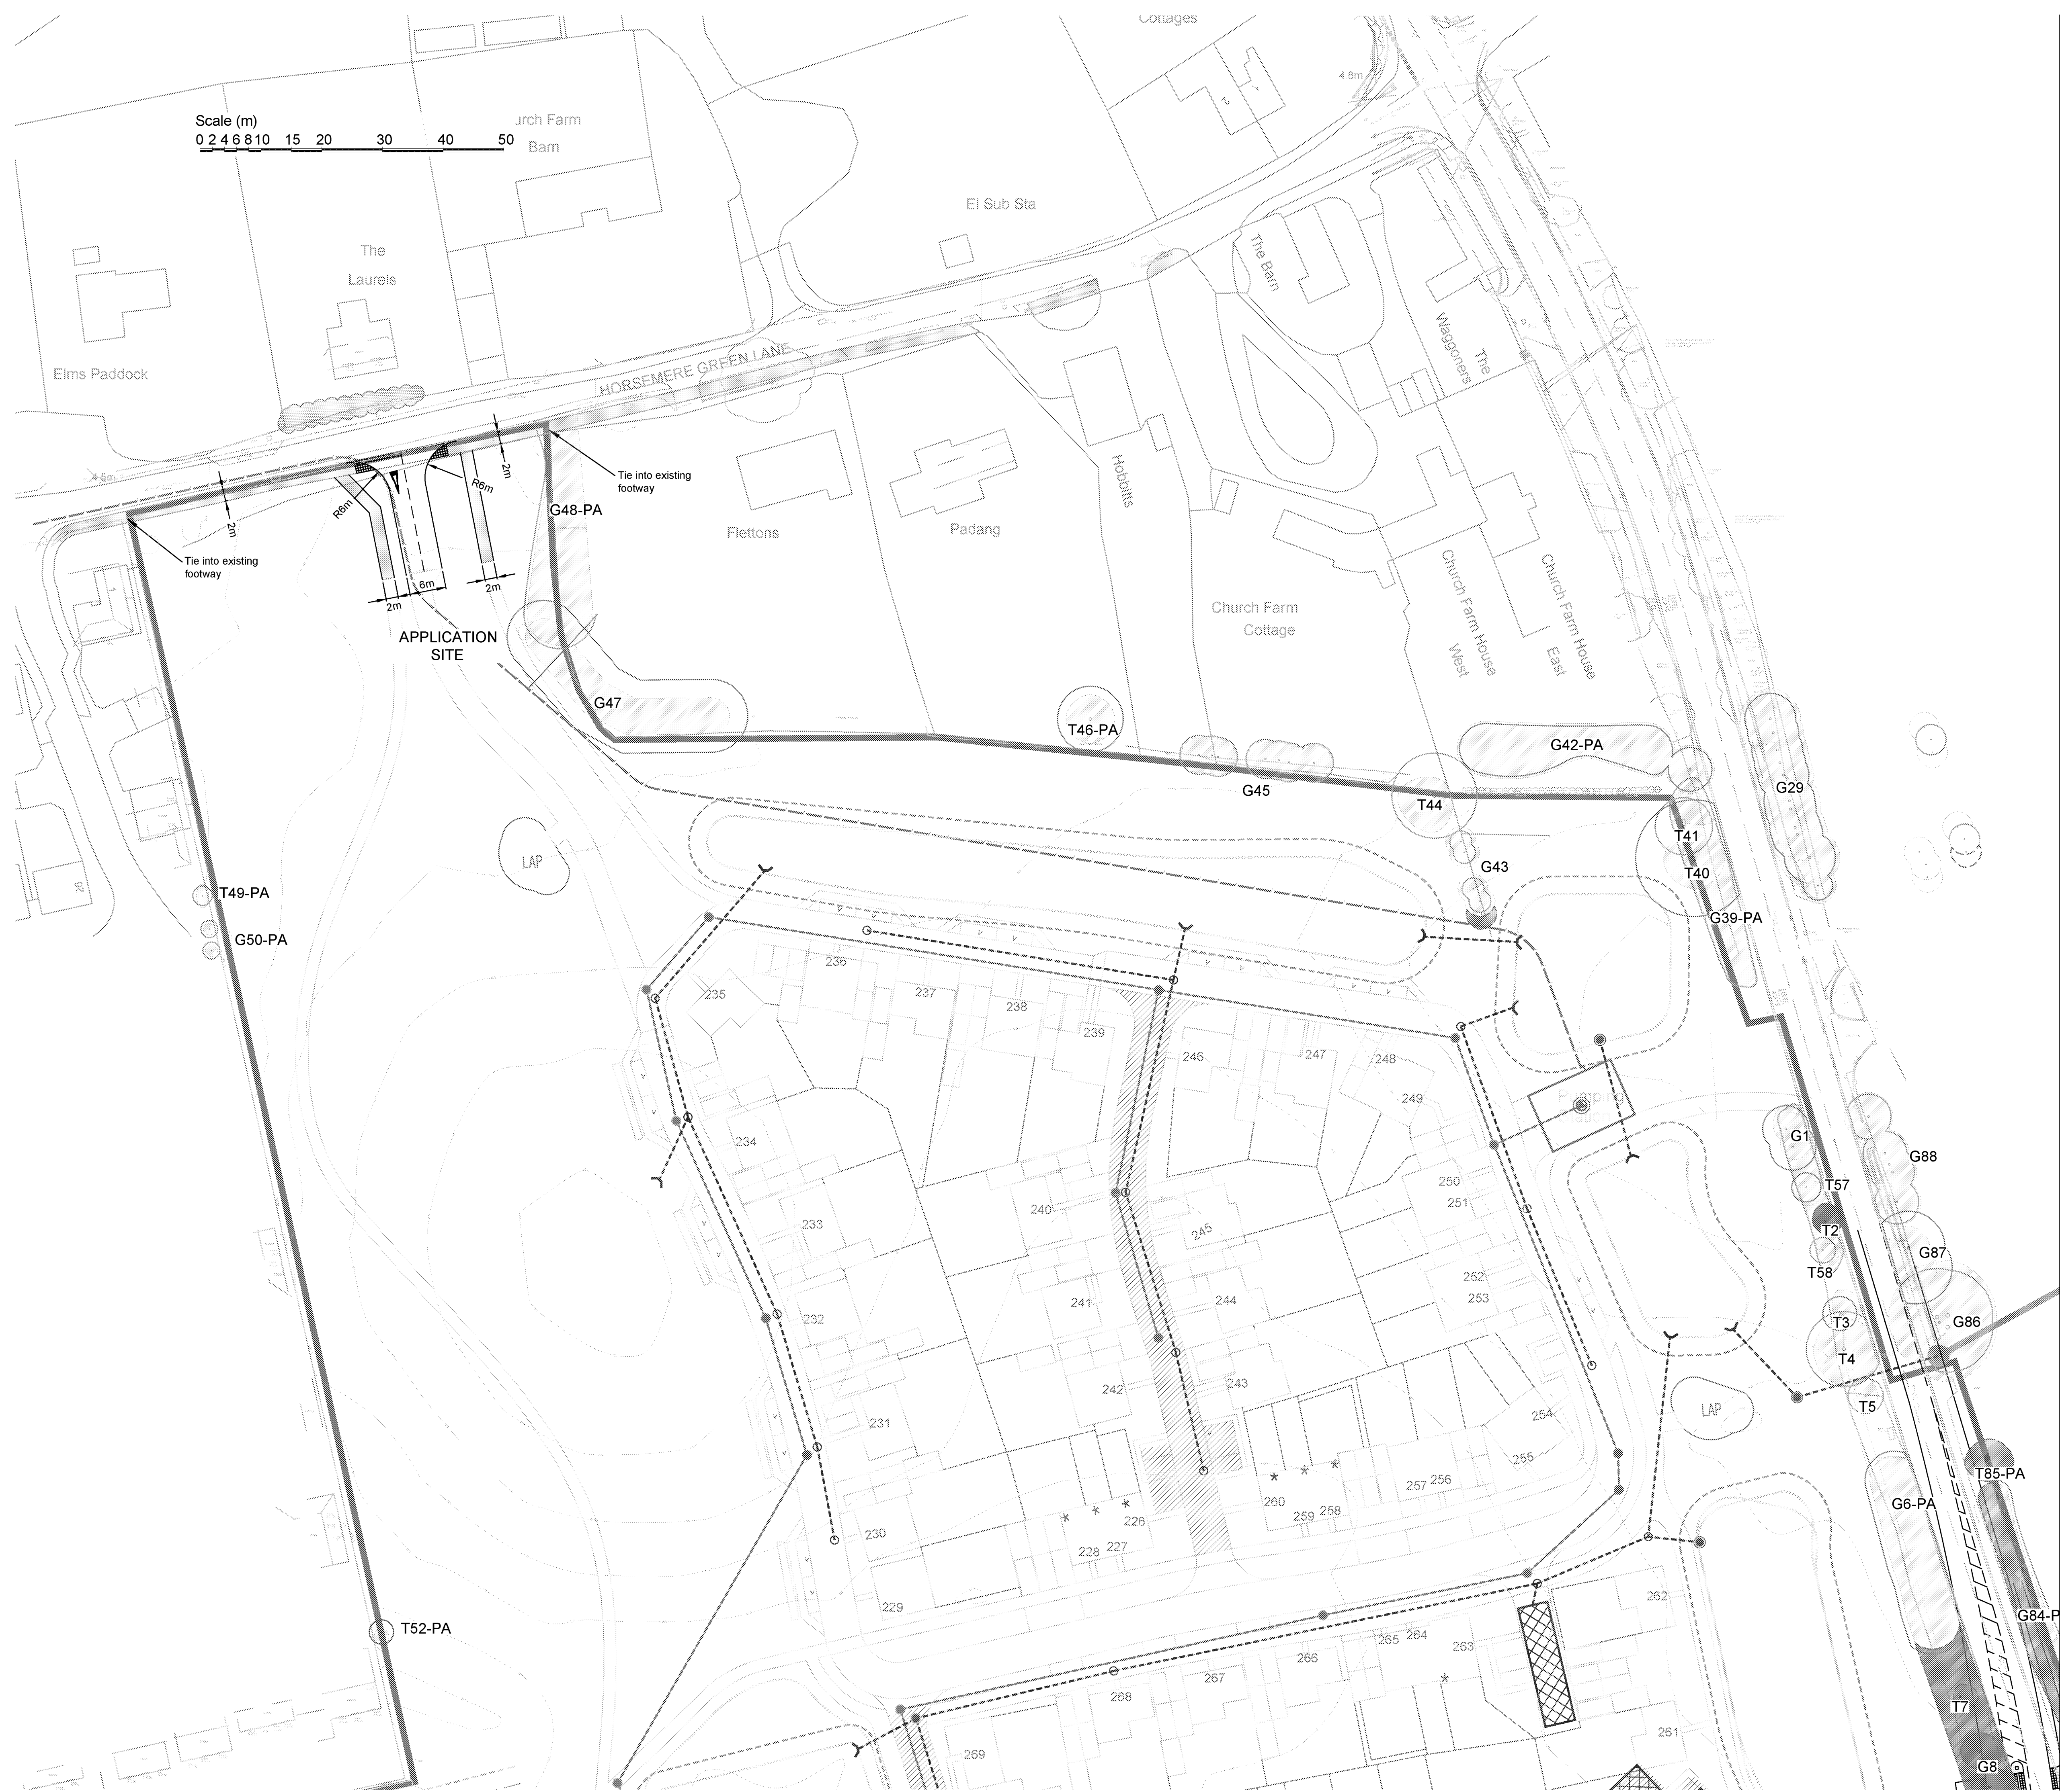
| Drawing no: 5646/21/B | Rev: 01 | Sheet number: 1 of 7 |

### Tree Retention Plan

- 3.10 The proposed drainage layout is shown on the tree retention plan. This will include the construction of surface water drains within the root protection areas of T4 and G86, which must occur as described in the arboricultural method statement.
- 3.11 A new attenuation basin will be excavated close to T40. The basin will be located outside the root protection area, however the 3m buffer surrounding the basin will encroach the root protection, therefore arboricultural supervision is recommended as a precautionary measure.
