# LIZARD

### Climping Mill, Climping, West Sussex

- Preliminary Ecological Appraisal Survey
- Day-time Bat Roost Assessment

### Planning Issue

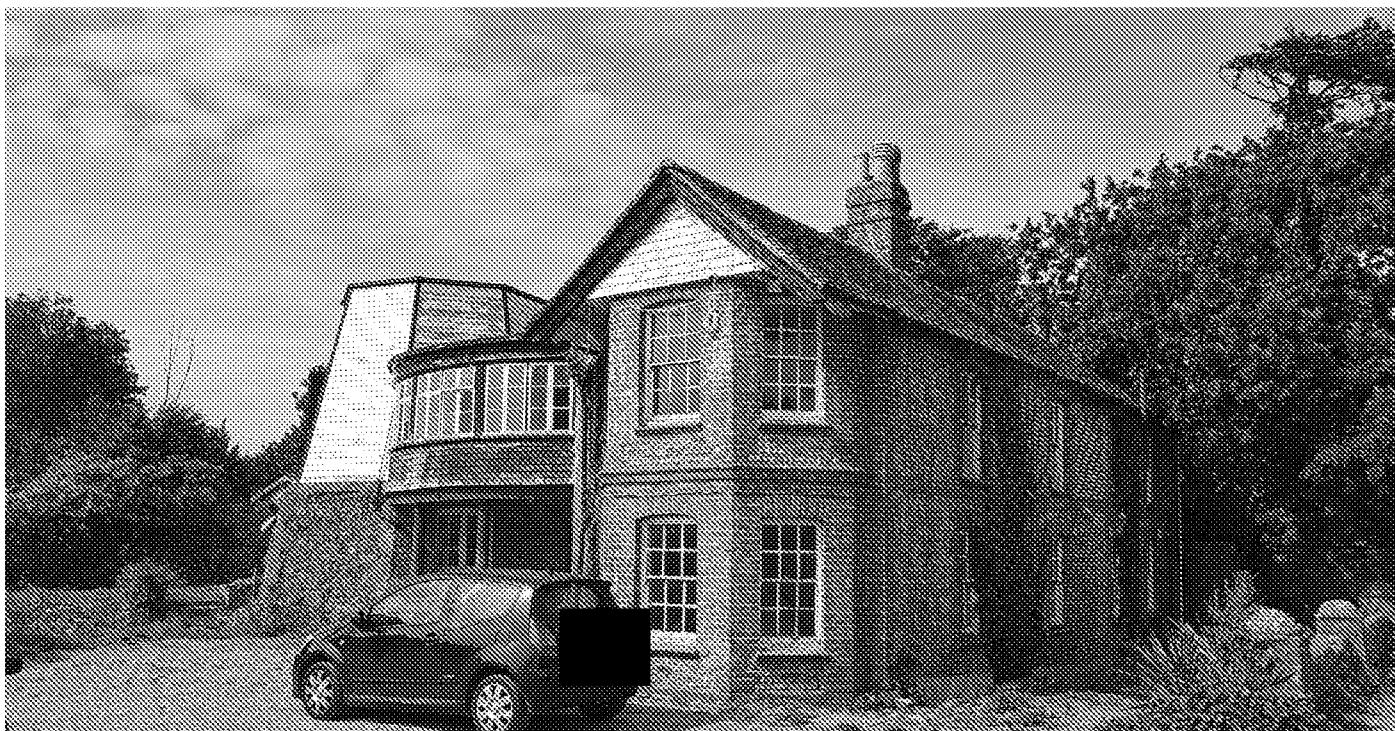
- 4.3.2 A large building of flint and brick construction which appears to have been extended numerous times over the years. The old windmill is still present, albeit with the top section and sails removed, and is attached to the main building via a flat roofed 'sun room'. The main section of building then extends along a north-south axis with a double gable roof, one section of which is clad in clay tile while the other is slate. The northern-most end of the building appears to be most recently constructed being an 'L' shape building of brick construction with tile roof.

- 4.3.3 Internally the building contains 3 no. open roof voids. Void no. 01 measures approximately 12m x 2.5m with a height to the ridge of c. 1.5m. The void is of traditional rafter construction with a mixture of BRM and bitumen roofing felt. Numerous rat and mouse droppings were recorded throughout. A small number of brown long-eared bat and pipistrelle sp. droppings were recorded at the point where the sun room joins adjoins this area. Void no. 02 measures approximately 16m x 3m with a height to the ridge of c. 1.5m. The void was similar in construction to void no. 01. A small number of pipistrelle droppings were recorded to the south and west of the central chimney. Void no. 03 was 'L-shaped' with a height to the ridge of c. 3m. Wooden sarking was present throughout. A small number of BLE droppings were recorded to the western section of the void.

| <b>Ref.</b> | <b>External Assessment</b> | <b>Internal Assessment</b> | <b>Suitability</b> |
|---|---|---|---|
| B1 | Warped/slipped/damaged roof tiles could provide access. Some missing mortar beneath ridge tiles. Small areas of lifted lead flashing. | Small number of pip sp. & Plecotus sp. droppings in void 1, Small numbers of pip sp. droppings in void 2 & 3. | <b>High</b> |

Photograph No. 1 - View of Building B1, assessed as providing High bat roost suitability.

- 6.2 Refurbishment of Building B1 and B2 has the potential to impact upon a bat roost (*should one be present*). Before any works which may affect the roof/void of these buildings (*including erection of scaffolding, works to upstairs ceilings, re-roofing, extensive upstairs wall removal etc*) a full bat survey will be required. Building B1 should be subject to 3 no. survey visits while Building B2 will require 2 no. survey visits. Survey visits should be undertaken during the optimal survey season (*May-September, with at least 2 no. surveys for Building B1 and 1 no. survey for Building B2 undertaken during the peak months of May-August*) and in optimal weather conditions (*+10°C, calm, dry*) in accordance with best practice guidelines (*Bat Surveys for Professional Ecologists: Good Practice Guidelines (BCT, 2016)*).

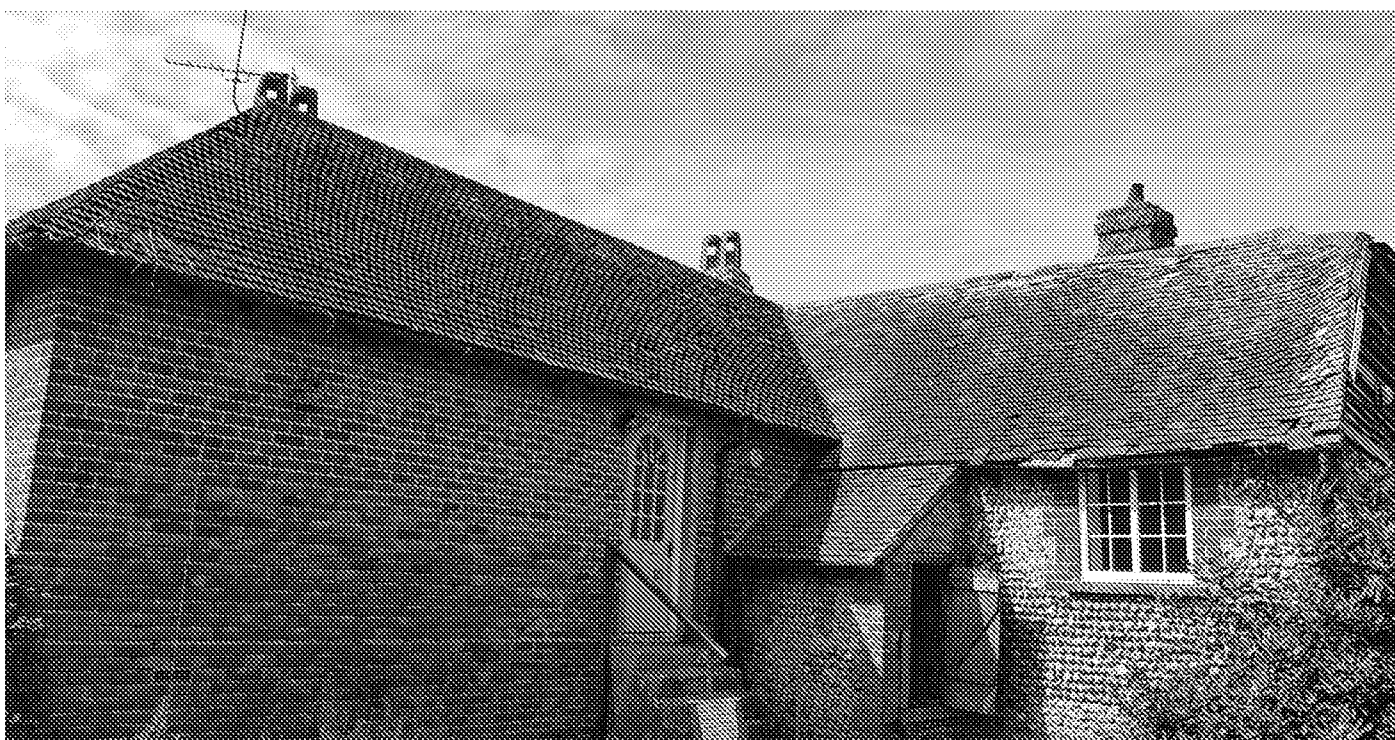
- 4.3.4 A small single-storey flint and brick cottage with clay tile roof. The roof is in poor condition with numerous slipped/broken tiles recorded throughout. Internally, the roof void contained a moderate amount of cobwebs as well as mouse droppings. No roofing membrane was present resulting in large amounts of debris within the void. Access was limited however a small number of droppings of a size and shape characteristic of pipistrelle sp. were recorded around the loft hatch.

| <b>Ref.</b> | <b>External Assessment</b> | <b>Internal Assessment</b> | <b>Suitability</b> |
|---|---|---|---|
| B2 | Numerous warped/missing/lifted roof tiles. | No roof membrane. Limited access into the roof void; small number of pipistrellus sp. droppings recorded near the roof hatch. | <b>Moderate</b> |

Photograph No. 2 - Building B2, assessed as providing moderate bat roost suitability.

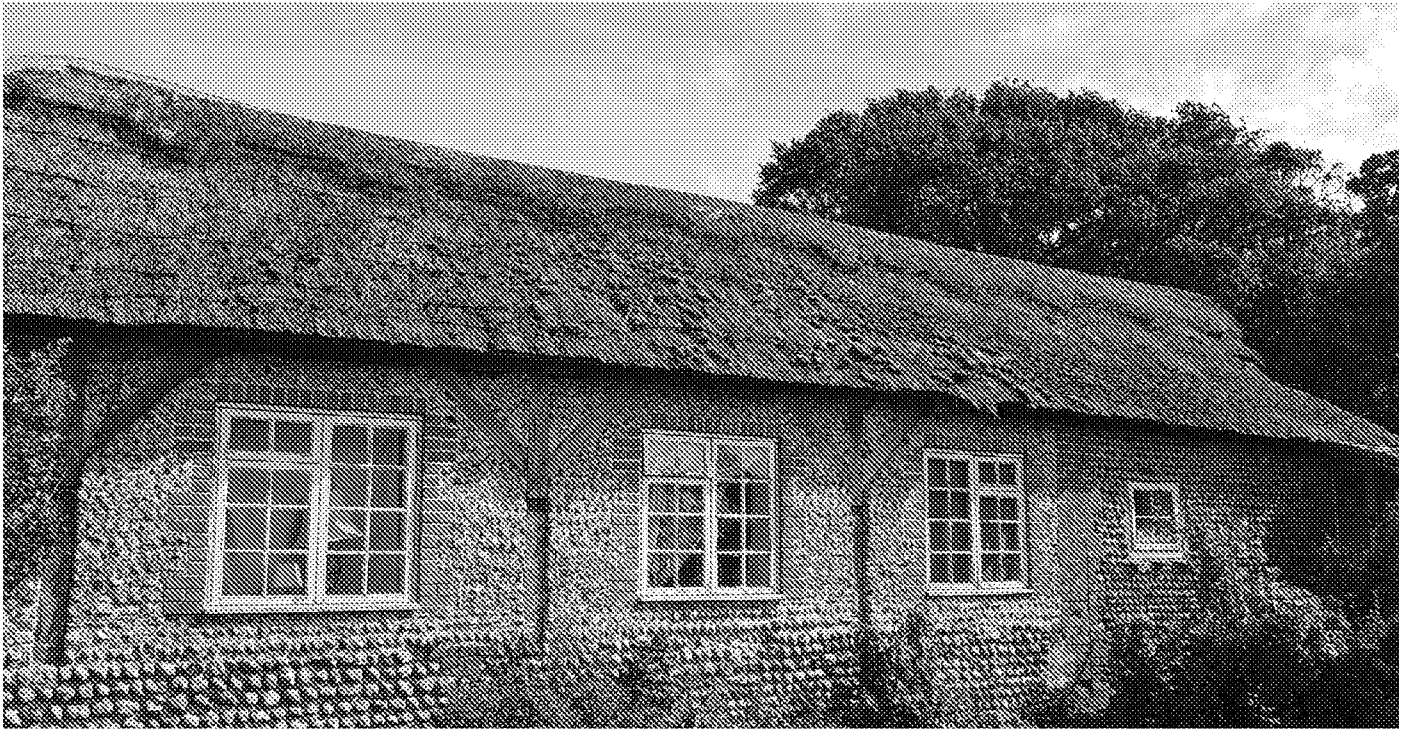
- 4.3.5 A single storey flint cottage with thatch roof in poor condition. Deterioration of the thatch has resulted in reasonably high light levels within the roof void. Dense cobwebs were noted throughout as well as ivy ingress. No evidence of bats was recorded internally/externally.

| <b>Ref.</b> | <b>External Assessment</b> | <b>Internal Assessment</b> | <b>Suitability</b> |
|---|---|---|---|
| B3 | Potential access at the eaves. | No evidence internally. Void considered too light to support a roost. No potential for crevice dwellers in the thatch. | <b>Negligible</b> |

Photograph No. 3 - Building B3, assessed as providing negligible bat roost suitability.

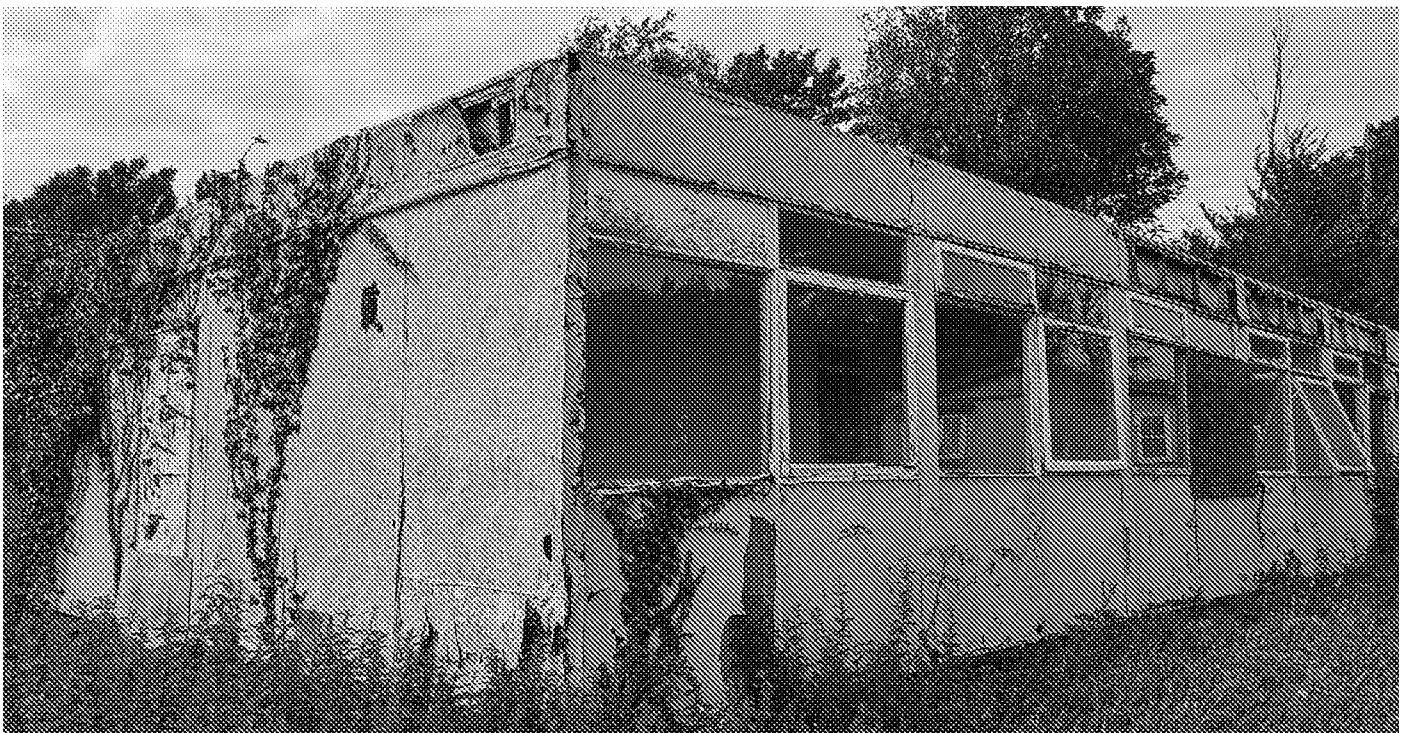
- 4.3.6 Building B4 was formerly utilised by the private school which used to own the site. The large pre-fabricated flat roofed building has fallen into a state of disrepair and now has numerous missing windows, collapsed ceilings and holes in the roof. In its current state the building is considered to be too damp, draughty and light to support a bat roost.

| <b>Ref.</b> | <b>External Assessment</b> | <b>Internal Assessment</b> | <b>Suitability</b> |
|---|---|---|---|
| B4 | In very poor condition, damp and draughty throughout. | No roof void. | <b>Negligible</b> |

Photograph No. 4 - Building B4, assessed as providing 'negligible' bat roost potential.

- 6.3 Buildings B4 and B5 have been assessed as offering '*negligible*' bat roost suitability. The demolition of these buildings to facilitate the construction of the new dwelling on site is considered unlikely to contravene *The Conservation of Habitats and Species Regulations 2010*.

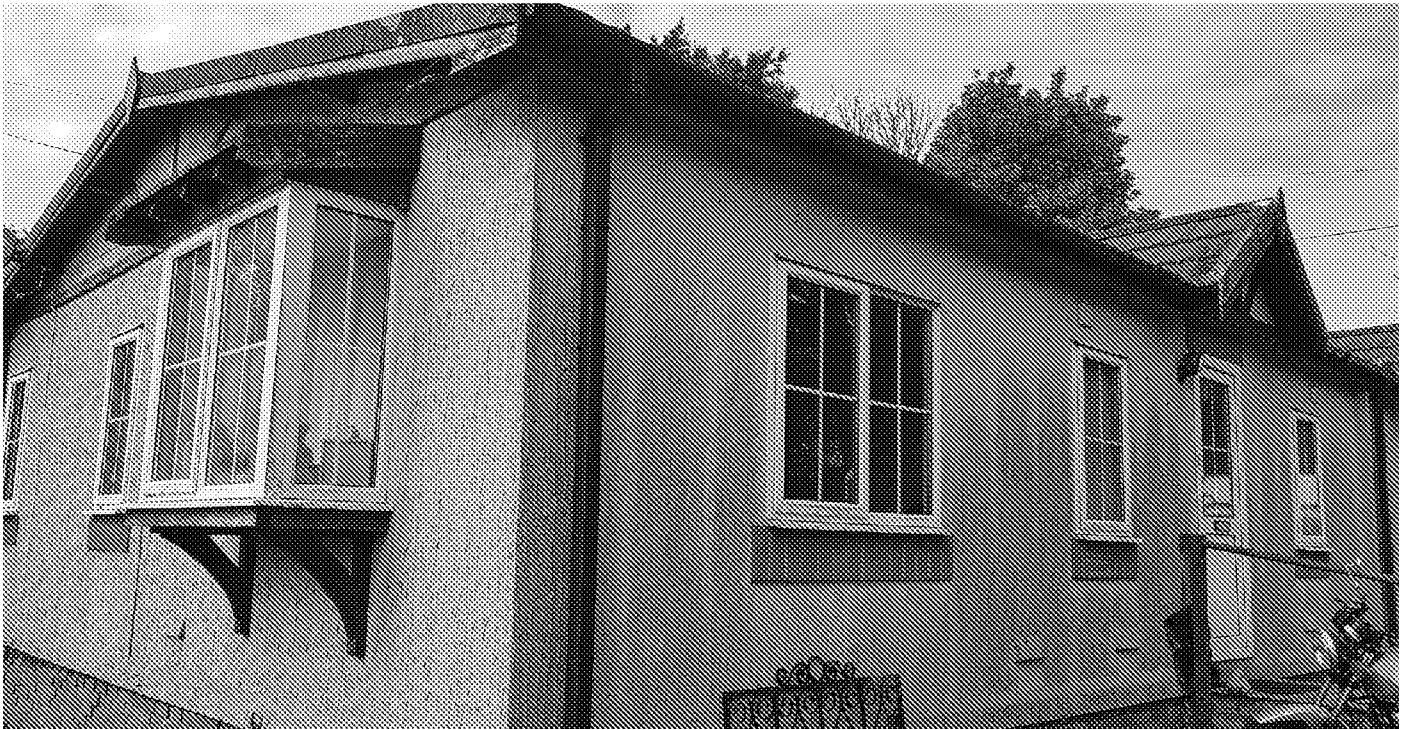
- 4.3.7 A large park home located to the north-western section of the site. The buildings is of modern construction with felt and tile roof which was in good condition. PVC windows were in good condition as were the wooden soffits and fascia; no potential access points were noted. No access was available internally.

| <b>Ref.</b> | <b>External Assessment</b> | <b>Internal Assessment</b> | <b>Suitability</b> |
|---|---|---|---|
| B5 | Recent construction, limited potential access points. These which were recorded were cobweb covered. | No internal access. | <b>Negligible</b> |

Photograph No. 5 - Building B5, assessed as providing 'negligible' bat roost potential.

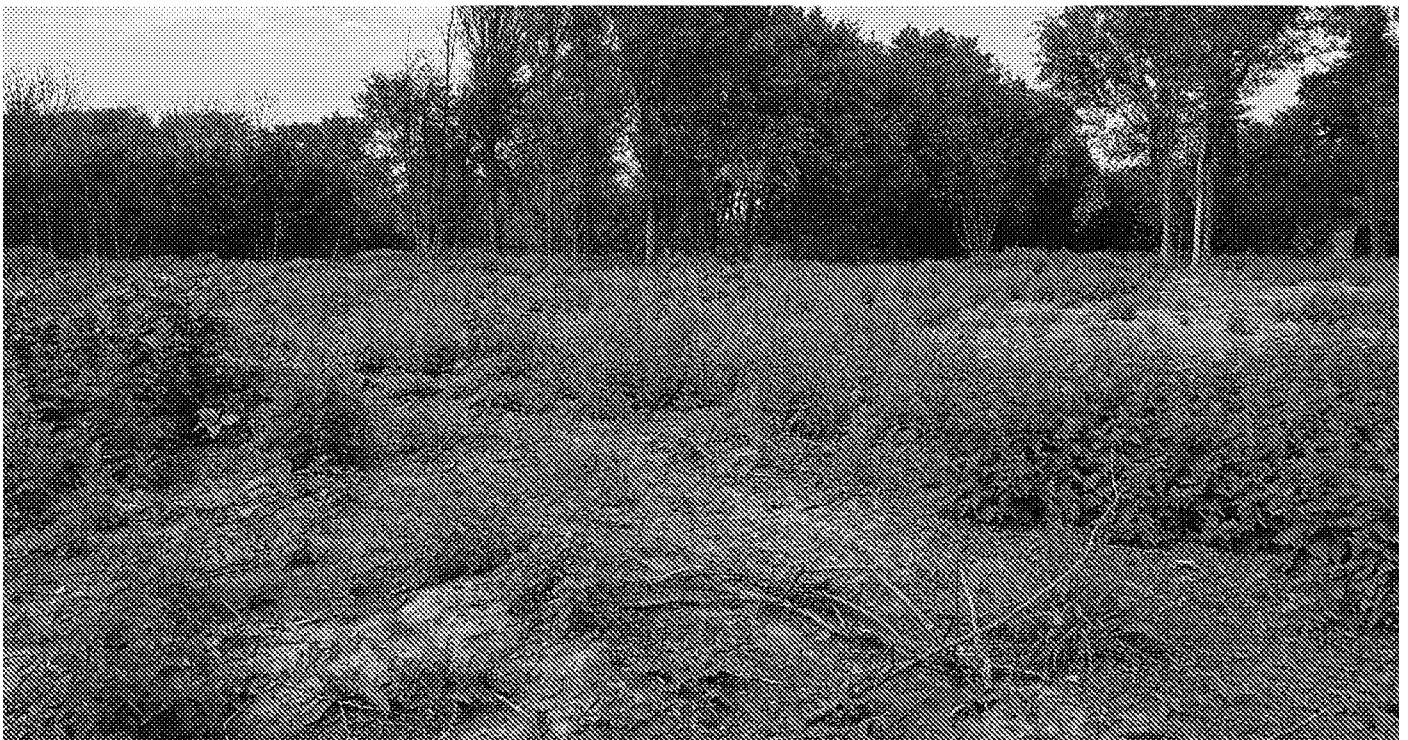
4.2.7 Large sections to the western sections of the site appear to have been recently cleared, resulting in bare ground which is beginning to be re-colonised.

Photograph No. 6 - View of the western section of the site looking towards the north.

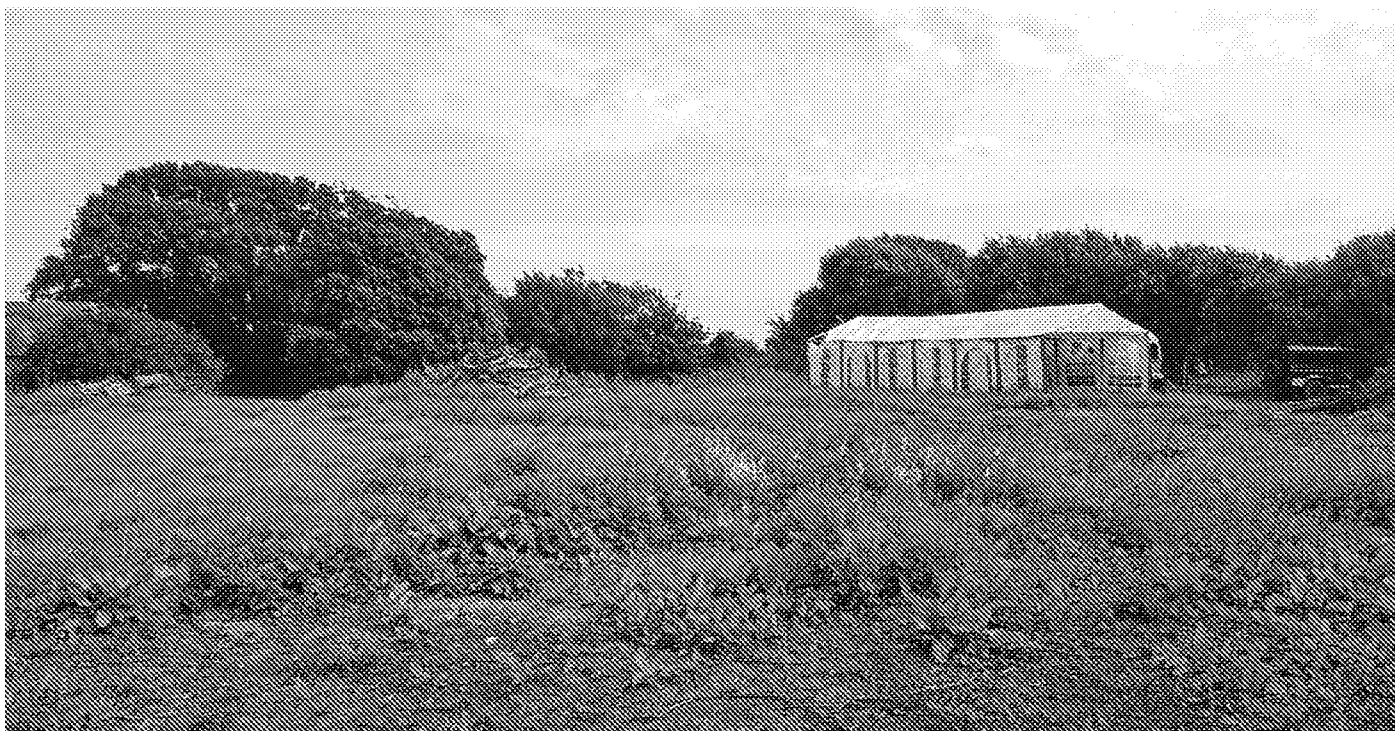
Photograph No. 7 - View across the western section of the site looking towards the south-east.

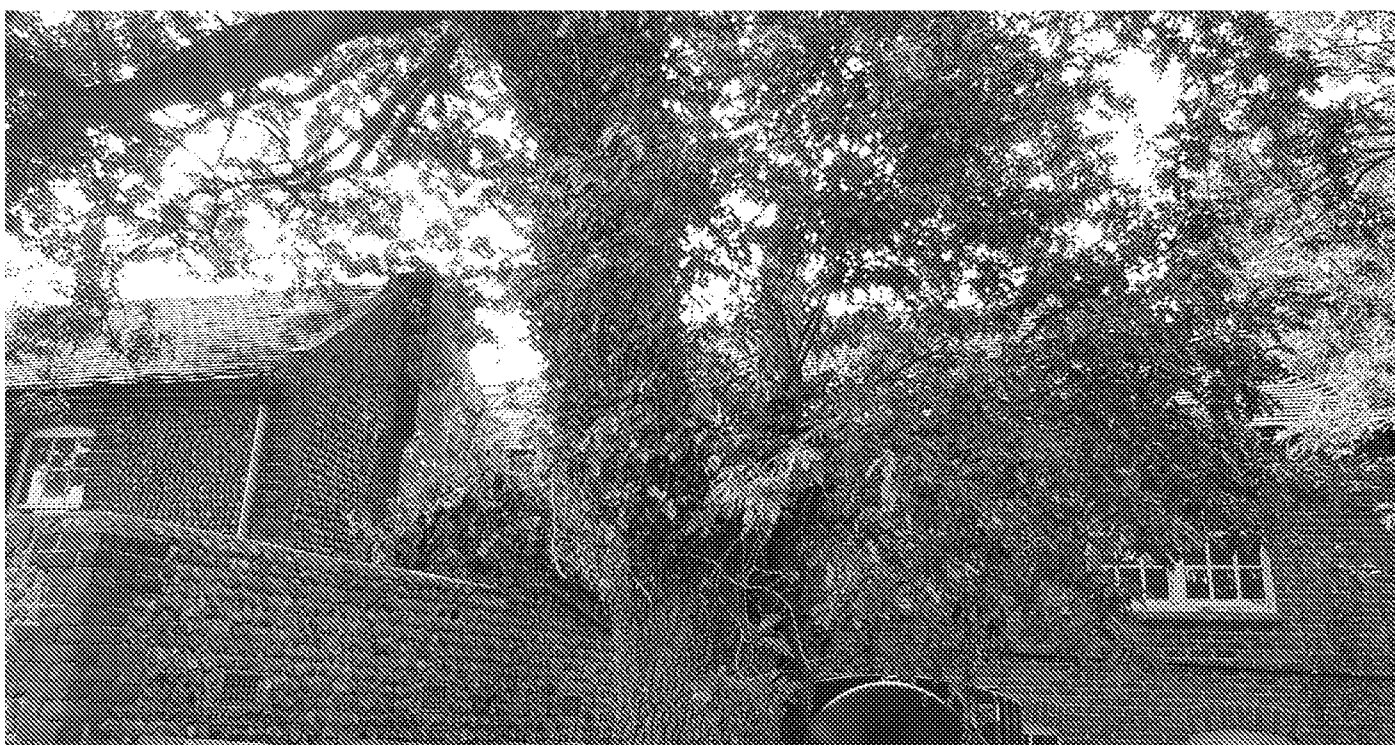
- 4.4.1 Trees which may be impacted by the development were fully assessed during the course of this survey. The majority of the trees on site are semi-mature specimens and offer no discernible bat roost features.
- 4.4.2 A single large oak tree to the north-east of the site (*T01*) has been assessed as providing '*low*' bat roost suitability. This tree holds ivy cover throughout while a large tear-out was recorded at c. 2.0m height. No direct evidence of bats was recorded.

Photograph No. 8 - Tree T01 which was assessed as providing 'low' bat roost suitability.

- 5.6 A single tree (*T01*) has been assessed as providing some bat roost suitability. This tree has been assessed as providing 'low' bat roost suitability. This tree is recommended for retention; should removal be required the tree should be soft-felled under ecological supervision.
