# Heritage Statement

## Climping Mill, Climping Street

| <b>Written by:</b> | Ignus Froneman B.Arch.Stud ACIfA IHBC | <b>Date:</b> | 13 January 2020 |

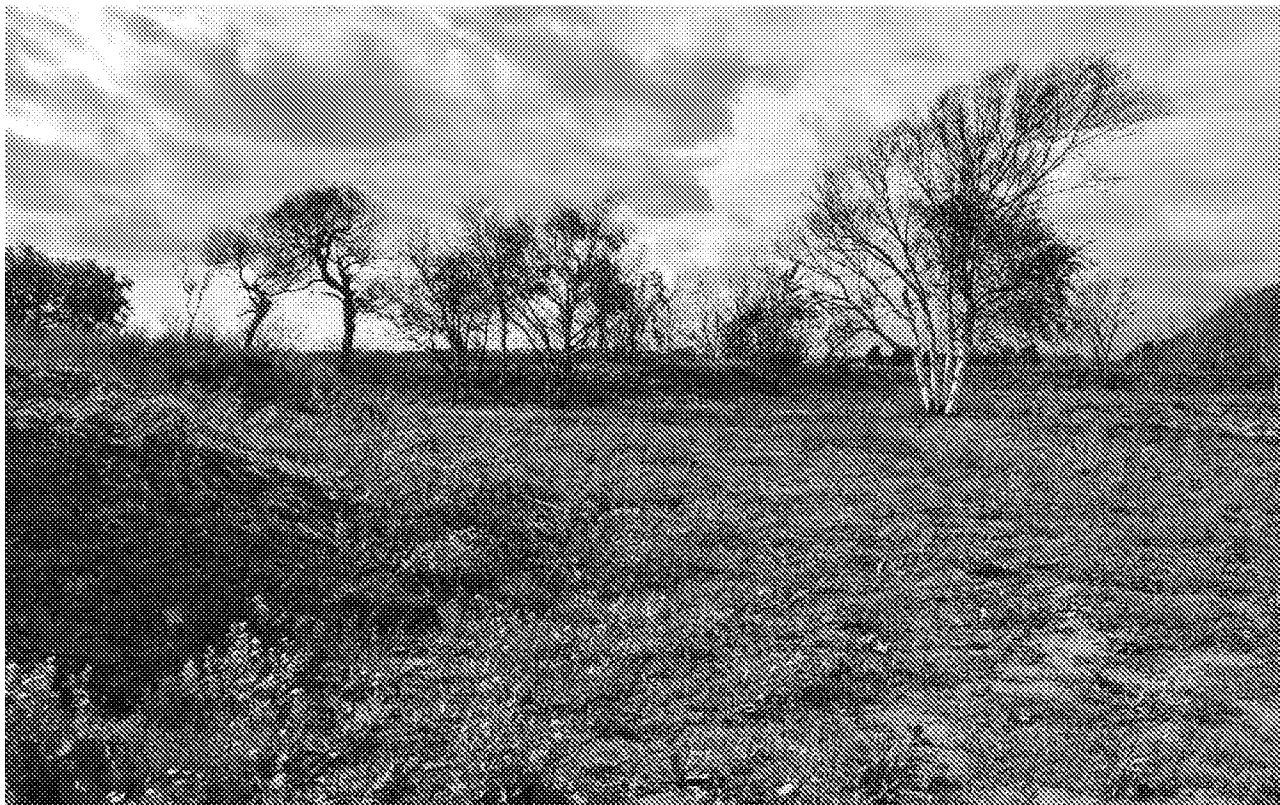
**Photo 1:** The peripheral earth bunds, appearing as soft green landscape features.

- 3.3 Essentially, on the ground the groundworks manifest as peripheral low earth bunds, and vegetation has now started to take hold, making the bunds (as intended), soft green landscape features (e.g. **Photo 1**). Tree planting is also proposed, and has been undertaken, but the trees have not yet become established.

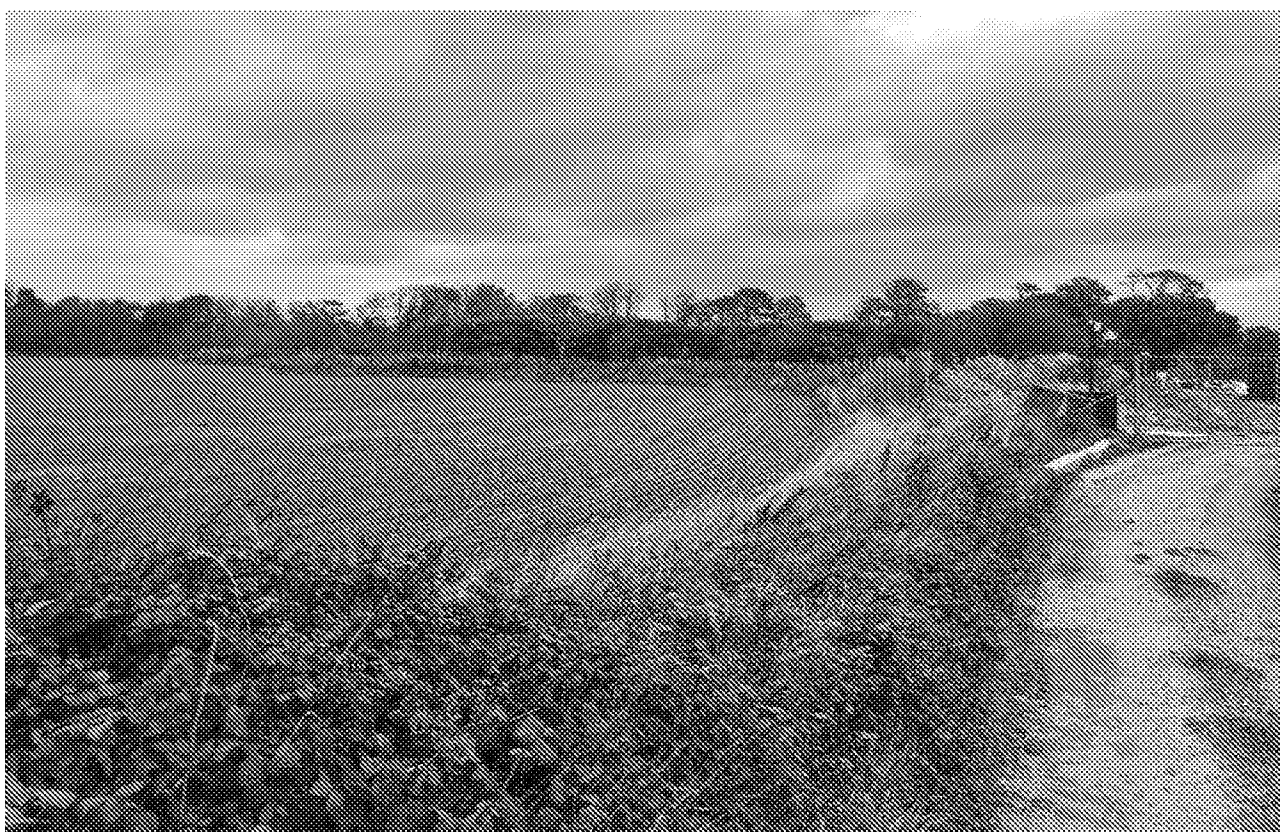
**Photo 2:** The peripheral earth bund, seen on approach from the south.

- 3.4 As **Photos 2 and 3** show, from a distance the bunds blend well into the boundary vegetation, although on those photos the trees that form part of the planted peripheral vegetation has not yet grown noticeably.

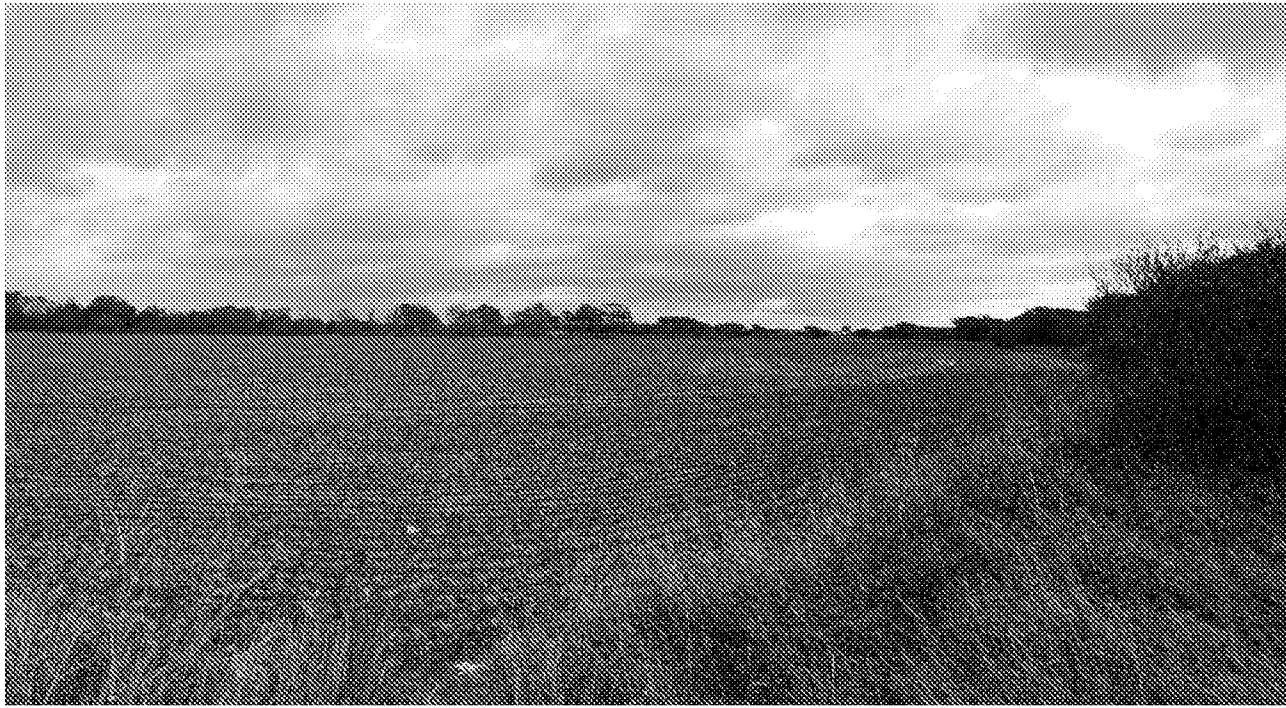
**Photo 3:** The longer view from the south.
