Bexstone House

Eastergate

Bat Survey Report 2018

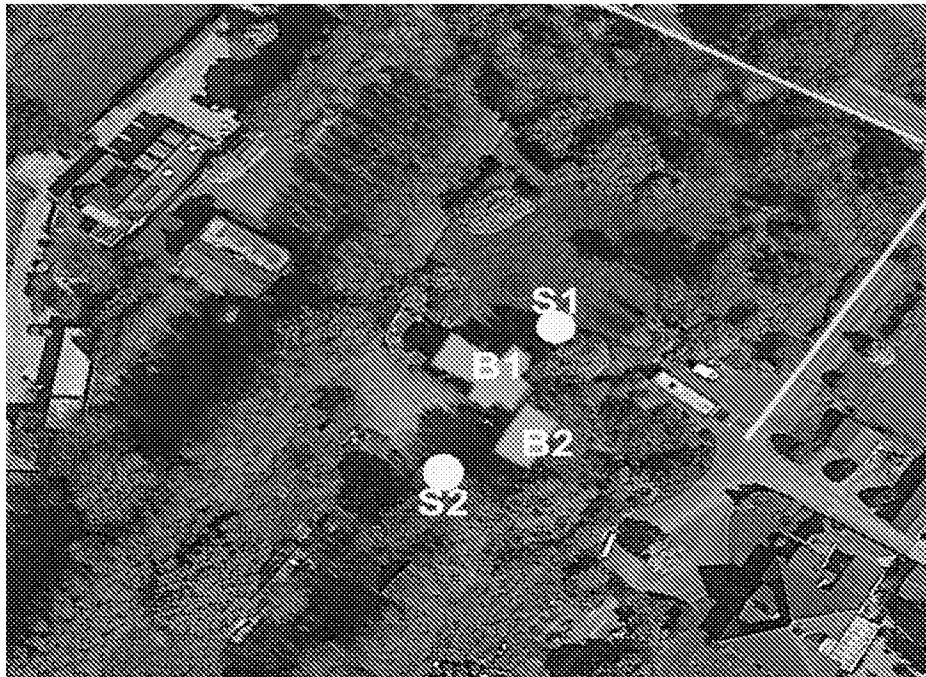
*Figure 2: location of surveyors (S1, S2) and buildings (B1, B2)*

- 2.6 All surveyors were equipped with either Bat Box Duet heterodyne and frequency division detectors, Elekon Batscanner detectors and an Echo Meter Touch 2 with iPad. The buildings surveyed and the number of surveys are shown in figure 2 below.
