**TARS FARM, CHURCH LANE, BARNHAM, BOGNOR REGIS PO22 0DB**

**Bat Daylight and Evening Emergence Survey**

July 2013

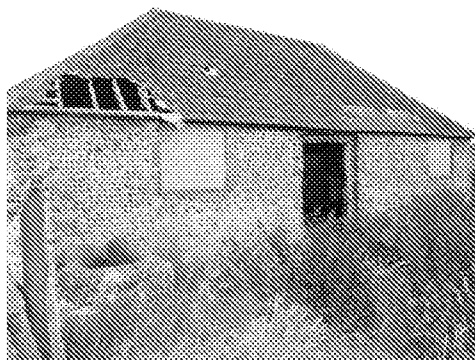
Building 1

A single storey building with flint walls, an unlined slate roof, an open doorway and bricked up windows. There is a large hole in the roof. No bats or evidence of bats was found within the building but there is considered to be some potential for bats to roost in crevices in the walls and above roof timbers.

- 5.1 Due to the presence of bats within the local area it is recommended that some roosting features are incorporated into the redevelopment of the site in order to increase the biodiversity potential of the site and to compensate for the loss of potential roosting sites within the existing buildings (principally building 1 and 2).

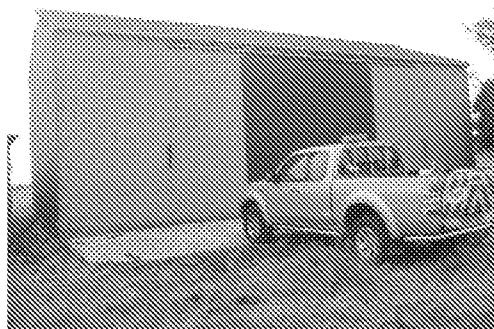
Building 3

This relatively modern building is currently being used as a hay store. The walls are constructed of block and it has a pitched corrugated asbestos type roof over a metal frame. The large sliding doors are kept shut. The floor had been swept in readiness for the storage of hay at the time of this survey. No bats or evidence of bats was seen and the potential of this building for bat use is considered to be low, although there is a possibility that bats might find a roosting place behind barge boards or any overlaps in roofing materials.

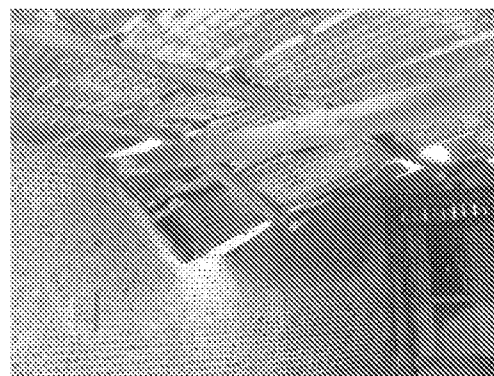
Interior, Building 4

This open-fronted building has a sloping, corrugated iron roof with a timber frame and some roof supports made from old telegraph poles. The roof is in danger of collapse. Building 4 is joined to one of the old walls from the now ruinous flint barn. No bats or evidence of bats was seen and the potential of this building, for bat use, is considered to be low.

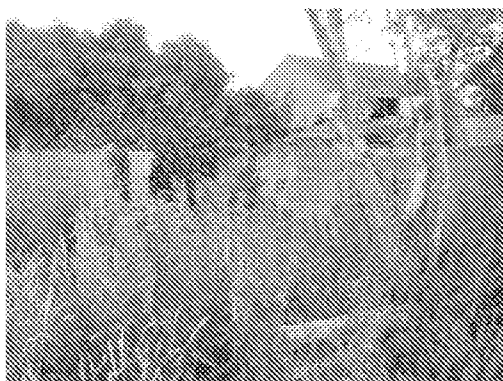
This low, block building is in a state of collapse but appears to have once housed pigs or sheep. The potential for bat use is considered to be low.

Remains of Building 7 through to Building 2

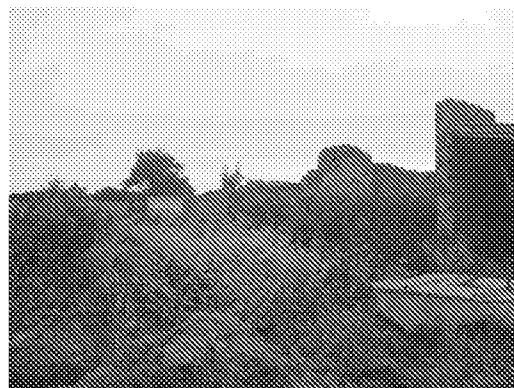
Only ruined walls, with a few remaining 'arrow' slots, remain of this large old flint barn. A search of interior walls was hampered by nettles and other thick vegetation. The old barn is considered to offer a low potential for bat use.

This ruined building appears to have been a cow shed, once attached to the old flint barn. Little remains of this building, which is considered to have a low potential for bat use.

Building 4 and remains of Buildings 5 & 6
