## Fire Risk Assessment

The Breakers  
29 Tamarisk Way  
East Preston  
West Sussex  
BN16 2TE

# Fire Risk Assessment

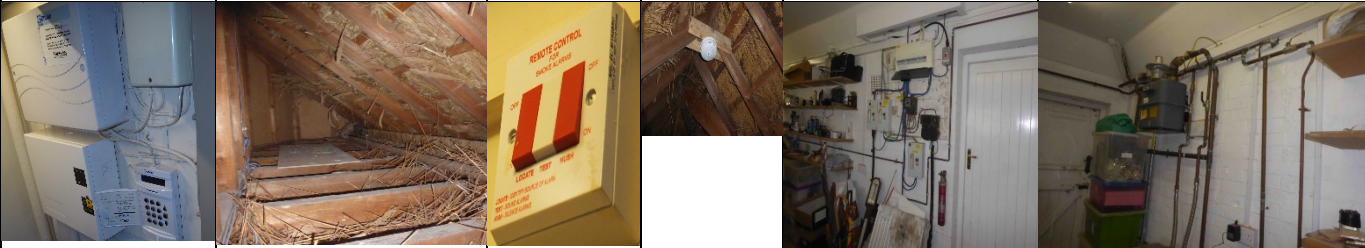
| Location | Hazard | Persons at risk | Risk H/M/L | Existing controls | Further Action | By whom & date actioned |
|---|---|---|---|---|---|---|
| Roof spaces | Accumulation of straw and thatch fallen from inside roof | Owner & visitors | Med | Heat detectors are fitted and connected to the intruder alarm by Chubb with auto dial. # | A review of the fire alarm should be carried out and consideration to installing a zoned panel meeting BS 5839 part 6 LD1 or LD2 AFD as a minimum. | A fire alarm company should be asked to review existing system. |
| | | | | | | # The intruder alarm is a Recall Windsor Panel Recall are no longer manufacturing and went into administration in 2017. The switch button looks like a ALCO as normally found in flats or HMO's There is a label recommending replacement Sept 2019 on the pattress box. |
| Intruder Alarm panel | Inside roof space | Basic test reset switch | Heat detector | Garage electrics | Gas meter and supply | |

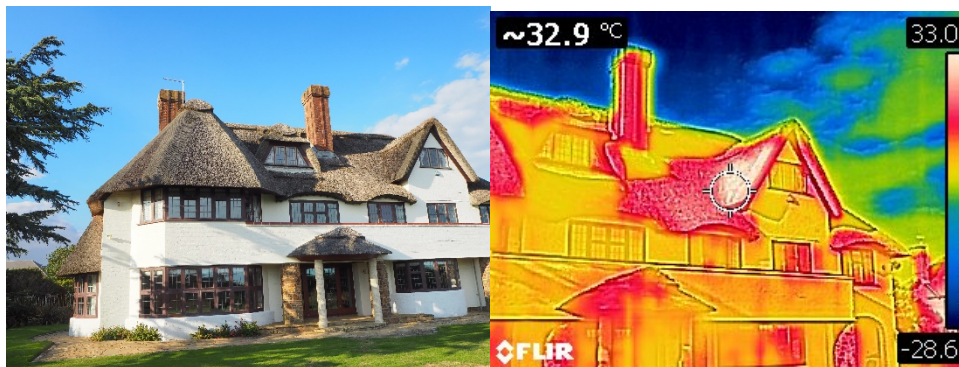
Should the property become involved in a thatch roof fire in all likely hood the house would not be saved – there are a number of hazards as previously identified the rear of the property is particularly at risk and if involved in fire would quickly spread.

| Location | Hazard | Persons at risk | Risk H/M/L | Existing controls | Further Action | By whom & date actioned |
|---|---|---|---|---|---|---|
| House at risk of being lost to fire | Risk of fire starting on thatch roof | Owner & visitors | High | Controls outside of owners control. | Consider major works i.e. replacing entire roof in traditional materials. | |
