## **Bat Survey and Report**

Church Field, Station Road, East Preston, West Sussex

August 2007

canopyCCFEP.0207.BAT01

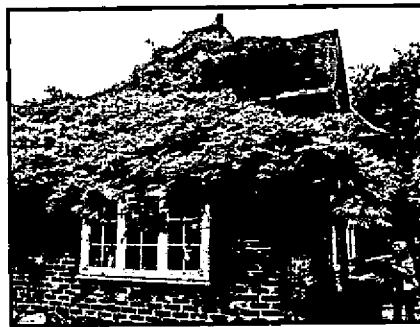
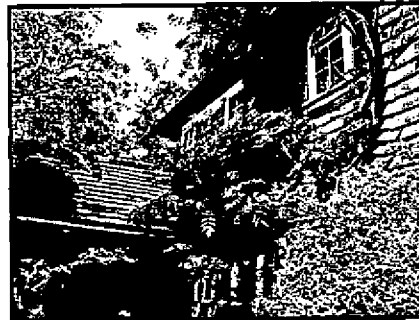
- 1.5 The large garden has recently had a number of large trees removed which previously excluded much light from the house. This, together with the wisteria and mature shrubs that still exist, will have made the building cool as well as dark. To the south of the house is a large, unmaintained pond with weed covering its surface.

*Climbing plants and mature shrubs grown on or close to the house*

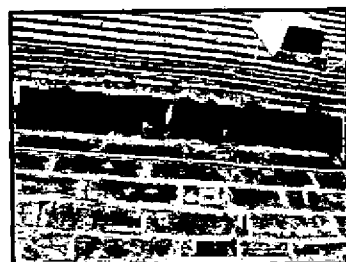
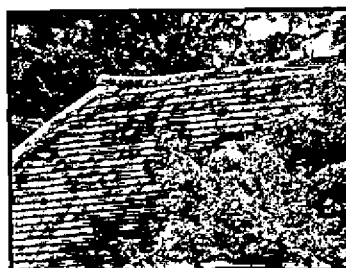
- 3.1 A visual survey of the building was carried out using powerful binoculars and a lamp to illuminate areas under the hanging tiles, this method also allows identification of rub marks, droppings and other identifying signs left by bats. It also illuminates areas where there are undisturbed cobwebs.

*Areas of tiling both on the walls and roof were inspected*

- 7.2 It is recommended that the hanging tiles and ridge tiles are removed very carefully by hand, rather than by machine. If bats are found during this process then work must immediately cease and advice be sought from a licensed bat worker or Natural England.

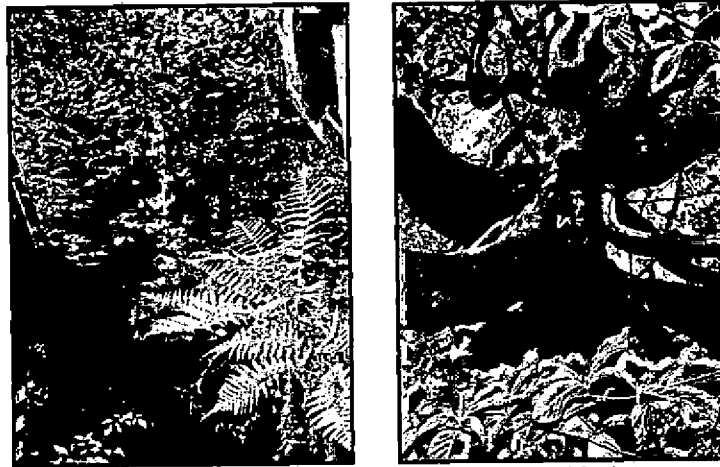
- 3.6 All trees were inspected for possible roosting sites. Particular attention was given to crevices, cracks, splits or holes that could be used by bats.

*Some of the trees on the site which have potential for bats*
