# Factual Soakage Test & Groundwater Monitoring Report

**Project Name:** Quercus Nursery

**Location:** Littlehampton Road, Ferring, BN12 6PG

**Project ID:** J14325

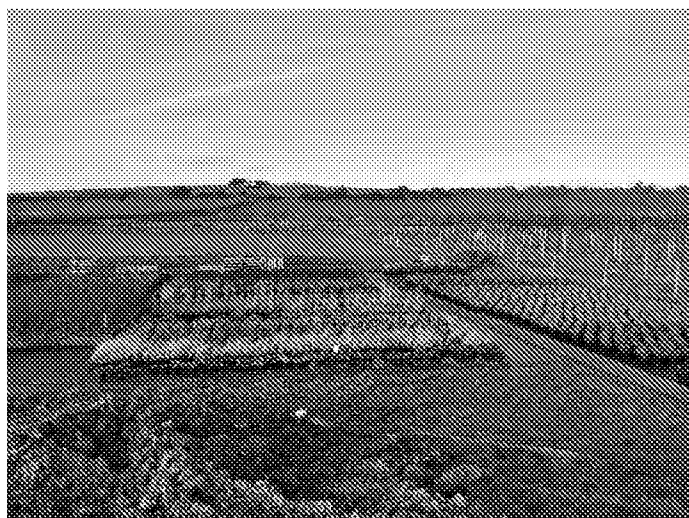
Planter beds and TP3 – view north
