YEOMANS HONDA, LITTLEHAMPTON RD, WORTHING

GROUND CONDITION ASSESSMENT

AUGUST 2018

Project No.                        J18-035

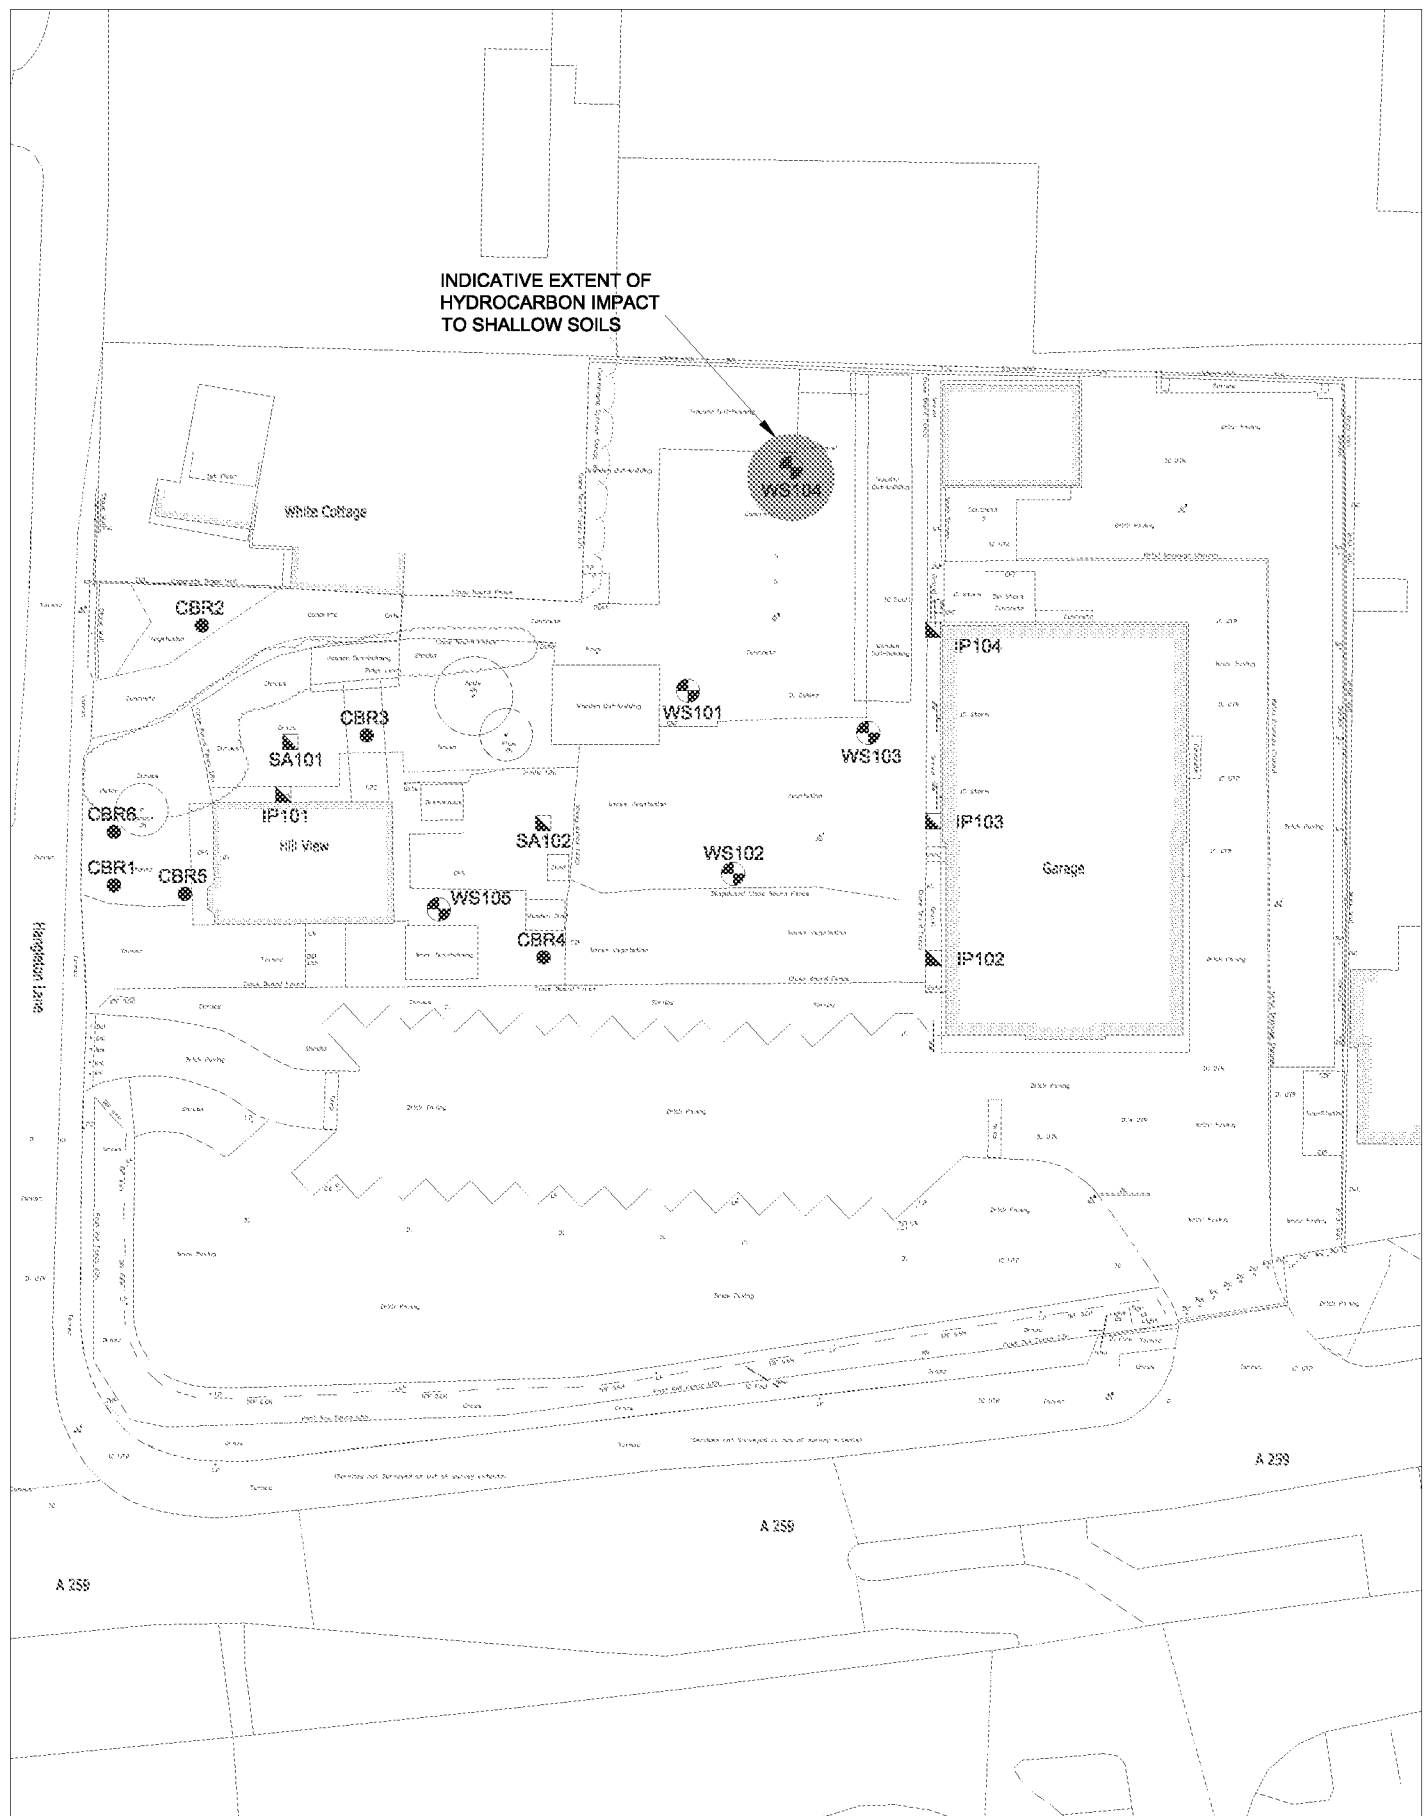
**FIGURE 2: INVESTIGATION LOCATION PLAN**

- 5no. windowless sample boreholes (WS101 to WS105) to a maximum depth of 5.0mbgl.
- Hand excavation of 4no. foundation inspection pits (IP101-104).
- Trial pit soakaway testing at 2no. locations in accordance with BRE 365.
- CBR testing (using a Dynamic Cone Penetrometer) at 6no. locations.

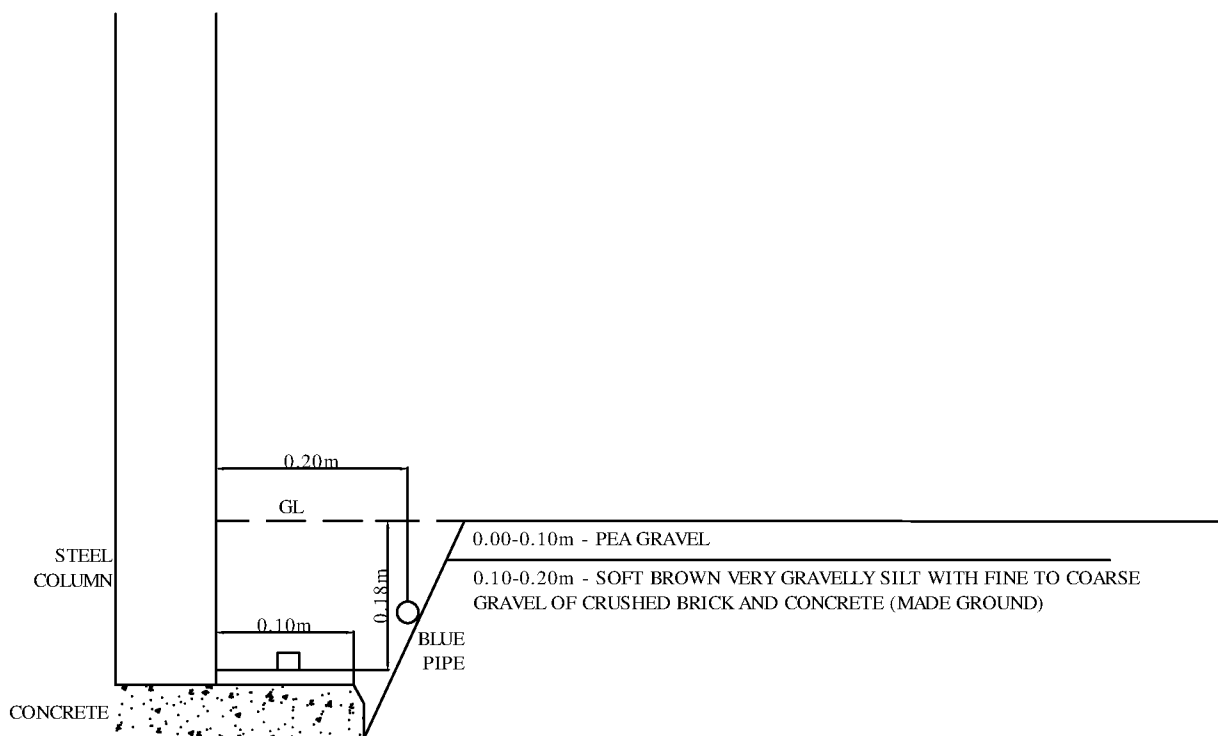
| drawing number | IP102 | | | rev. | 0 |

| Location | Rationale | Max depth (mbgl) |
|---|---|---|
| IP102 to IP104 | Hand excavated pits to inspect the foundation construction of the existing car dealership building along the boundary with the proposed car dealership building. | 1.20 |

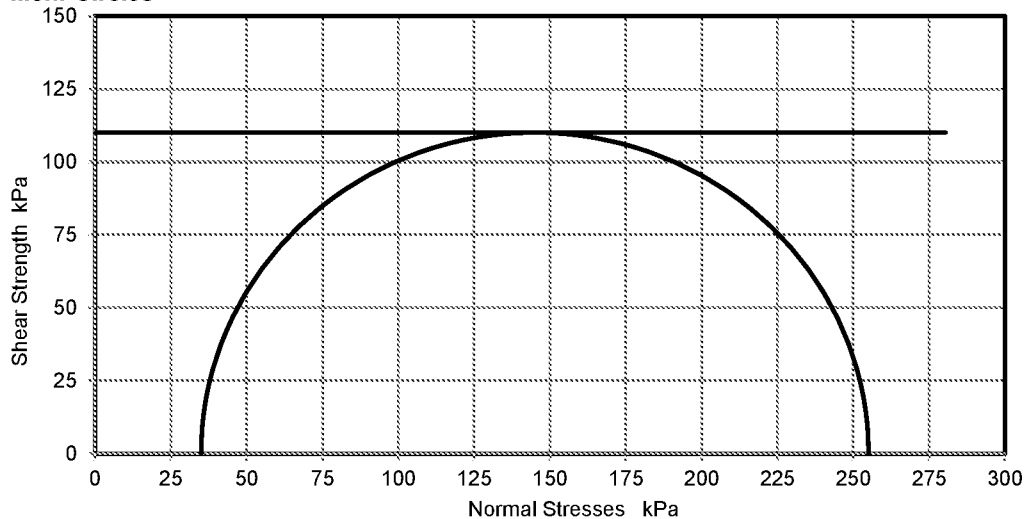
#### Mohr Circles

Mohr circles and their interpretation is not covered by BS1377. This is provided for information only.

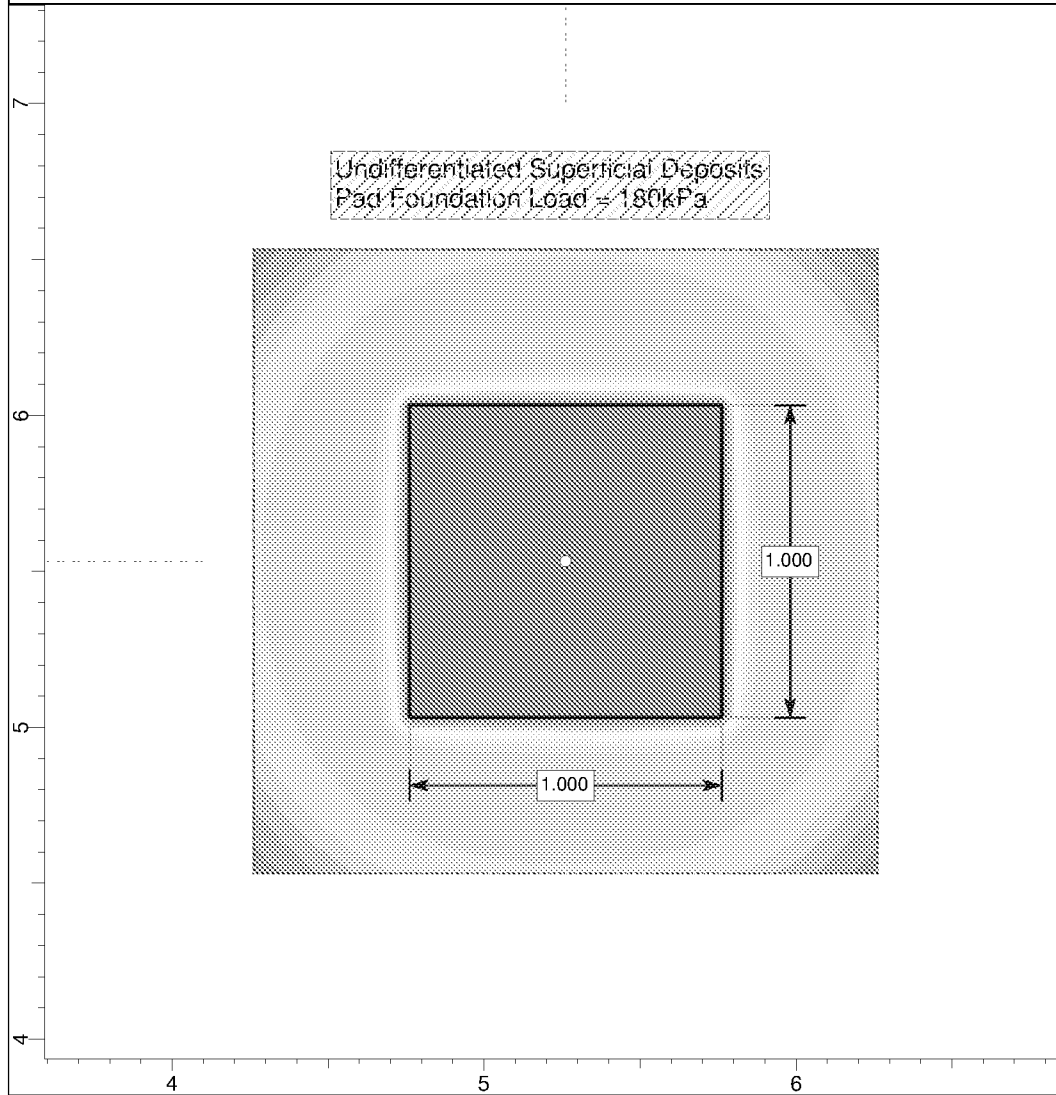
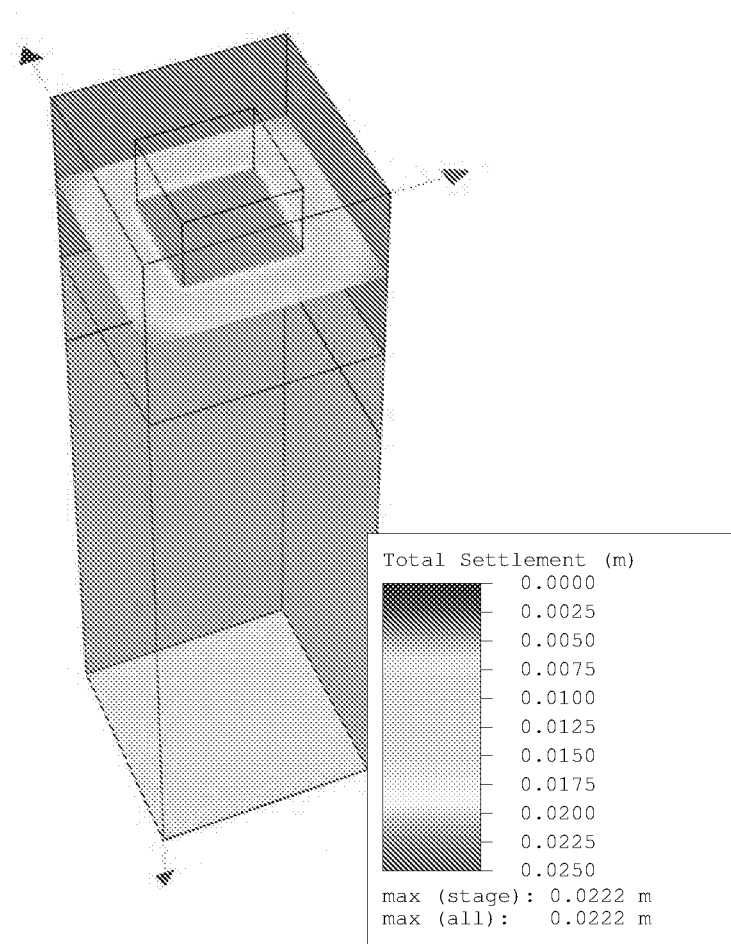
Data Type: Total Settlement

| | Analysis Description | | | Pad Foundation | |

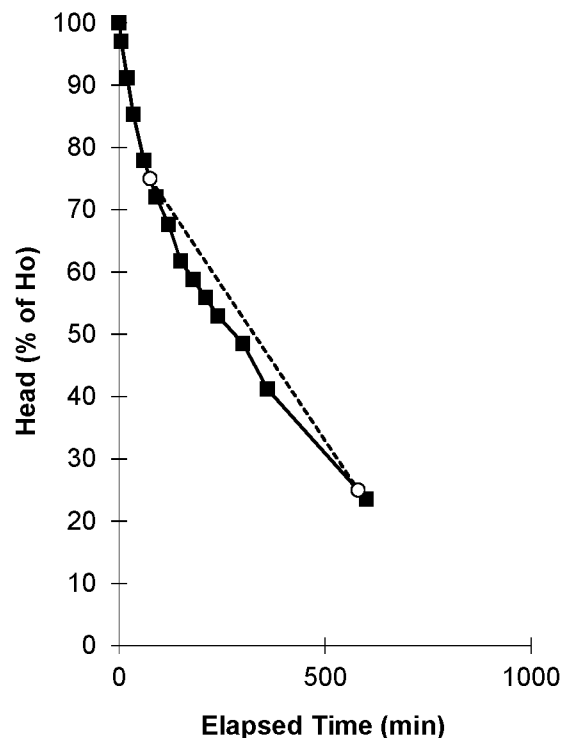
Final data point extrapolated due to slow infiltration. Therefore f value is indicative only.

Infiltration tests were undertaken at three locations across the site. Due to slow infiltration, the test results were extrapolated to achieve the final data points. Infiltration rates recorded in the modified tests ranged from  $1.54 \times 10^{-6}$  to  $7.87 \times 10^{-7}$  m/sec. The values recorded are consistent with low permeability and poor drainage conditions.
