***40 Little Paddocks, Ferring, Worthing, BN12  
5NJ***

***GEOTECHNICAL GROUND INVESTIGATION REPORT***

*Project No. 1188-20*

**REPORT ON GEOTECHNICAL GROUND INVESTIGATION  
AT 40 LITTLE PADDOCKS, FERRING, WORTHING, BN12 5NJ**

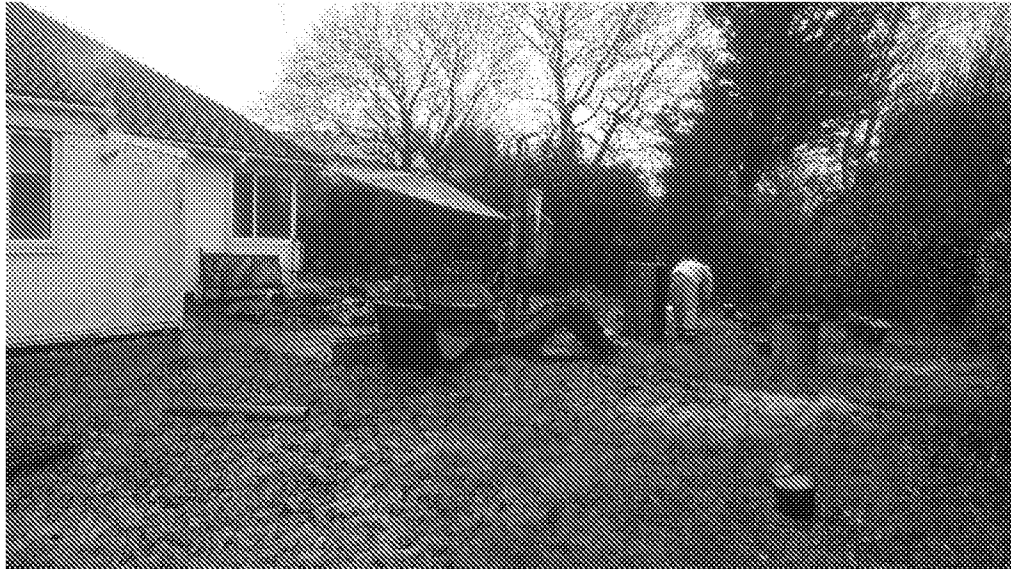
| <b>Photo<br/>No.1</b> | <b>Figure 5</b> | | | | |

| <b>Description:</b><br><b>Terrier Rig Performing<br/>Drilling at the location</b> | | | | | |

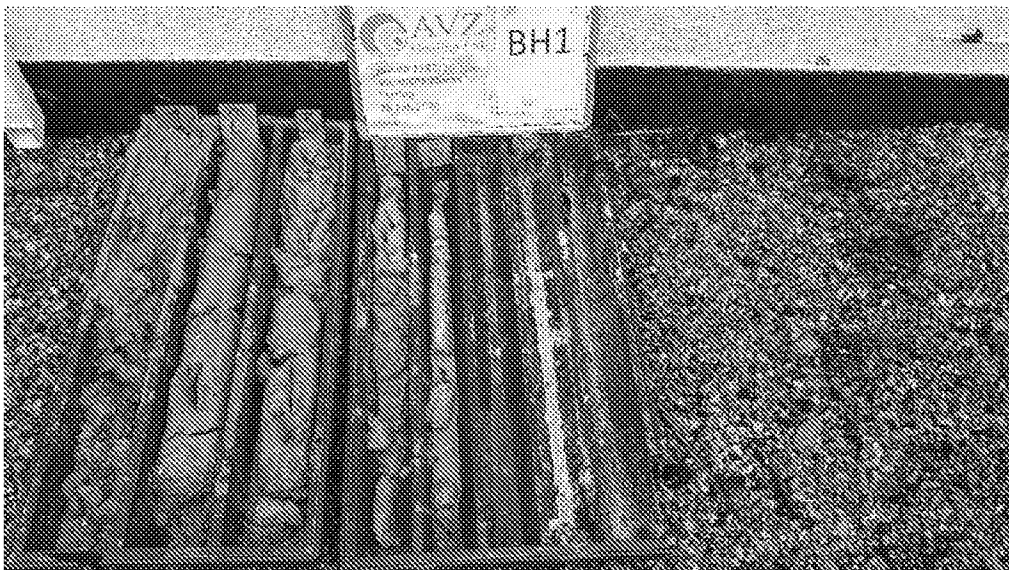
| Photo<br>No.2 | Figure 5 | |

| <p><b>Description:</b><br/><b>Core Recovered</b><br/><b>From BH1</b></p> | | |

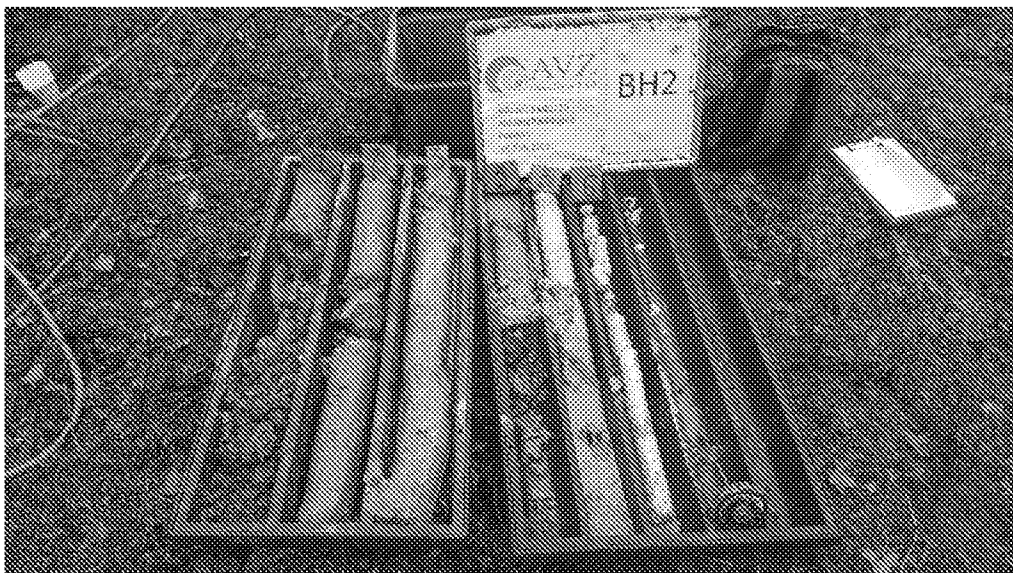
| Photo<br>No.3 | Figure 5 | |

| <b>Description:</b><br><b>Core Recovered</b><br><b>From BH2</b> | | |

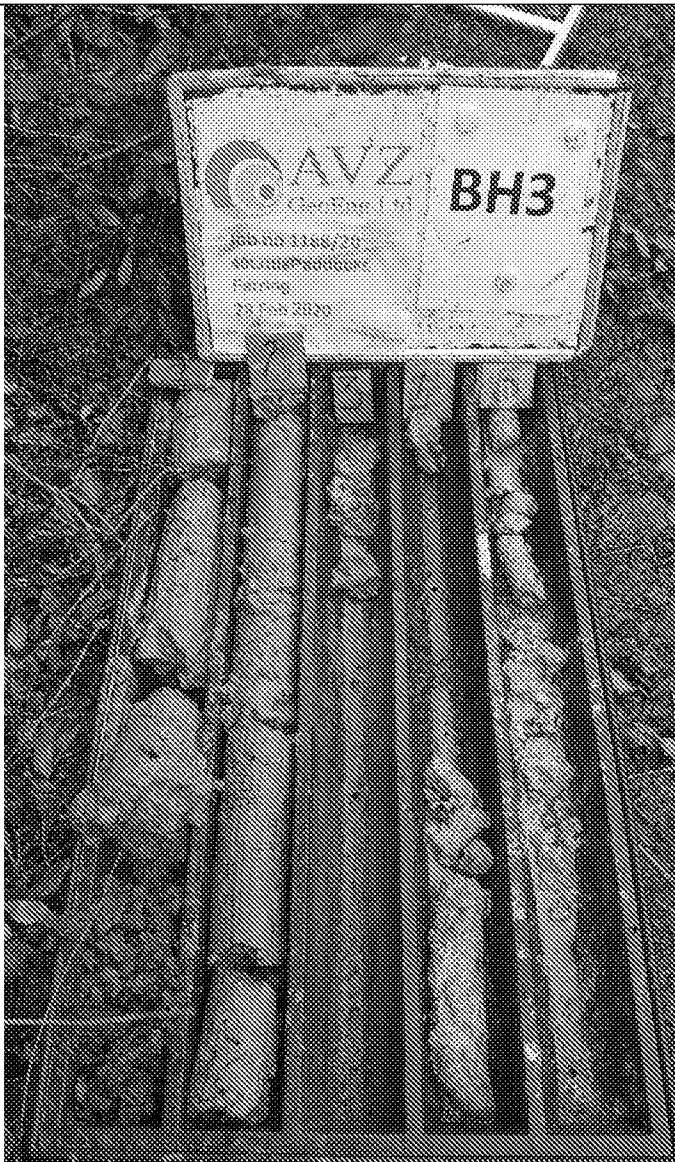
| Photo<br>No.4 | Figure 5 | |

| <b>Description:</b><br><b>Core Recovered</b><br><b>From BH3</b> | | |

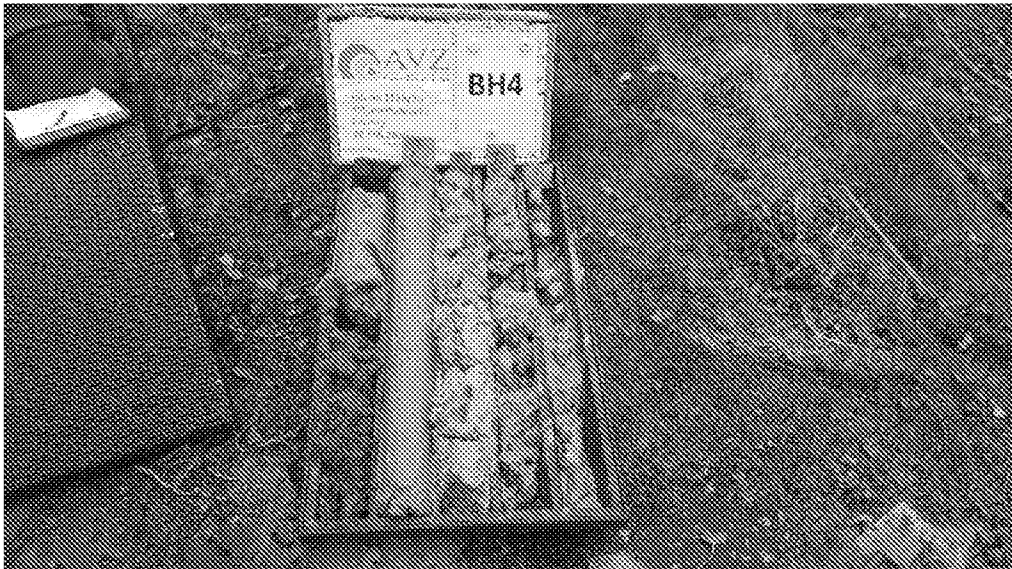
| Photo<br>No.5 | Figure 5 | |

| <b>Description:</b><br><b>Core Recovered</b><br><b>From BH4</b> | | |
