**SUMMERLEY CORNER  
SOUTH SITE  
SUMMERLEY LANE  
BOGNOR REGIS  
WEST SUSSEX**

**GEOTECHNICAL AND  
CONTAMINATION (PHASE I AND II)  
ASSESSMENT REPORT**

**Report No. LW23175 August 2012**

PHASE 1 CONTAMINATION ASSESSMENT (DESK STUDY)

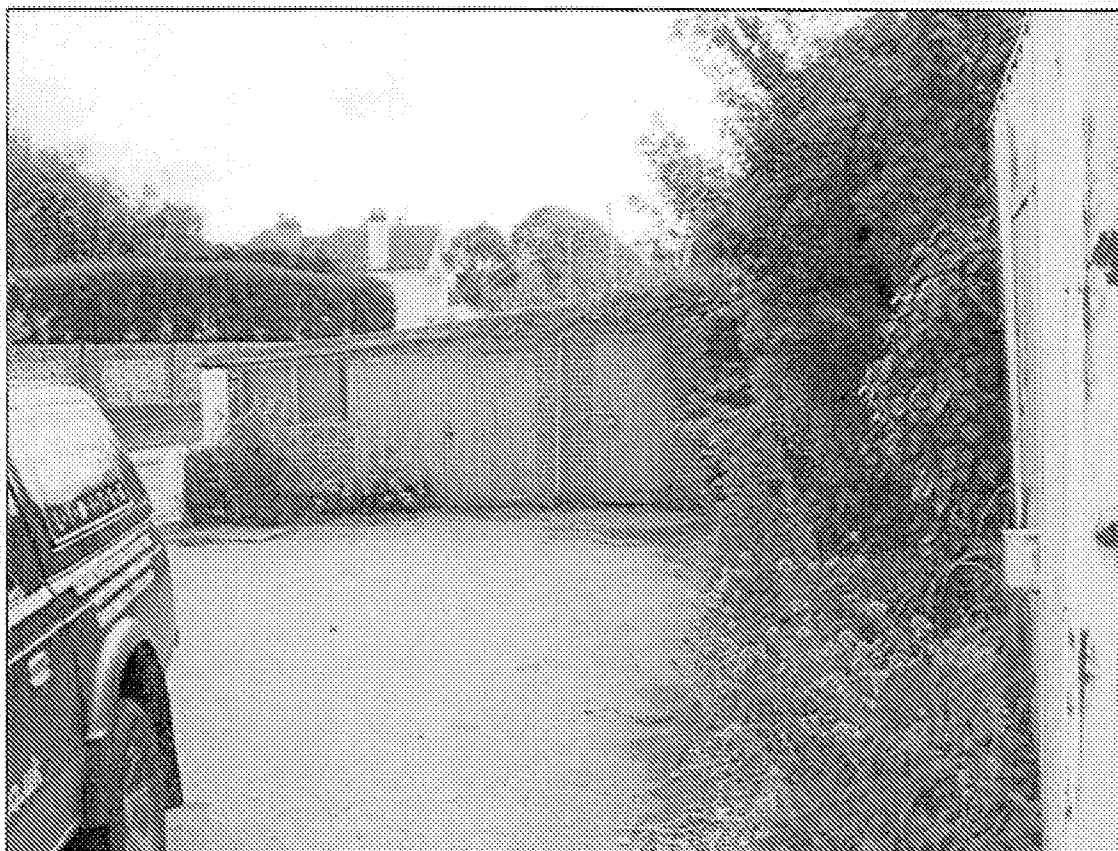
Photo 1 - Showing garage (North East corner of the Site).

Further works, including the inspection and testing of the soils beneath the concrete slab of the garage will be required and these are discussed in further detail in section 5.5 Recommendations.

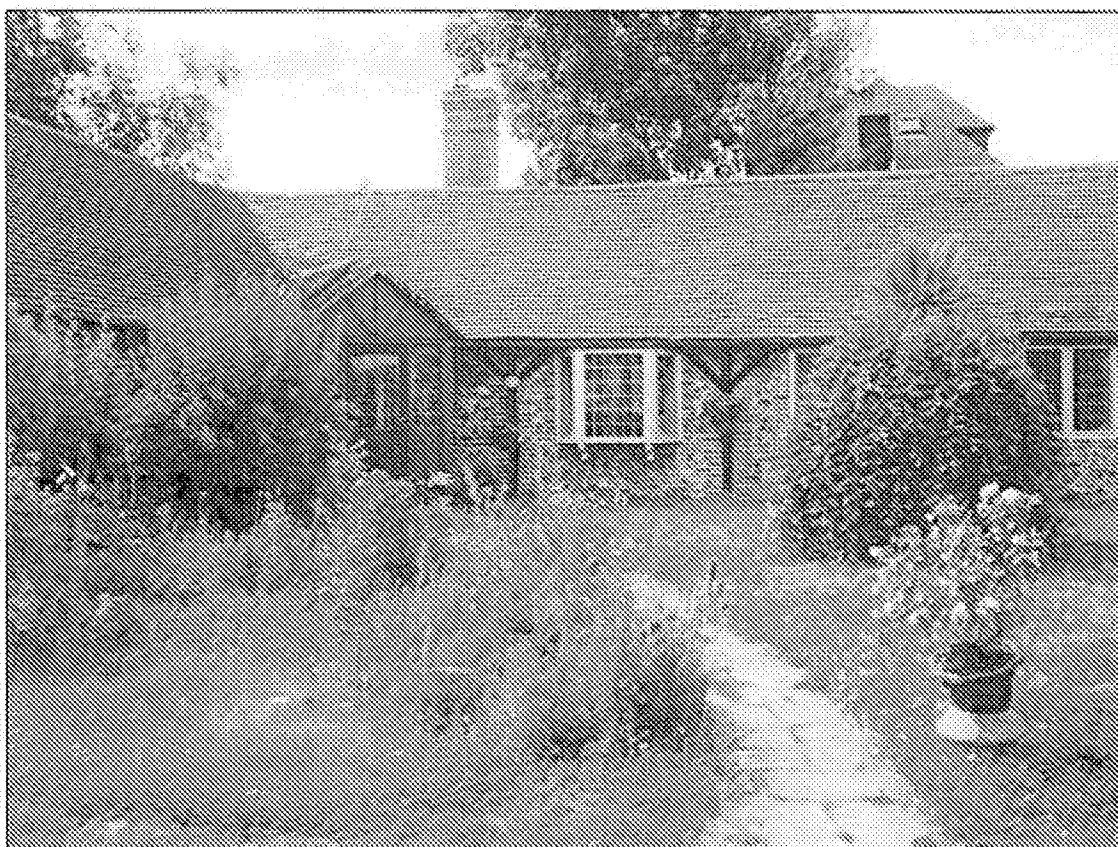
Photo 2 - Showing single storey L-shaped brick and flint built property with gardens

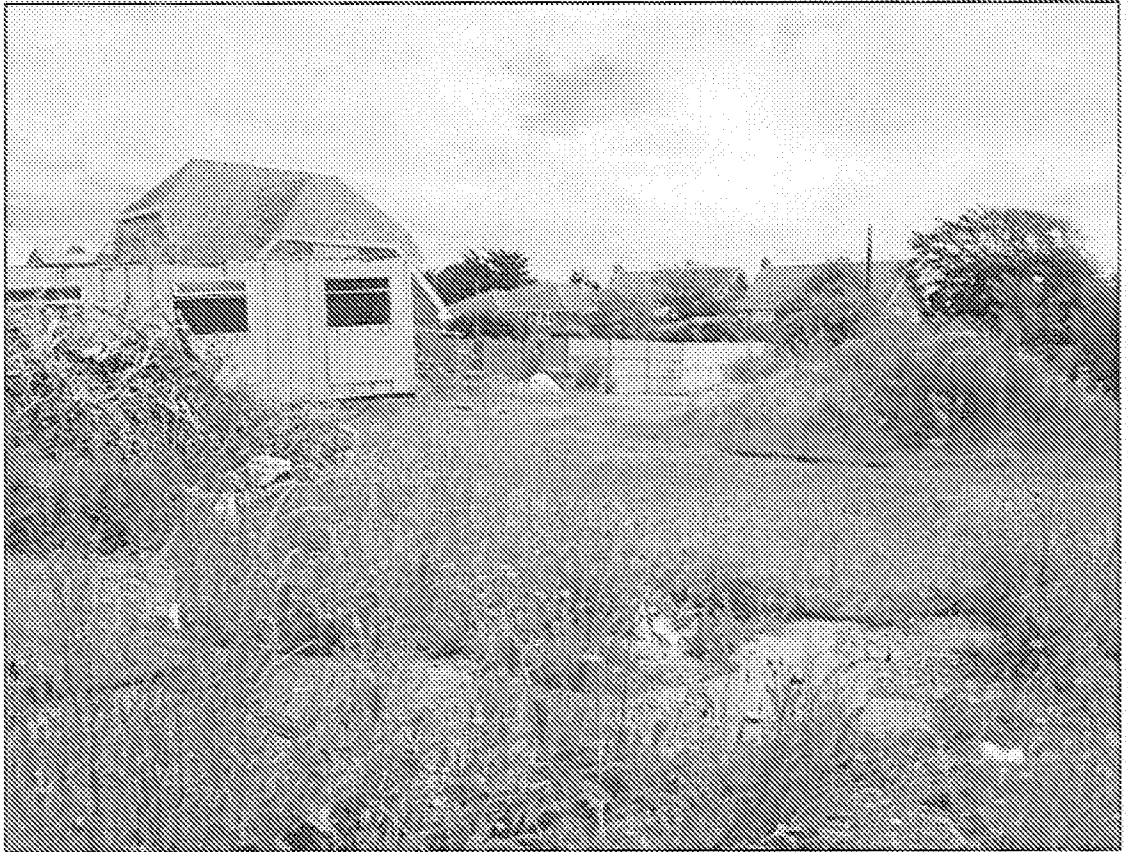
Photo 3 - Showing The western (hoarded) part of the site

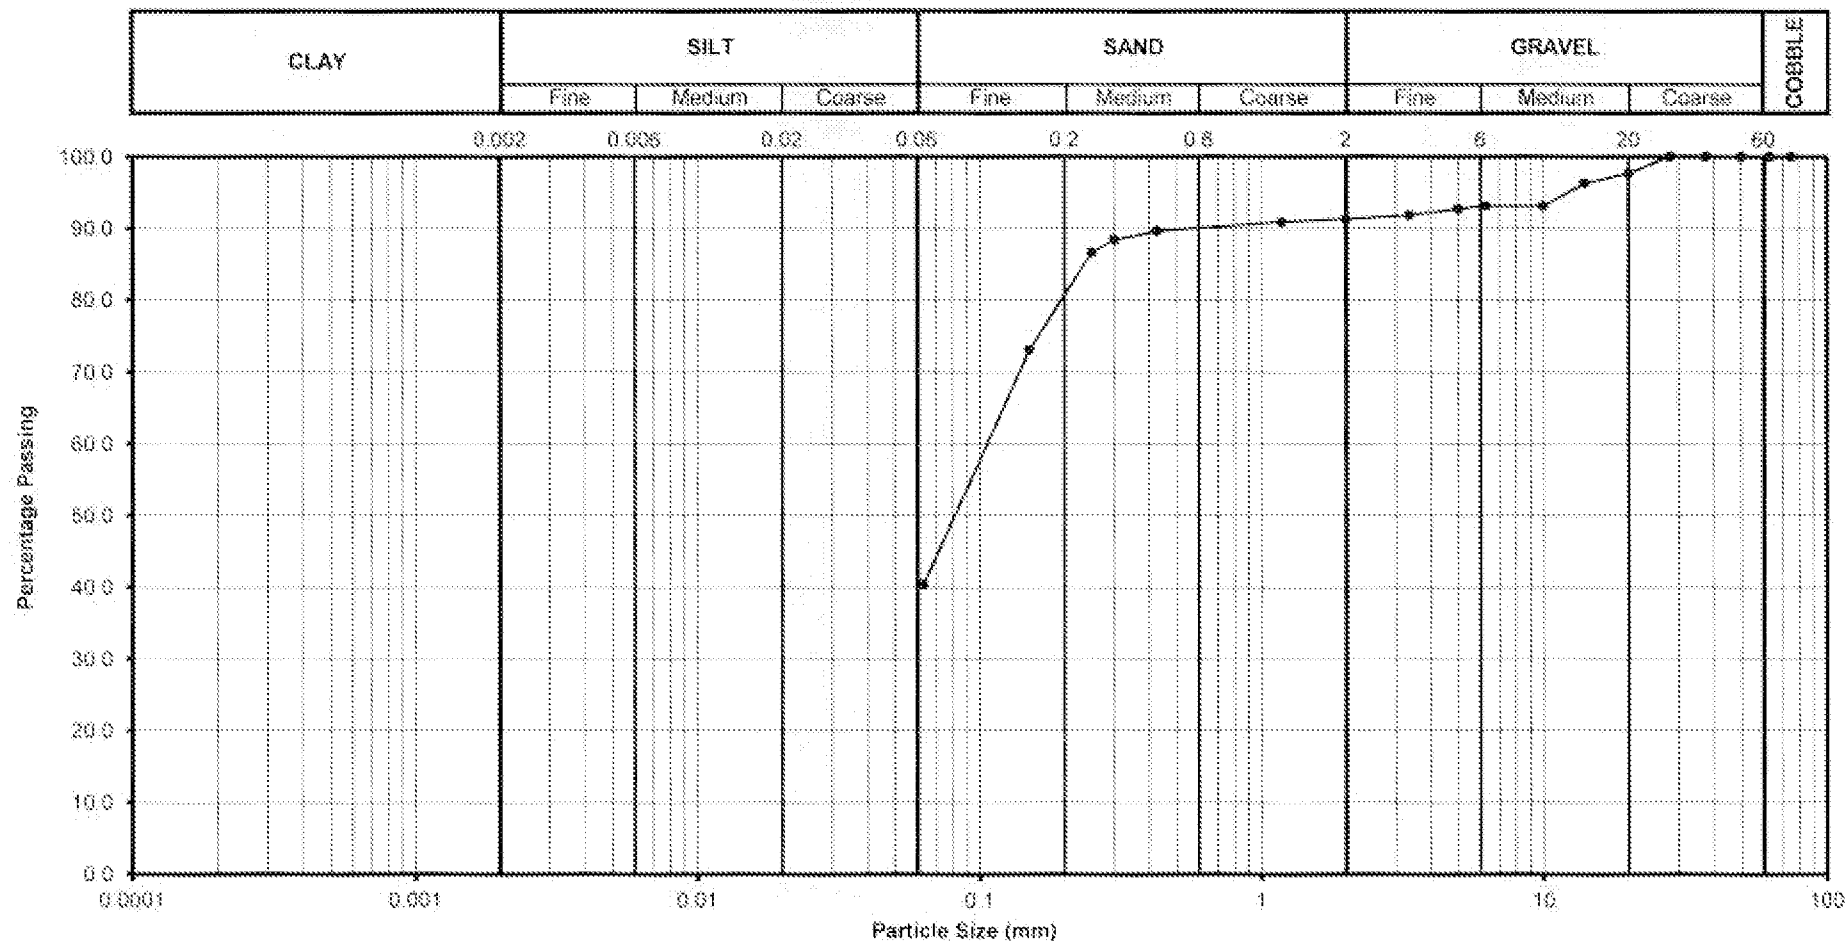
Particle Size Distribution by Wet Sieve; BS1377: Part 2 1990

| Job Name | Summerley Corner South Site, Summerley Lane, Bognor Regis | BH/ TP No. | WS1 | Sample Description | Slightly gravelly sandy CLAY/Silt. |
| Job No. | LW23175 | Sample Depth (m) | 2.00m | | |

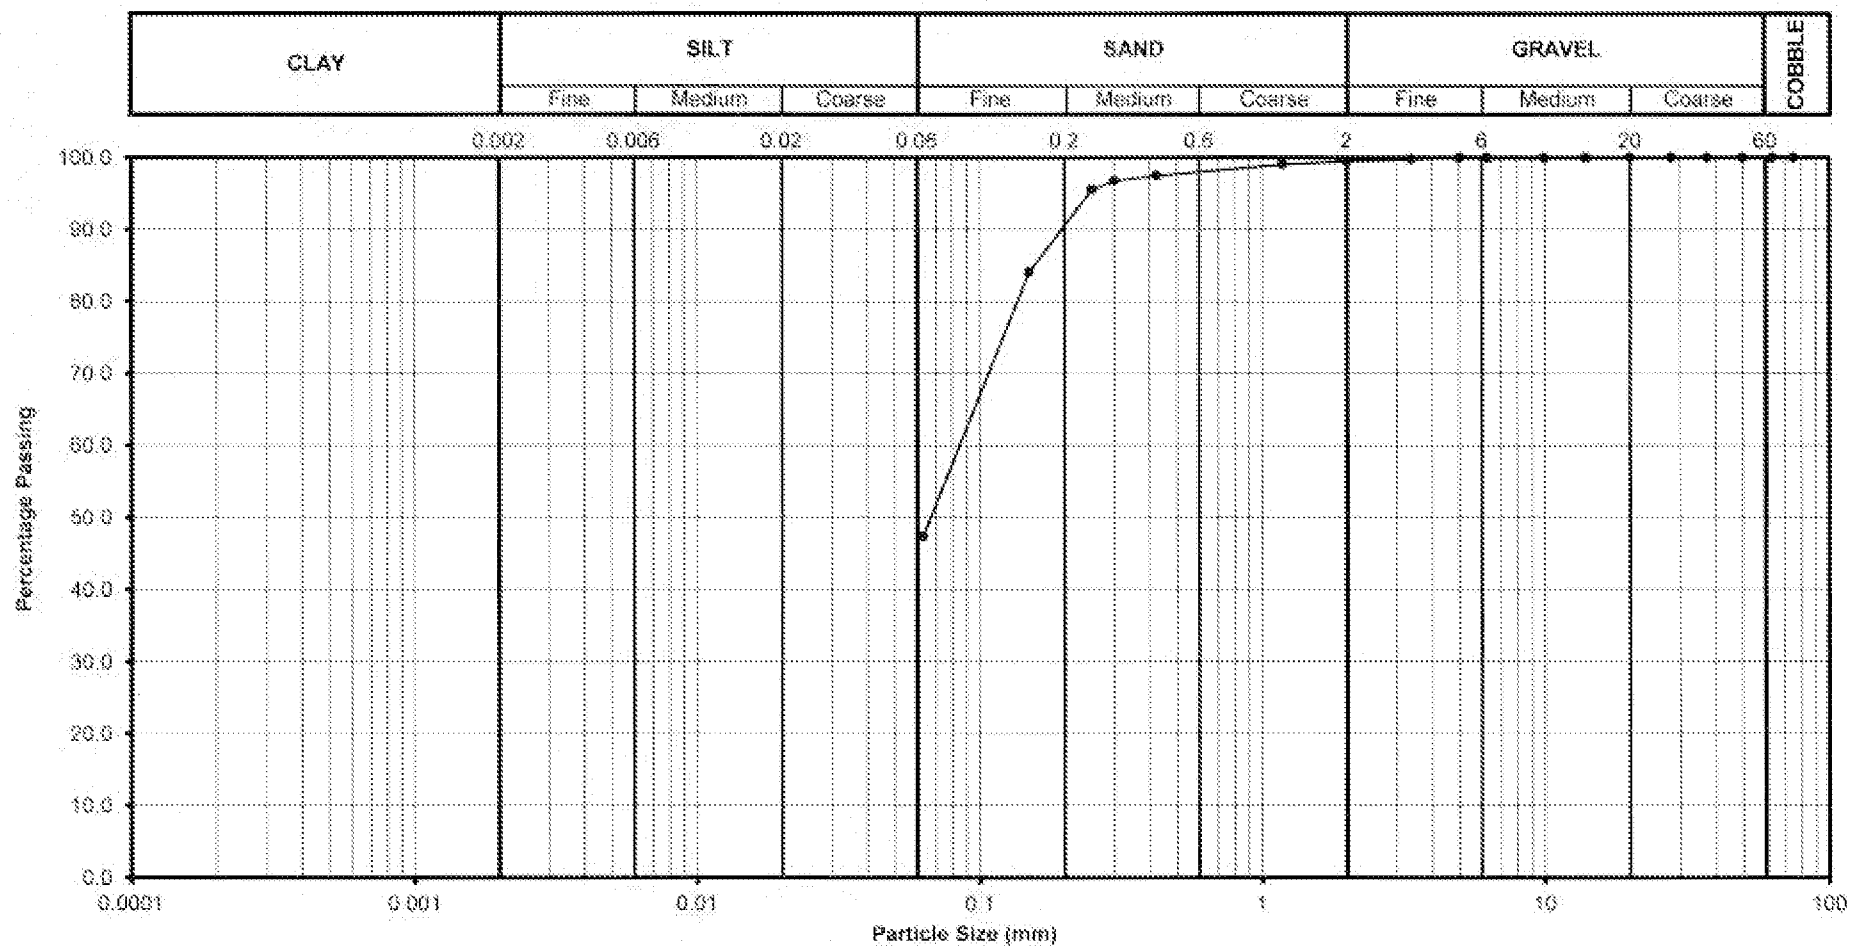
Particle Size Distribution by Wet Sieve; BS1377: Part 2 1990

| Job Name | Summerley Corner South Site, Summerley Lane, Bognor Regis | BH/ TP No. | WS2 | Sample Description | Sandy CLAY/SILT |
| Job No. | LW23175 | Sample Depth (m) | 1.50m | | |

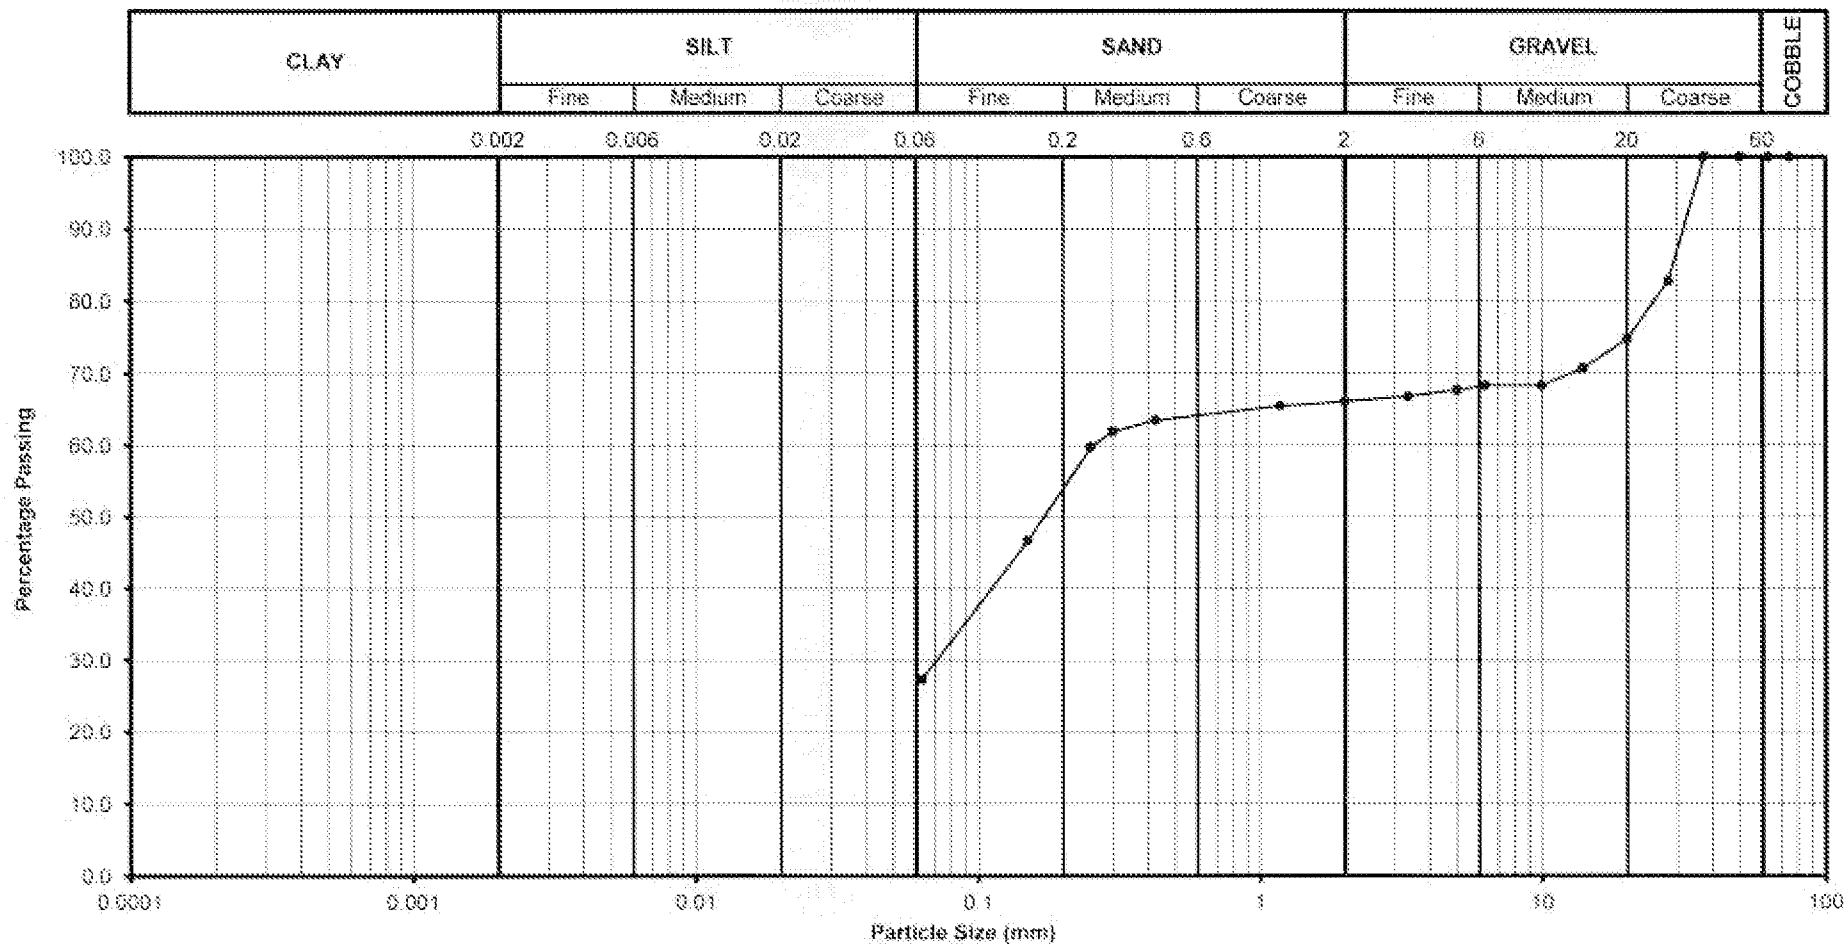
Particle Size Distribution by Wet Sieve; BS1377: Part 2 1990

| Job Name | Summerley Corner South Site, Summerley Lane, Bognor Regis | BH/ TP No. | WS5 | Sample Description | Very silty very gravelly SAND |
| Job No. | LW23175 | Sample Depth (m) | 2.50 - 3.00m | | |

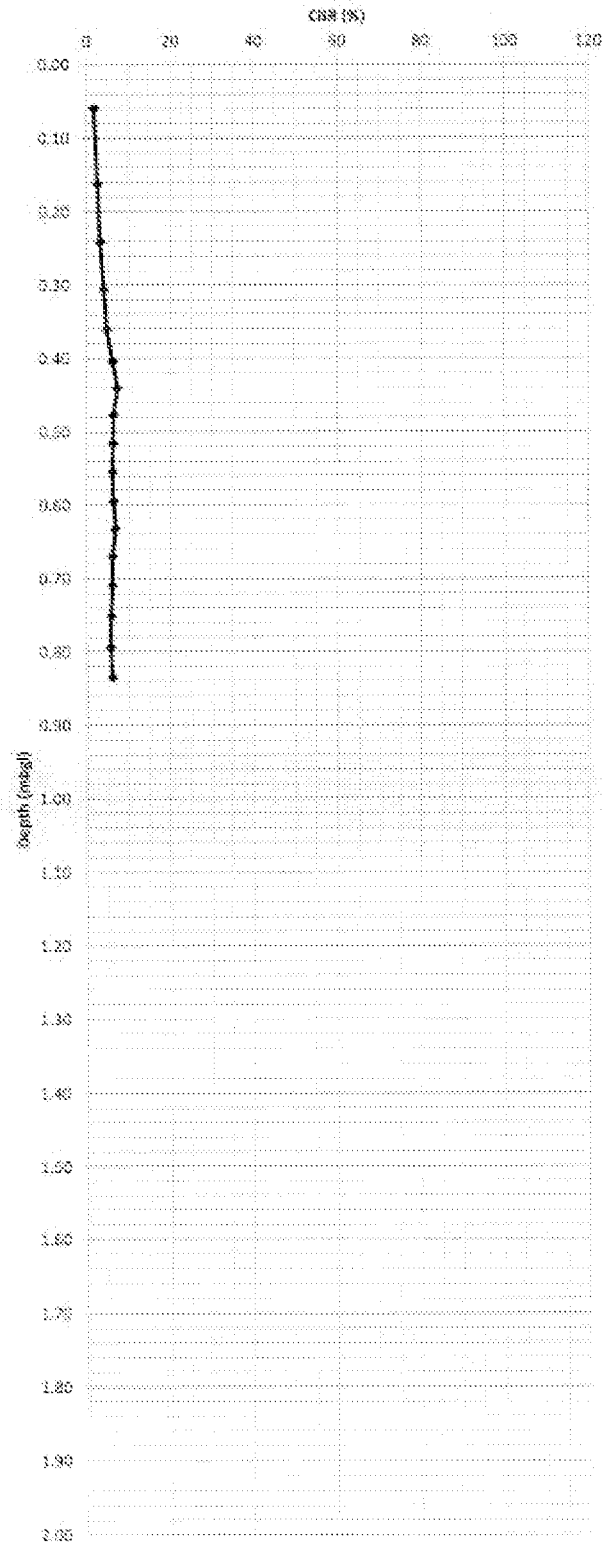
## TRL Dynamic Cone Penetrometer Record

Notes: CBR Value calculated in accordance with the TRL1 equation given in TRL Road Note 3.

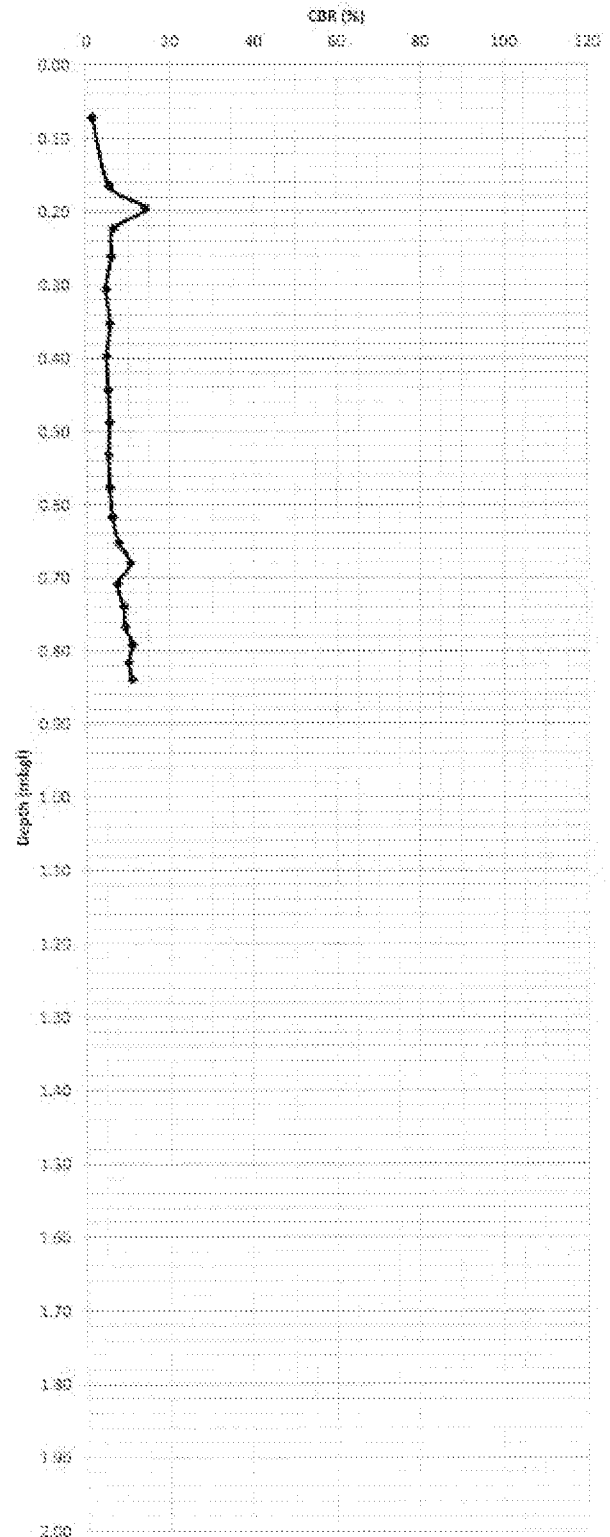
## TRL Dynamic Cone Penetrometer Record

Notes: C88 Value calculated in accordance with the TRRL equation given in TRRL Road Note 8.

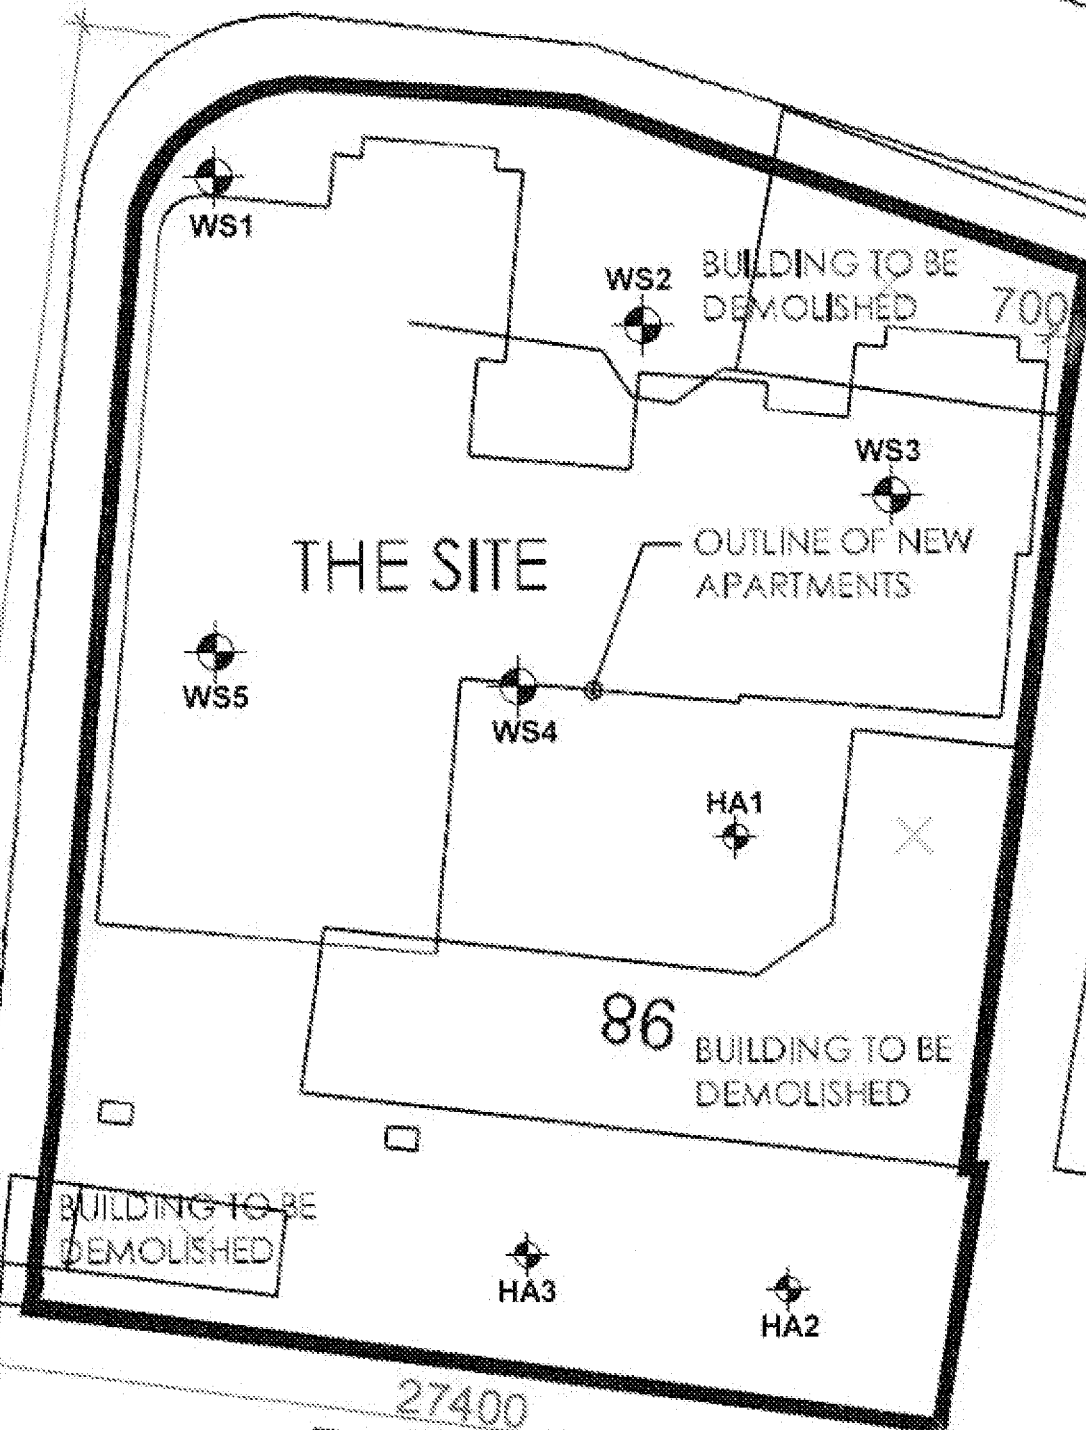
Figure 2  
LW23175

SITE: Summerley Corner South Site,  
Summerley Lane, Bognor Regis, West Sussex

Site Plan  
Not To Scale

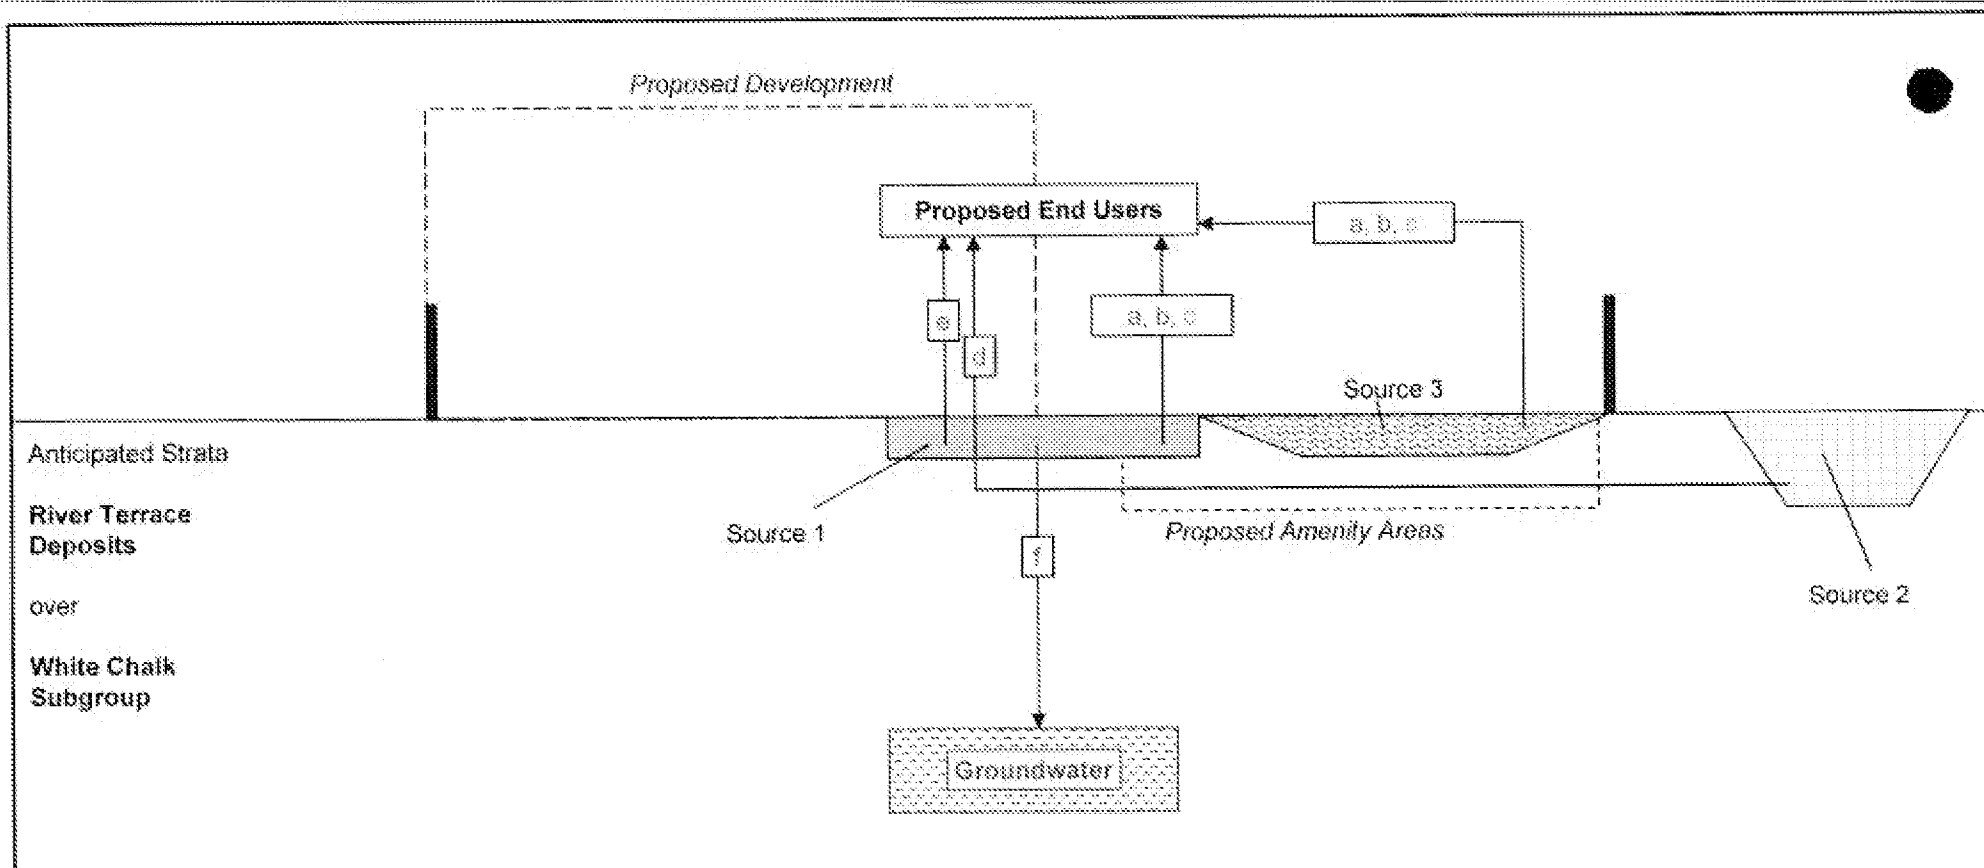
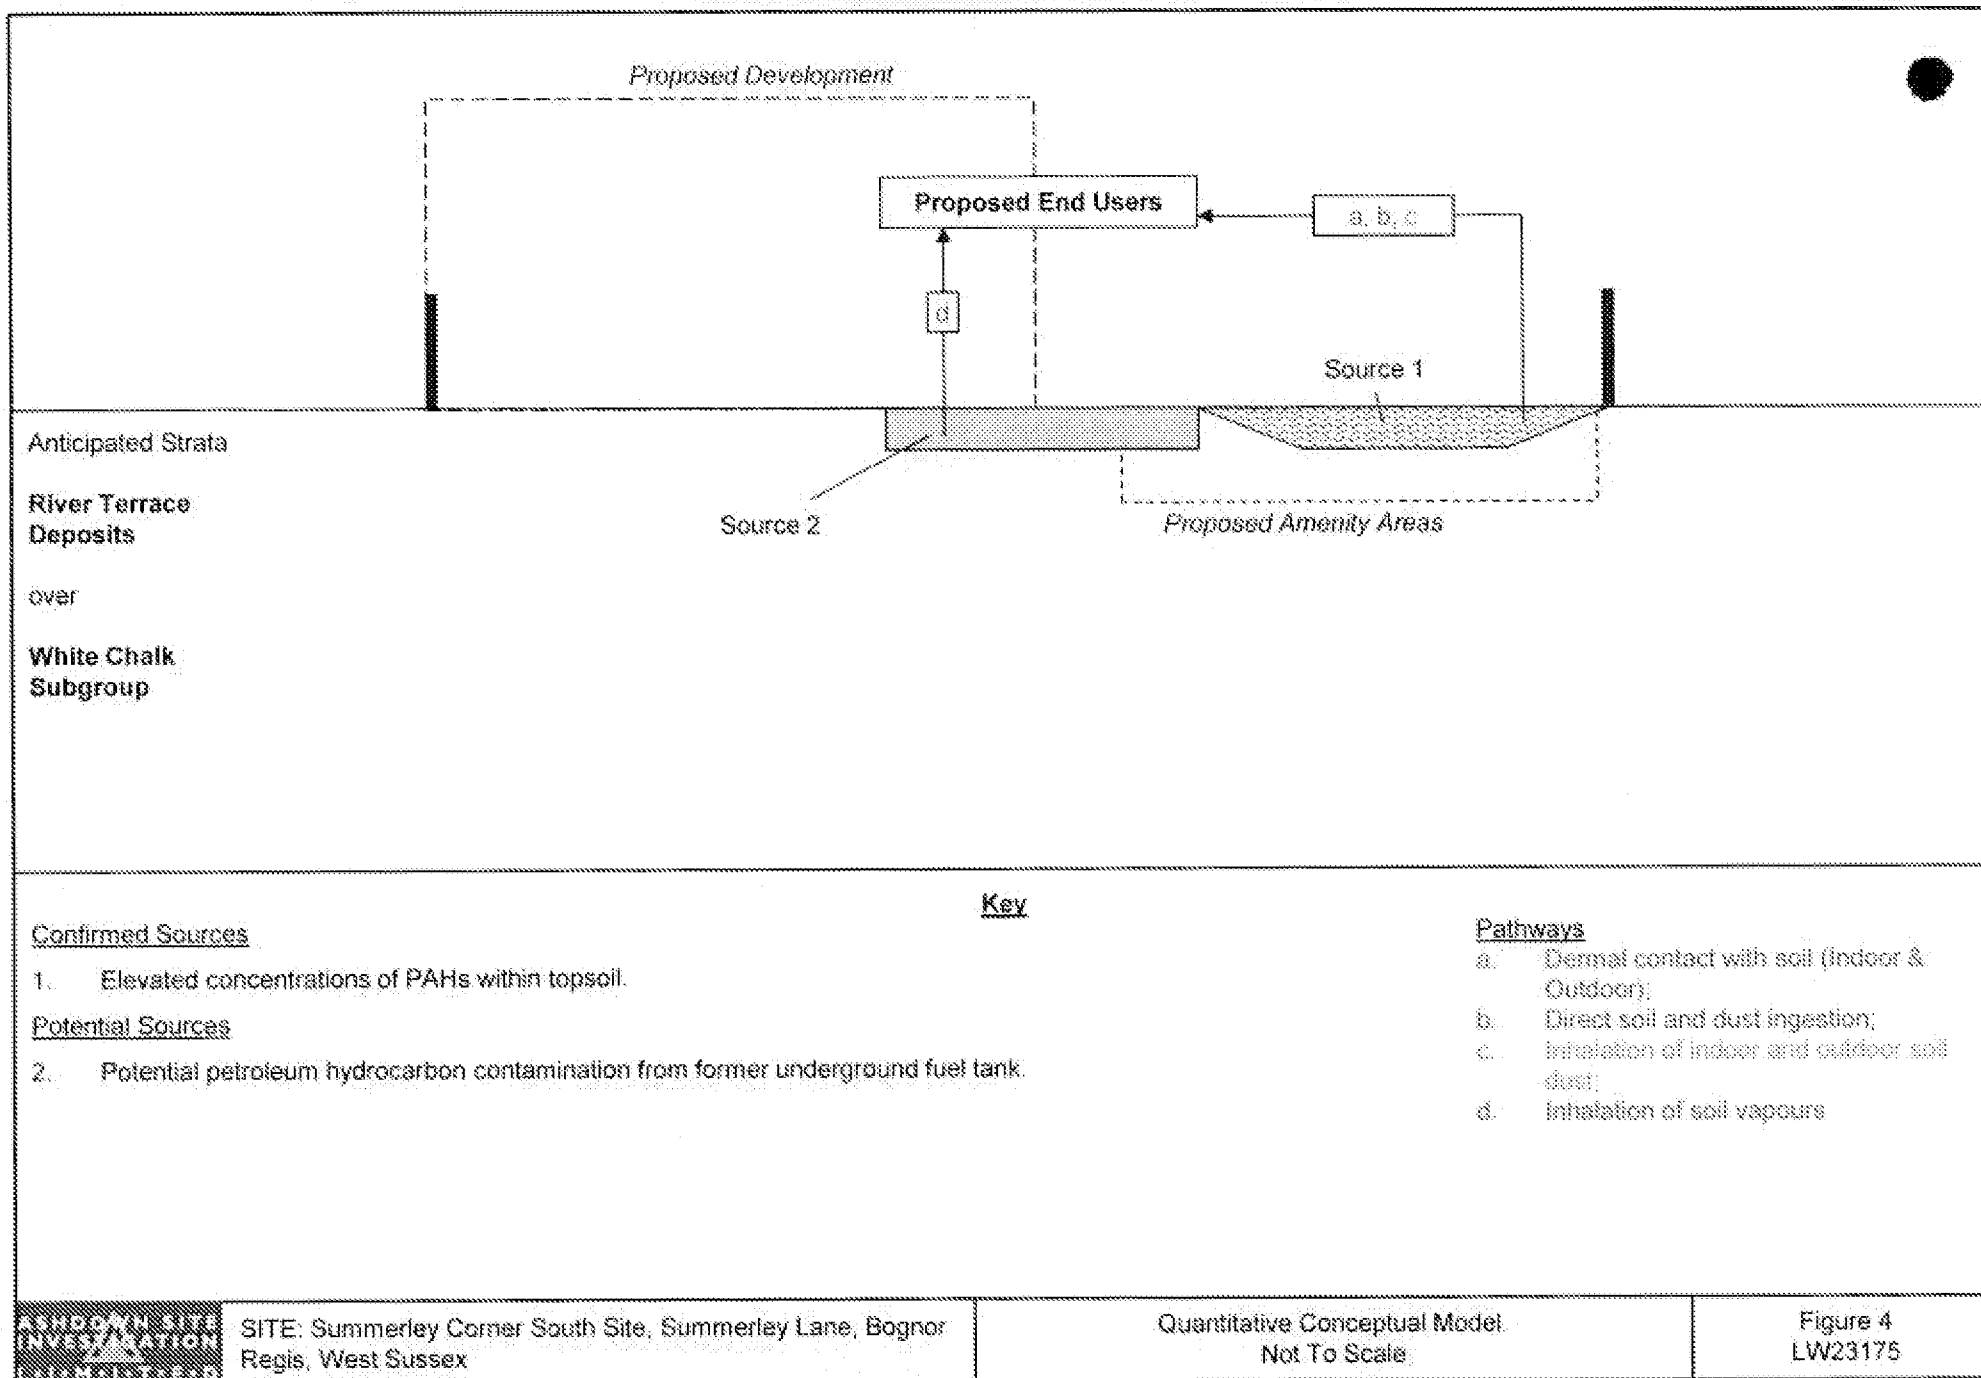
#### Sources

- a. Dermal contact with soil (Indoor & Outdoor);
- b. Direct soil and dust ingestion;
- c. Inhalation of indoor and outdoor soil dust;
- d. Inhalation of ground gases;
- e. Inhalation of soil vapours; and
- f. Groundwater flow
