**Bognor Regis Golf Club**

## **APPENDIX 8.8 - RIPARIAN MAMMAL SURVEY REPORT**

December 2021

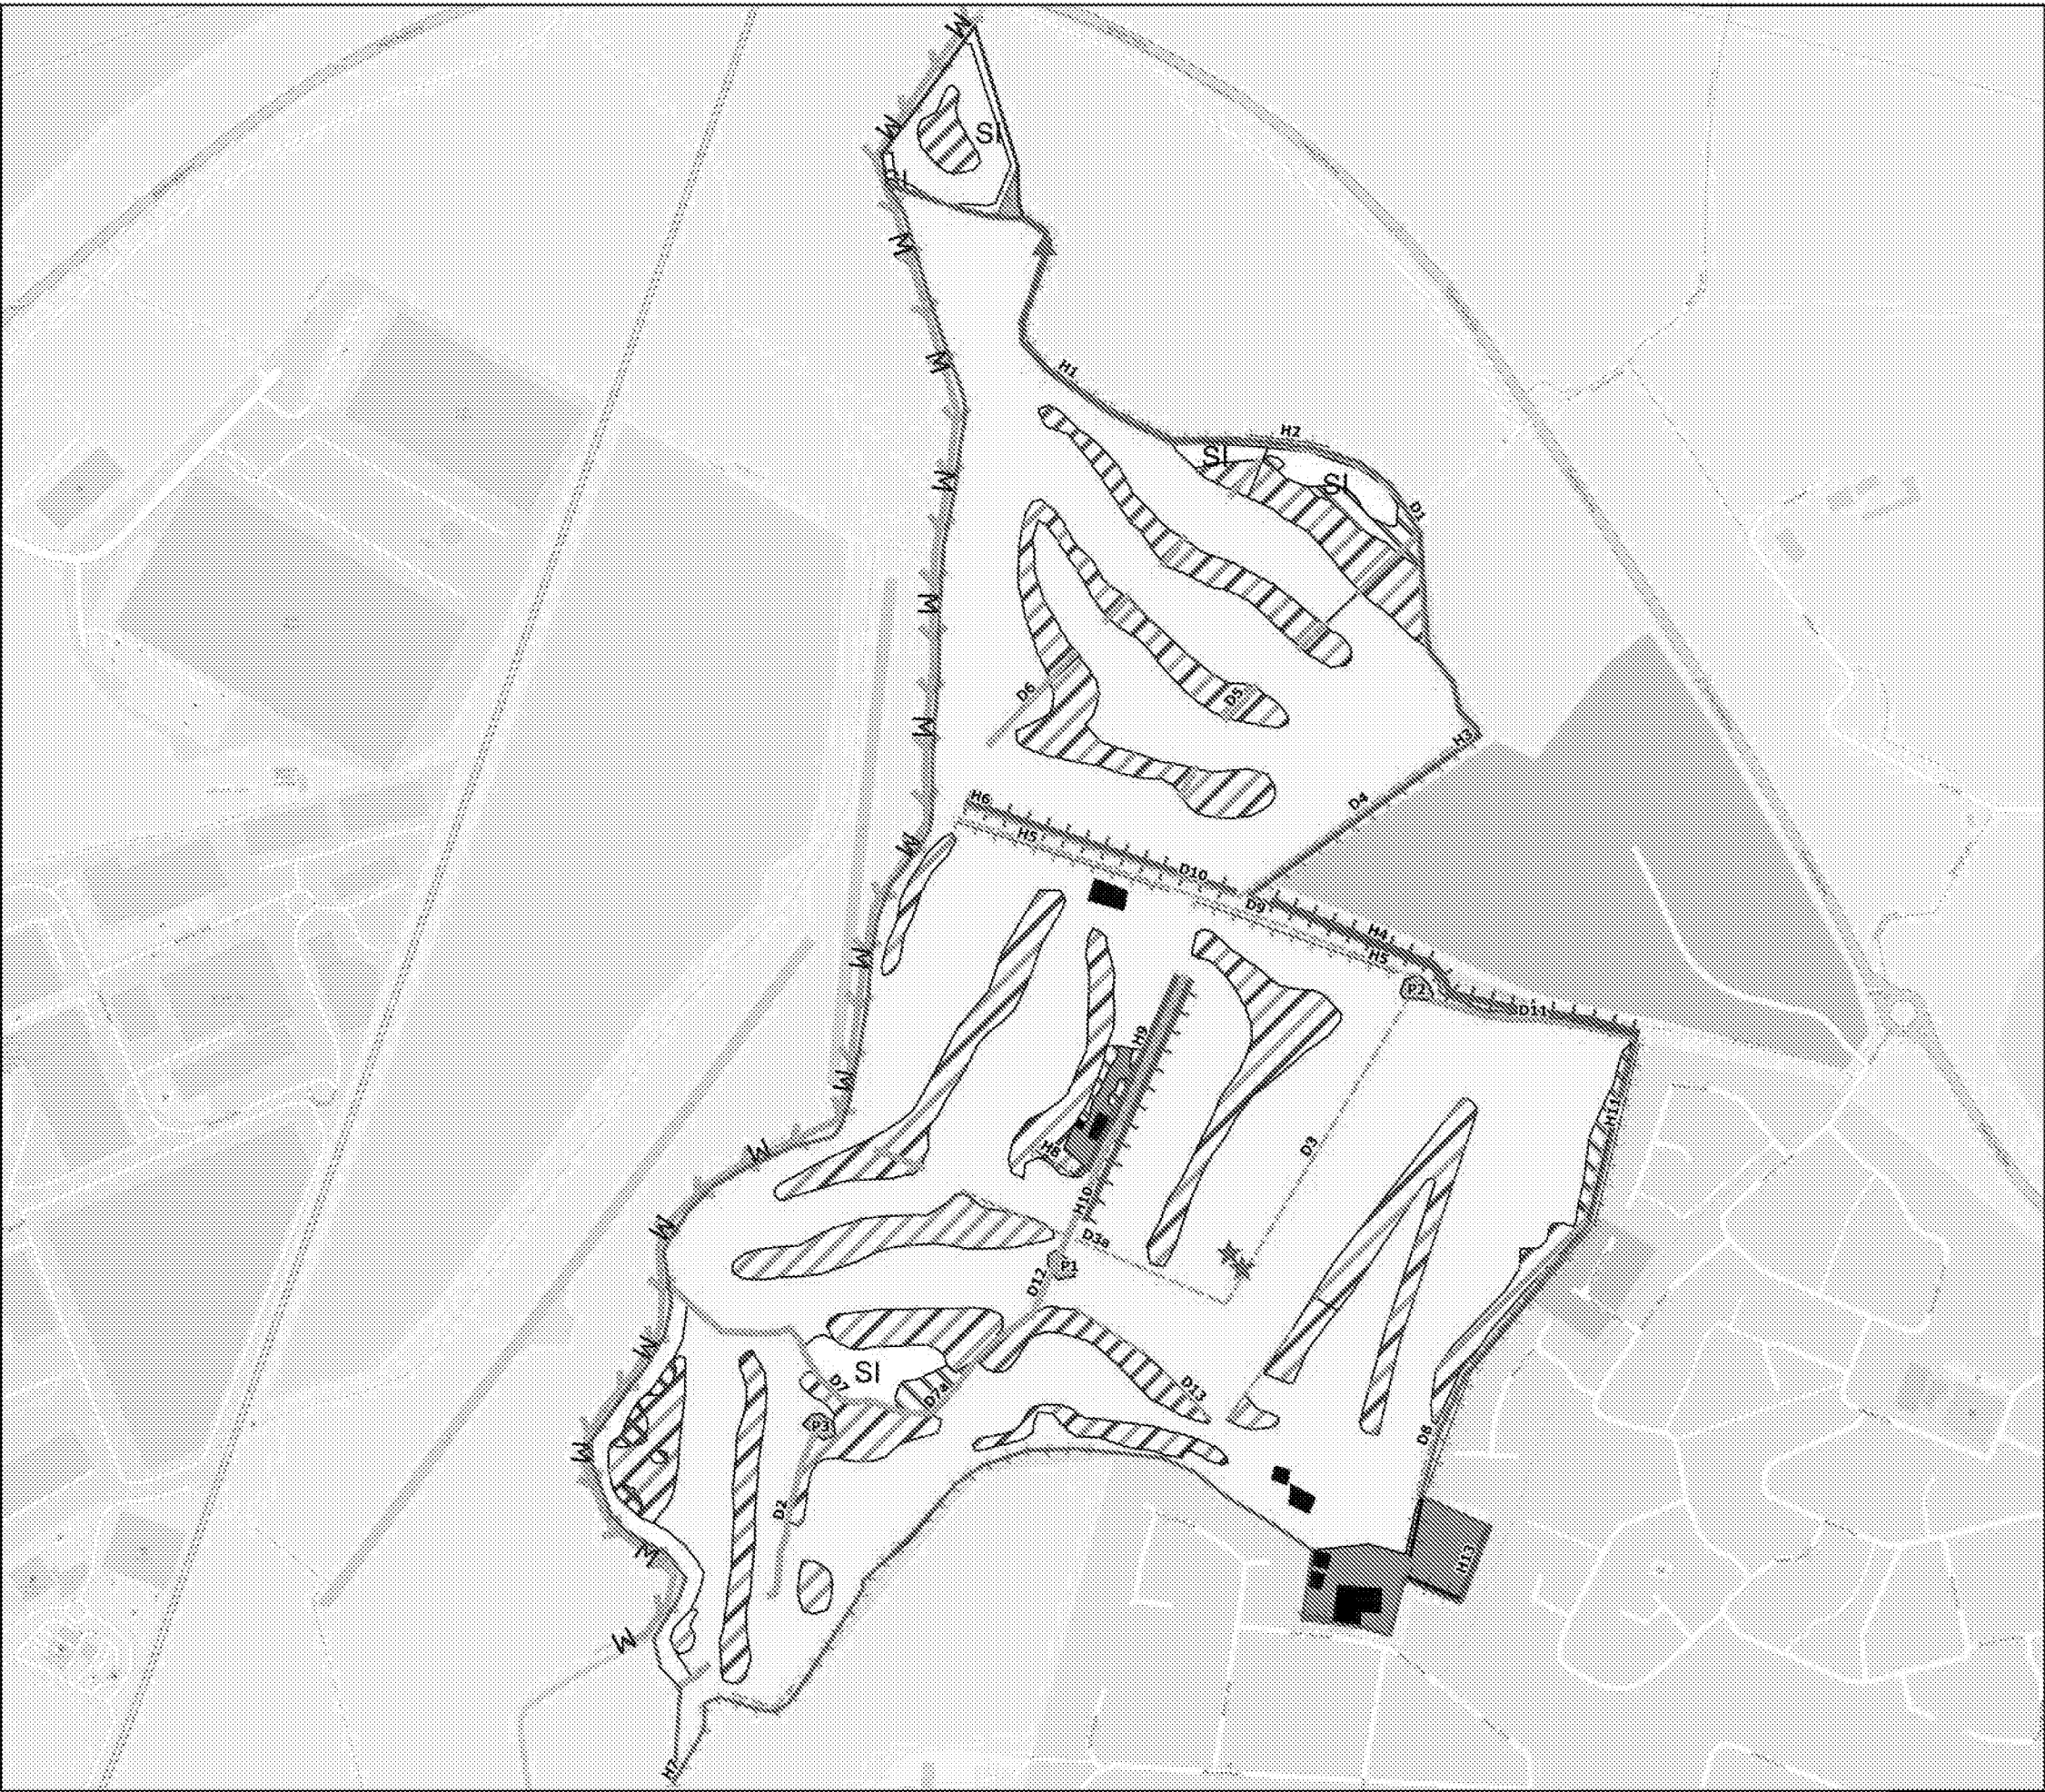
**Figure 2 7338-E-01**

- 4.1 *Figure 1* provides the locations of the consultation records, *Figure 2* presents the results of the previous water vole surveys, completed in 2016 and 2017 and the results of the update 2021 survey is presented on *Figure 3*.

- 4.5 There are three ponds and a network of wet and dry ditches on site as well as the Lidsey Rife, which flows north to south along the western boundary. A single pond (P4) was present off-site adjacent the northern boundary. Habitat descriptions for D1 – D13 are provided in *Table 2* below, with the locations provided on *Figures 2* and *3*.

- 4.11 Previous surveys at the site were completed during the optimal surveying period, with the first survey completed on 20<sup>th</sup> July and the second on 28<sup>th</sup> September 2016. In 2017, an update survey was completed on 12<sup>th</sup> May. Evidence of water voles at this time was recorded along the Lidsey Rife and in ditches D1, D2, D3 and D7 on site. During the 2021 survey, feeding stations and possible burrows, were observed at D1 and D3 only. No water vole evidence was noted in association with any of the surveyed ponds.
- 4.12 The locations of field evidence are provided on *Figures 2 & 3* and the survey details are provided in *Table 3* below.
