10 View South west toward site from Climping Street

| Bognor Golf Club (Relocated Site)<br>Landscape Strategy and Visual Appraisal | | |
| 171-Figure 35 | NTS | A3 |

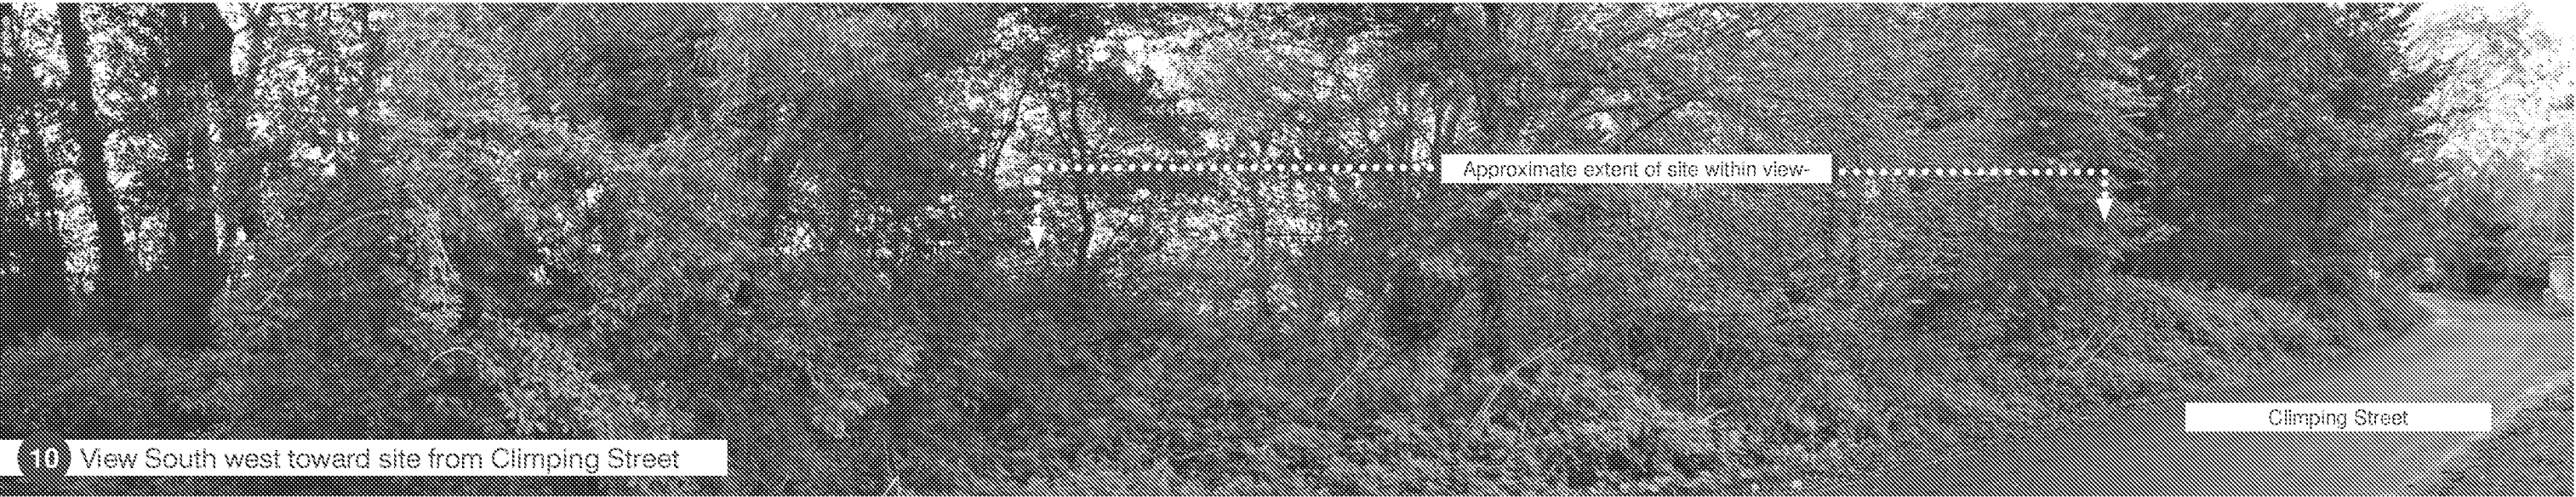
View from road enclosed by tree planting. Views towards the site are obstructed in summer by planting. Glimpsed views through the planting of vegetation bounding the west of the site may be possible, at distance, but not element of the interior would be visible.

| Description of View / Type of Effect | Sensitivity to Change | Magnitude of Change | Effects of Change |
|---|---|---|---|
| Construction: It is not anticipated that any construction activity would be visible, screened by intervening vegetation and built form. | Low | No Change | No Change |
| Year 1: It is not anticipated that any development would be visible, screened by interveing vegetation and built form. | Low | No Change | No Change |
| Year 15: Development would remain screened. | Low | No Change | No Change |
