**BLAKES MEAD,  
BOGNOR REGIS**

**MAINTENANCE**

# Post Installation Report

Blakes Mead

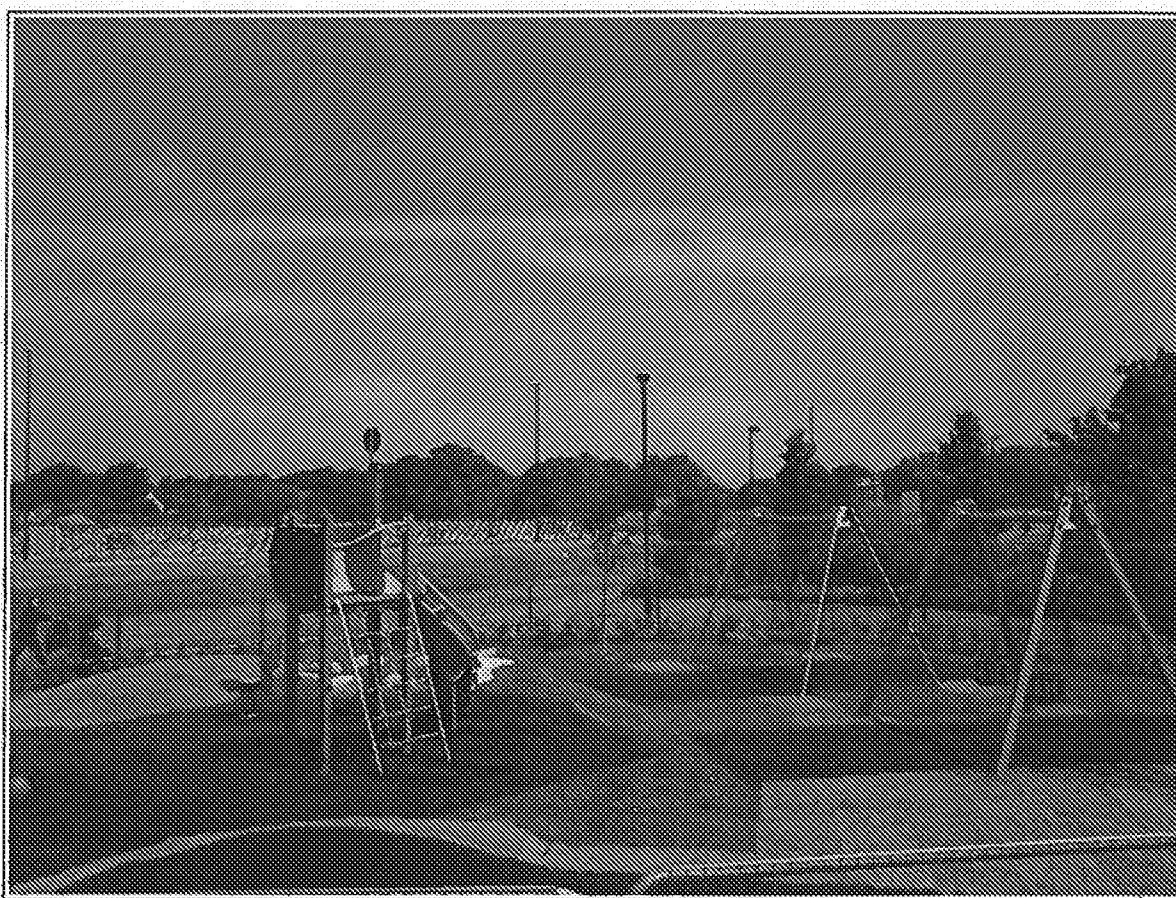
**Location:** The site is located in an area of public open space and is overlooked by a number of properties in the local community.

**Disabled Access:** Some accessible features – an area that presents difficulties to the majority of people with disabilities but in favourable circumstances and certainly in partnership can be accessed.

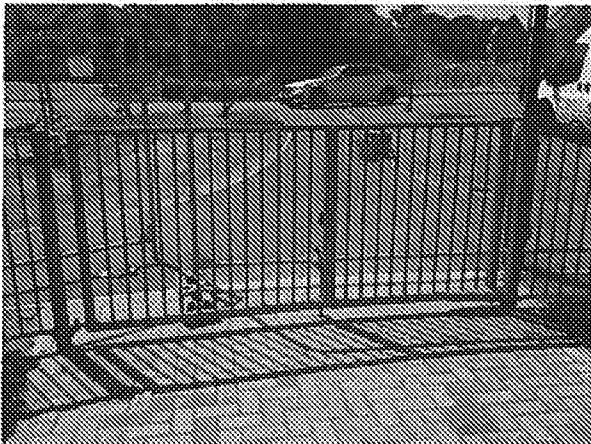
| 2 - Very Low Risk | |
|---|---|
| <b>Item:</b> | Ancillary Items - Combination Gate |

| Finding 1 |
|---|
| This item is satisfactory - no work required |

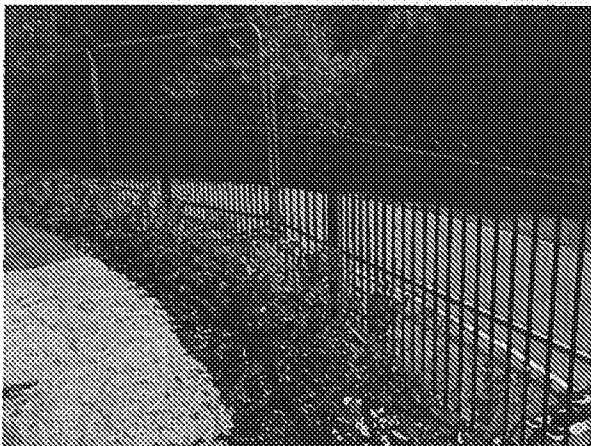
| 3 - Very Low Risk | |
|---|---|
| <b>Item:</b> | Ancillary Items - Bow Top Fence (Steel) |

| Finding 1 |
|---|
| This item is satisfactory - no work required |

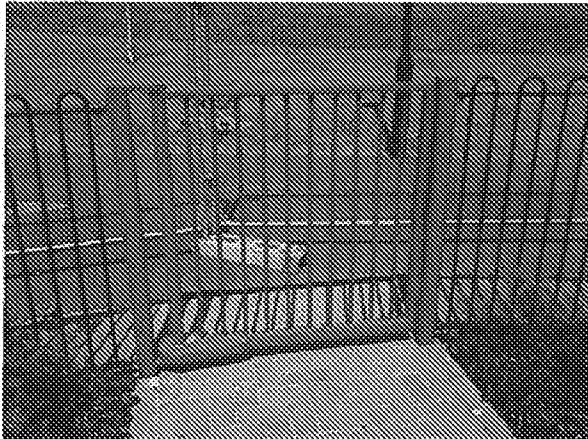
| 2 - Very Low Risk | |
|---|---|
| <b>Item:</b> | Ancillary Items - Self Closing Gate |

| Finding 1 | |
|---|--|
| This item is satisfactory - no work required | |

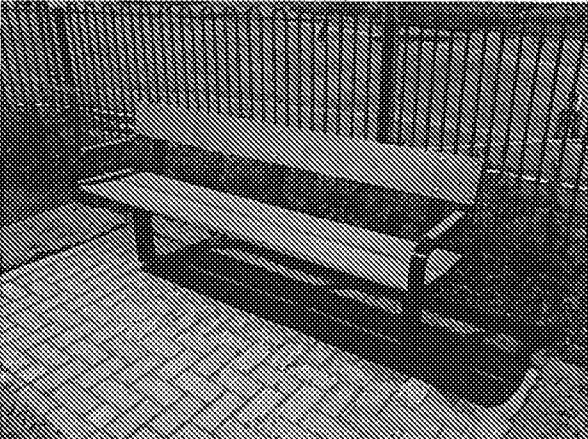
| 3 - Very Low Risk | |
|---|---|
| <b>Item:</b> | Ancillary Items - Bench |

| Finding 1 | |
|---|--|
| This item is satisfactory - no work required | |

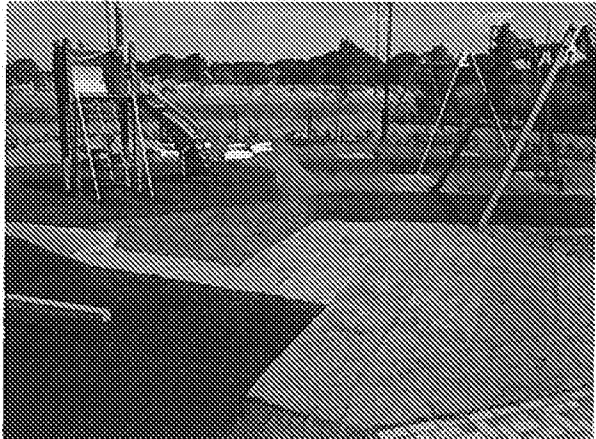
| i 4 - Very Low Risk | |
|---|---|
| <b>Item:</b> | Ancillary Items - Site General |

| Finding 1 | |
|---|--|
| Some of the turfed areas have dried out and the grass has died off - Rectify as required | |

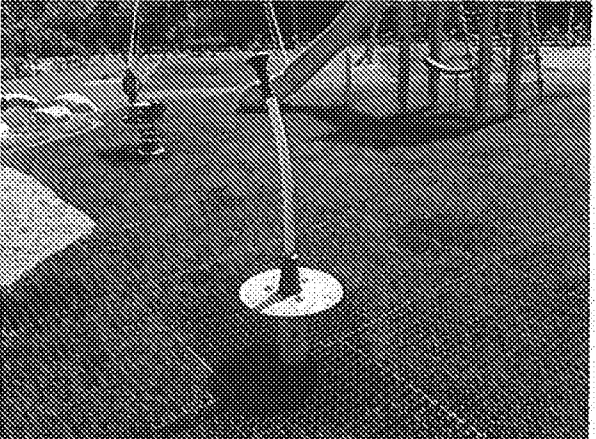
| i 4 - Very Low Risk | |
|---|---|
| <b>Item:</b> | Rotor Play - Spinning Pole |

| Finding 1 | |
|---|--|
| This item is satisfactory - no work required | |

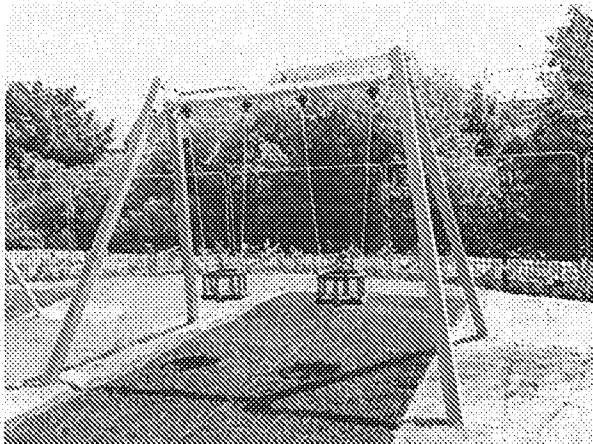
| i 4 - Very Low Risk | |
|---|---|
| <b>Item:</b> | Swings - 1 Bay 2 Seat (cradle) |

| Finding 1 | |
|---|--|
| This item is satisfactory - no work required | |

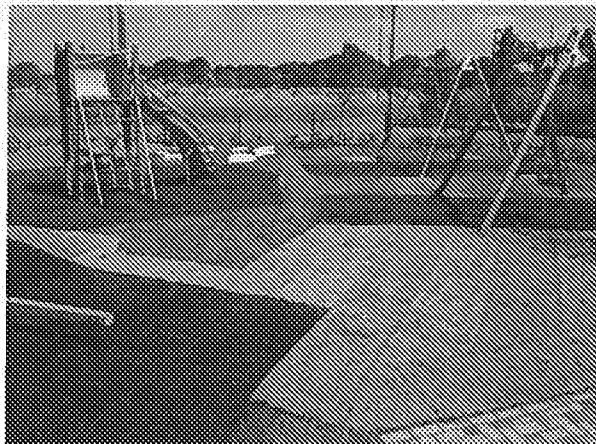
| i 4 - Very Low Risk | | | |
|---|---|---|---|
| <b>Item:</b> | Ancillary Items - Site General | <b>Risk Level:</b> | V - Very Low Risk |
| <b>Finding:</b> Some of the turfed areas have dried out and the grass has died off | | <b>Action:</b> Rectify as required | |
