**Factual Ground Investigation Report**

**Land south of Burndell Road, Yapton, West Sussex BN18 0HR**

**Reference: 15276/GIR**

**April 2016**

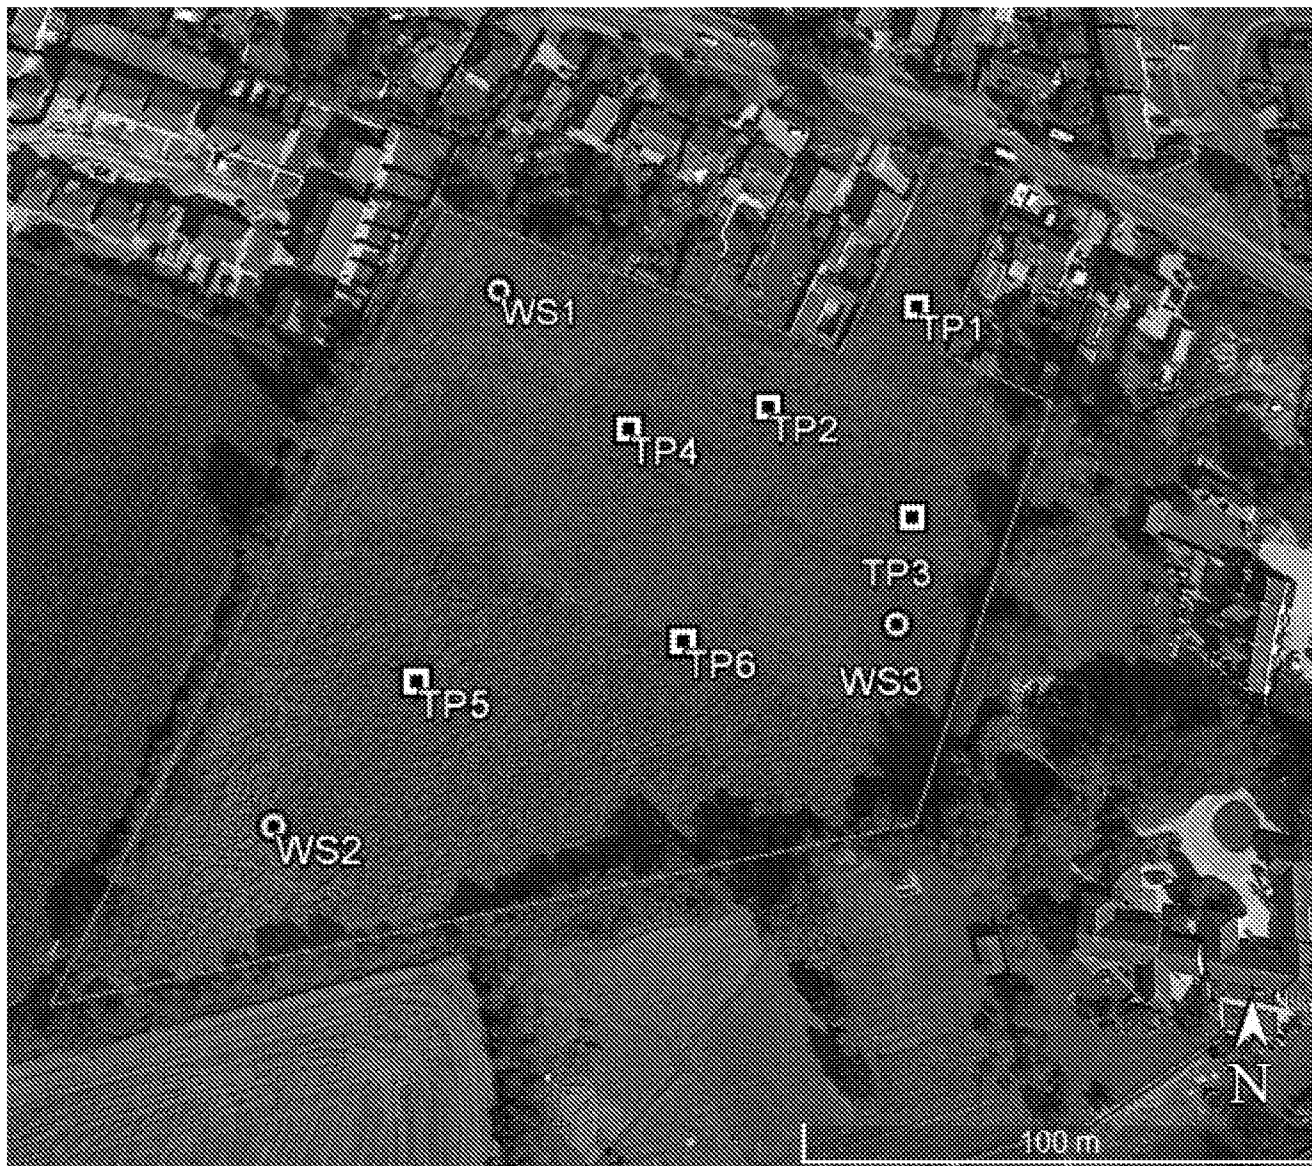
Figure number

The three windowless sampler boreholes (WS1, WS2 and WS3) were backfilled with gravel and bentonite following the installation of groundwater monitoring wells. Trial pits were backfilled with arisings and mounded over to allow for future settlement. All trial hole locations have been presented in Figure 3.

The approximate trial hole locations are shown on Figure 3.

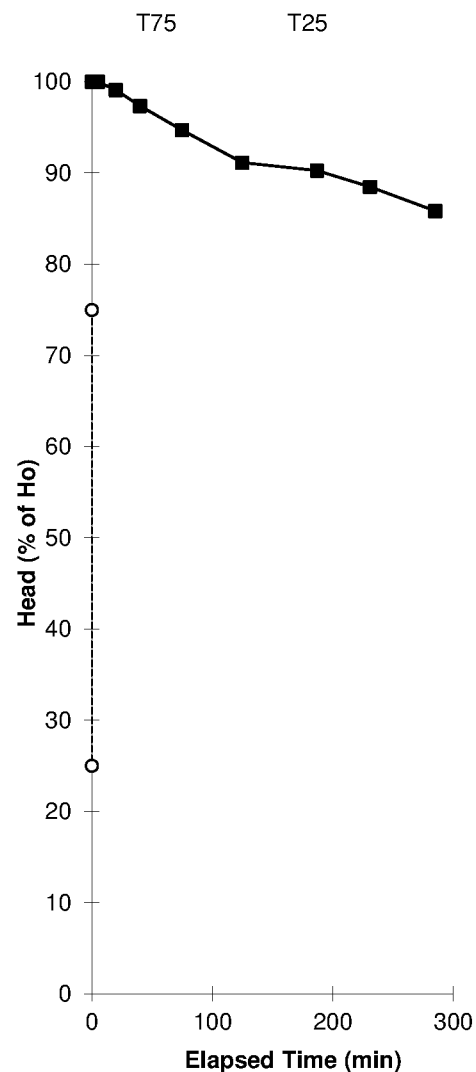
Poor infiltration observed throughout test period - unable to calculate infiltration rate

| Trial Hole/Test | Test Stratum | Test Depth (m bgl) | Infiltration Rate (m/sec) | Notes |
|---|---|---|---|---|
| TP1/S1 | RTD | 2.50 | N/A | Slow infiltration observed over test period – unable to calculate infiltration rate |

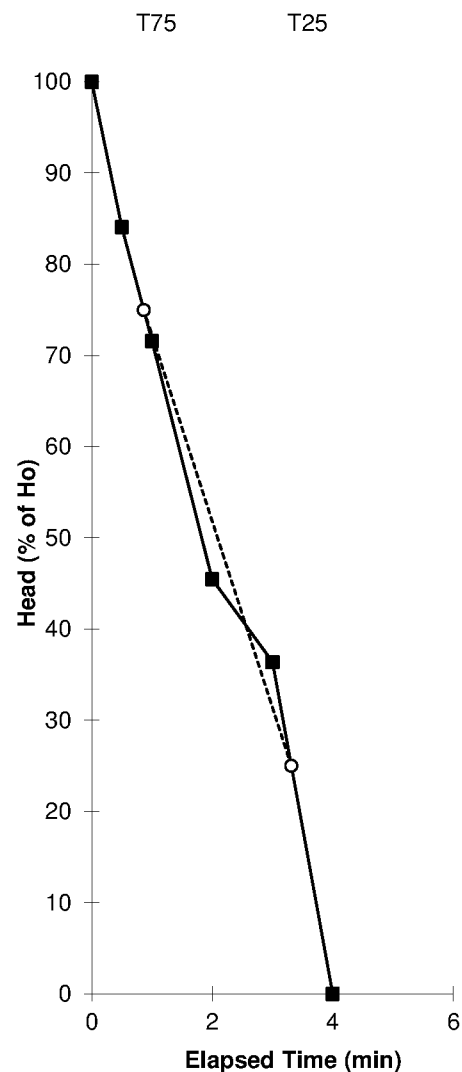
| T75 | 0.864 | 75 |
| T25 | 3.313 | 25 |

| Trial Hole/Test | Test Stratum | Test Depth (m bgl) | Infiltration Rate (m/sec) | Notes |
|---|---|---|---|---|
| TP2/S1 | RTD | 2.20 | $1.13 \times 10^{-3}$ | Considered as an outlier due to rapid draining possibly into the underlying chalk |

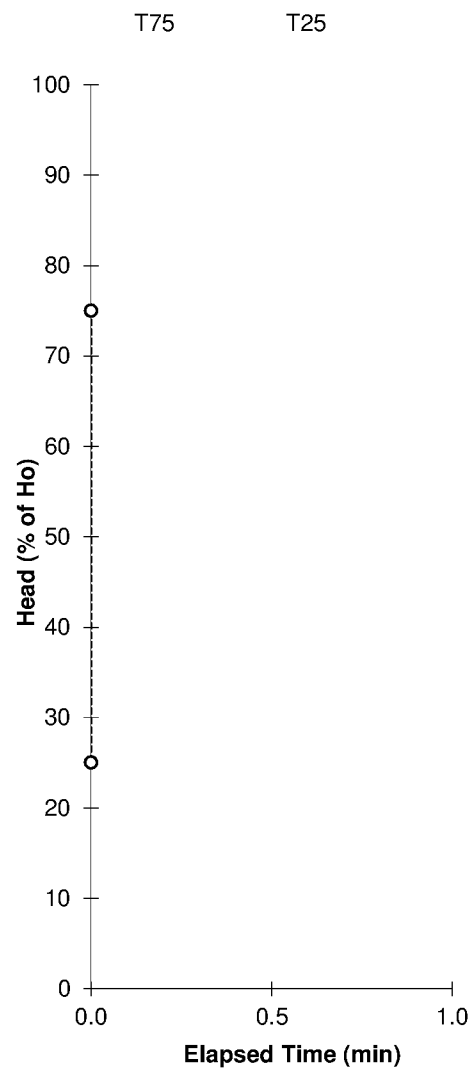
2,000L of water was pumped into the trial pit, however no head of water was obtained so soakaway testing could not be carried out.

| Trial Hole/Test | Test Stratum | Test Depth (m bgl) | Infiltration Rate (m/sec) | Notes |
|---|---|---|---|---|
| TP2/S2 | RTD | 2.20 | Rapid | Unable to achieve head of water due to rapid infiltration |

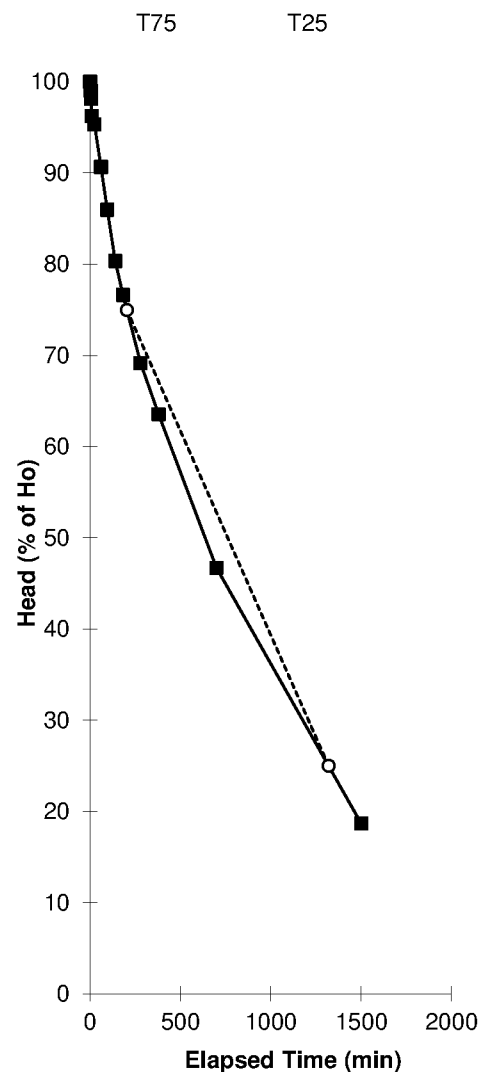
Data extrapolated from 182 minutes in order to calculate an infiltration rate.

| Trial Hole/Test | Test Stratum | Test Depth (m bgl) | Infiltration Rate (m/sec) | Notes |
|---|---|---|---|---|
| TP3/S1 | RTD | 3.10 | $2.56 \times 10^{-6}$ | Data was extrapolated from 182 minutes in order to calculate an infiltration rate |

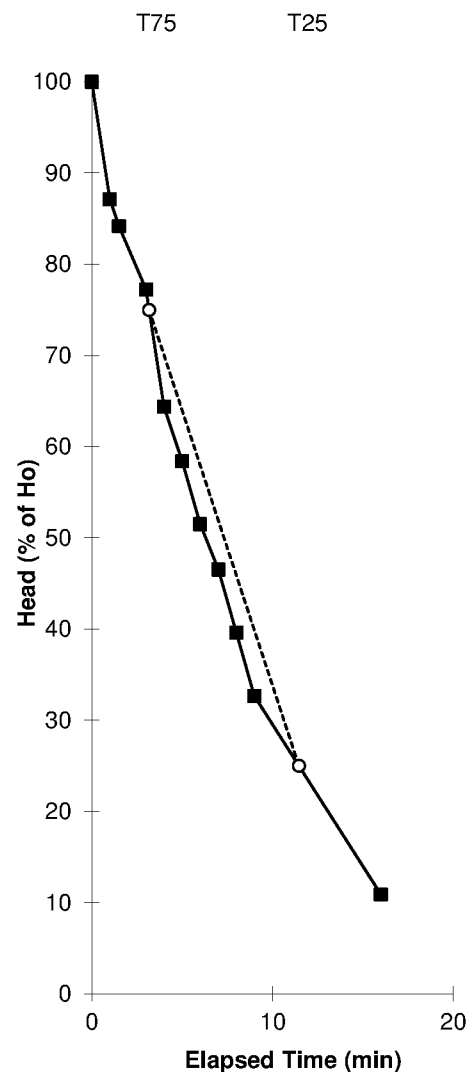
| T75 | 3.173 | 75 |
| T25 | 11.466 | 25 |

| Trial Hole/Test | Test Stratum | Test Depth (m bgl) | Infiltration Rate (m/sec) | Notes |
|---|---|---|---|---|
| TP4/S1 | RTD | 2.75 | $3.41 \times 10^{-4}$ | |

Infiltration rates varied across the site, from  $2.49 \times 10^{-4}$  m/sec in TP4, to  $2.56 \times 10^{-6}$  m/sec in TP3, with the infiltration rate being too slow to calculate within TP1. The result of  $1.13 \times 10^{-3}$  m/sec within TP2 has been considered as an outlier due to the high infiltration rate and the second attempt with no head of water obtained. This high rate was most likely due to the presence of the Lewes Nodular Chalk Formation below the test depth.
