**Phase II Ground Investigation Report**

**Land south of Burndell Road, Yapton, West Sussex BN18 0HR**

**Reference: 16707/GIR**

**January 2018**

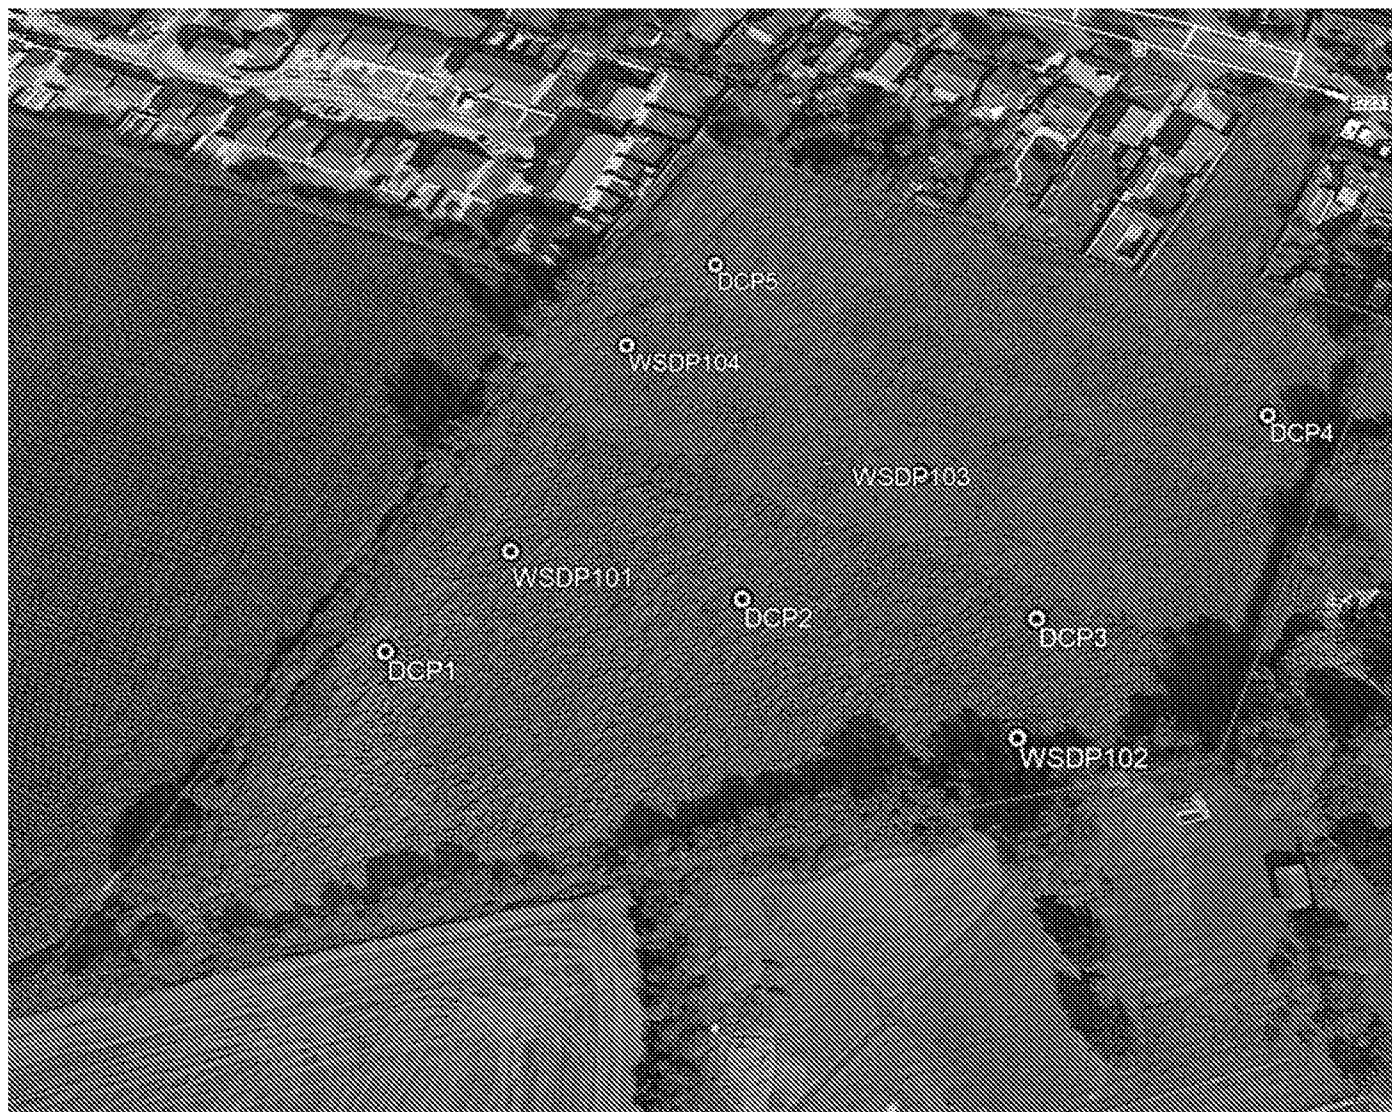
**Figure 3 – Trial Hole Plan**

- 3No. windowless sampler boreholes (WS1 – WS3);
- 3No. groundwater monitoring wells;
- 6No. machine excavated trial pits (TP1 – TP6);
- Infiltration testing (BRE DG365) within TP1 – TP4.
