# Ford Airfield, Arundel, BN18 0YH

Geo-environmental and geotechnical site assessment

Project no. 29228-R01 (01)

NOVEMBER 2018

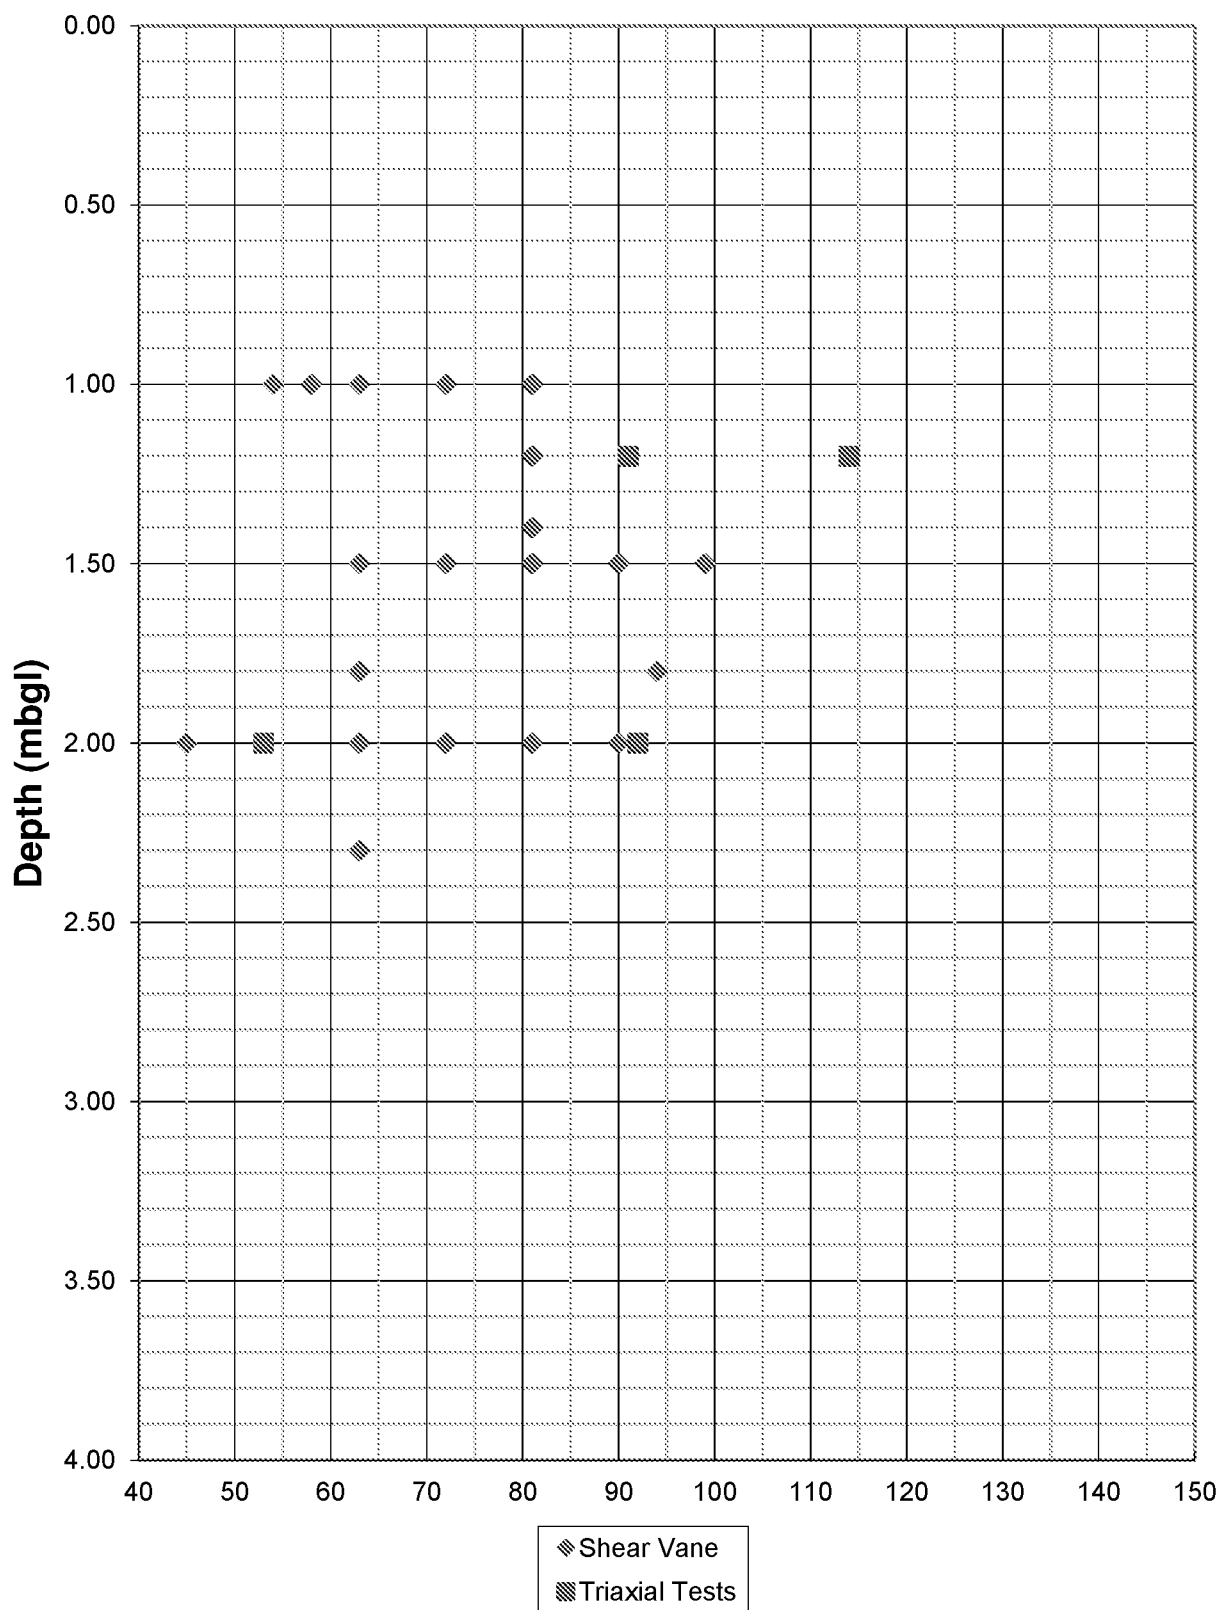
## Undrained Shear Strength Vs Depth

### Undrained Shear Strength Cu

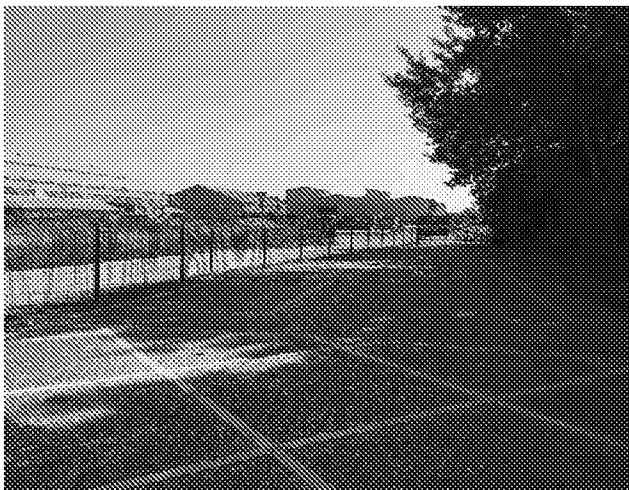
No.  
3

**Description:**  
Grundon waste recycling facilities in the  
northeastern portion of the site (site  
walkover ref 5).

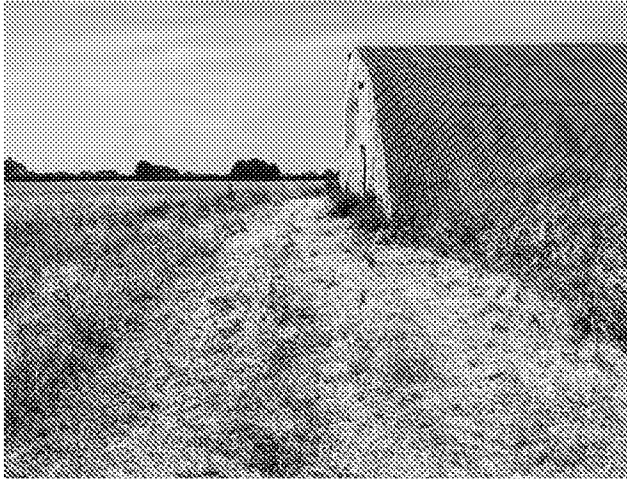
No.  
5

**Description:**  
Dome structure in southern portion of the site near former bulk fuel storage facilities (site walkover ref 7).

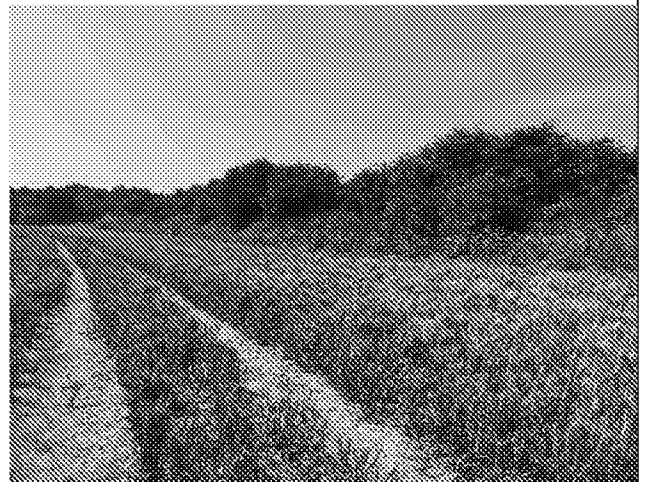
No.  
8

| 3) Evidence of made ground | <p>An earth mound is situated along the eastern boundary of the Grundon waste recycling facility (plan ref 11), and is classified by the Environment Agency as an inert landfill (see <b>Section 3.5</b>).</p> <p>Large fragments of reinforced concrete were noted in the vegetation behind the disused building in the northern portion of the site (plan ref 12).</p> |

**Description**  
Earth mound located to the rear of the Grundon waste facilities (site walkover ref 11)

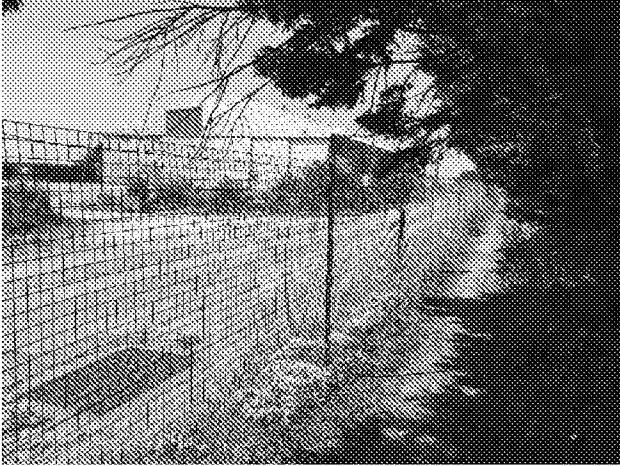
| No. | Description: |
|---|---|
| 13 | General pic – former hanger in Grundon waste facilities. |

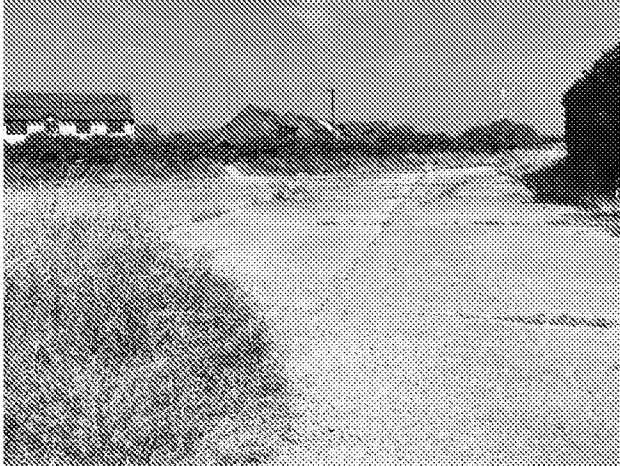
| 4) Hard standing | The former concrete runways and taxiways remain in the central and southern portions of the site. The concrete appears to be in good condition with few cracks. Any surface water on the former runway drains to a series of drain located along the edge of the runway. It is understood that the afield has it own dedicated surface water drainage system that discharges into the River Arundel. |

| No. | Description: |
|---|---|
| 14 | General pic - Former taxi-way located along the western boundary of the site. |
