APPENDIX 15.2  
**UNEXPLODED ORDNANCE RISK ASSESSMENT**

## Detailed Unexploded Ordnance Risk Assessment [In Accordance with CIRIA Report C681]

Project: Ford Airfield

Site Location: Ford Road, Ford, Arundel, BN18 0FL

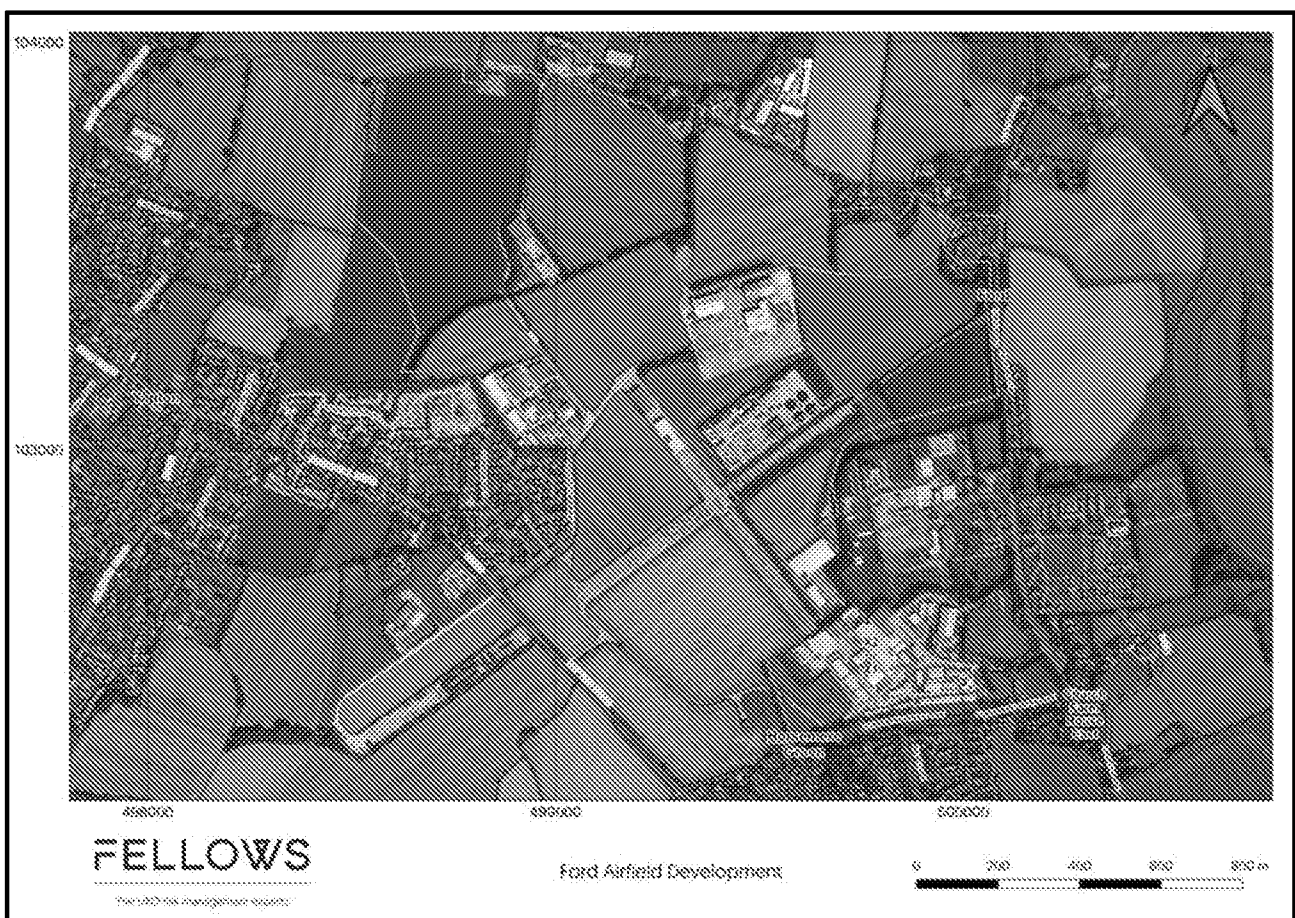
Figure 1. Showing aerial photography of the approximate site boundaries outlined in red. (Google Earth Pro, 2018)

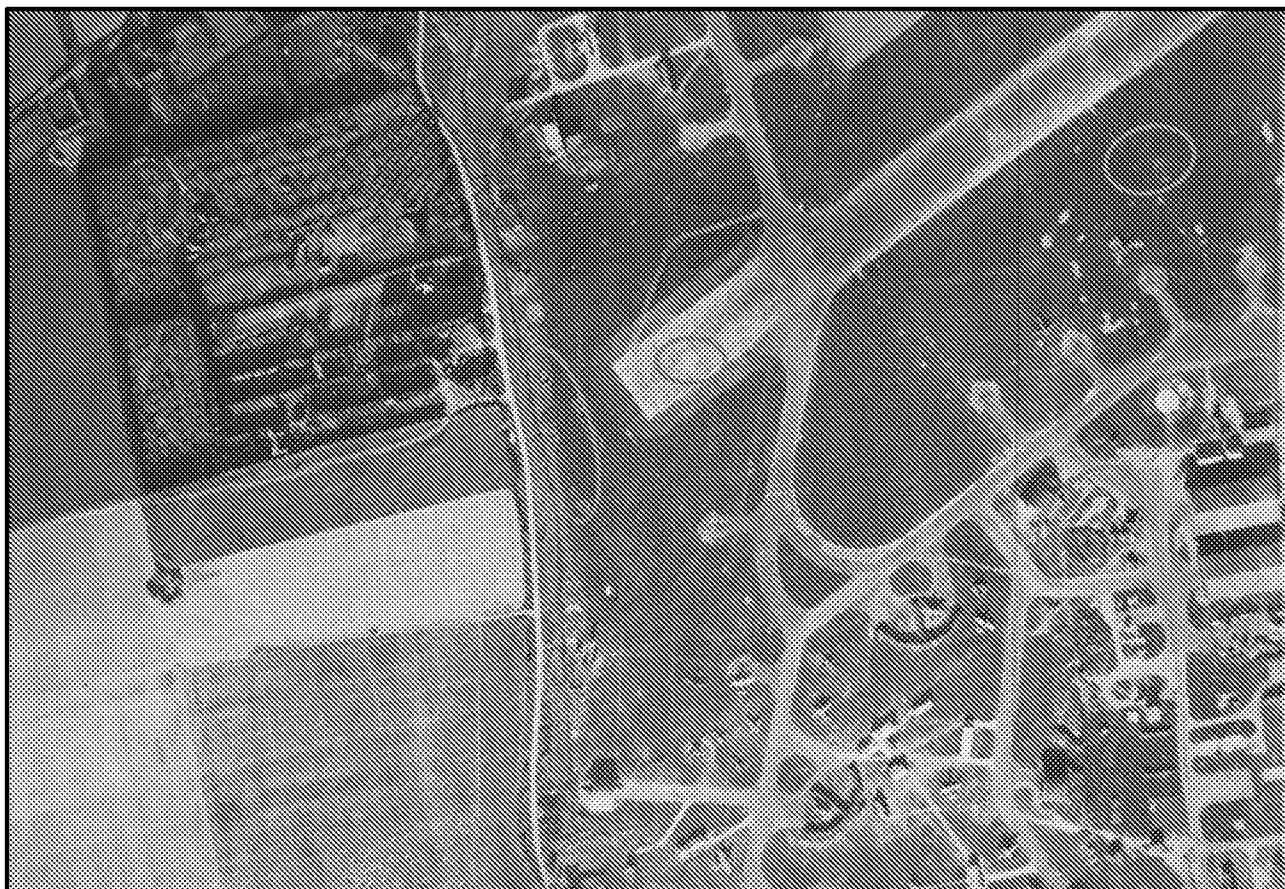
*Figure 2. Showing post war bomb damage. Craters are visible and have been circled in red.*

The Fleet Air Arm renamed the airfield HMS PEREGRINE and training units were stationed there at the beginning of WWII. Despite having little considerable involvement with the Battle of Britain, the Luftwaffe considered the airfield as strategically important. The airfield was bombed and heavily damaged by Luftwaffe Junkers Ju 87 aircraft on 18<sup>th</sup> August 1940. This was one of the the worst raids against airfield targets due to the extent of damage caused. This raid claimed 28 lives and destroyed the main airfield buildings and runway. 1946 RAF aerial photography shows some damage that has been repaired or buildings demolished and can be seen in figures 2 - 4.

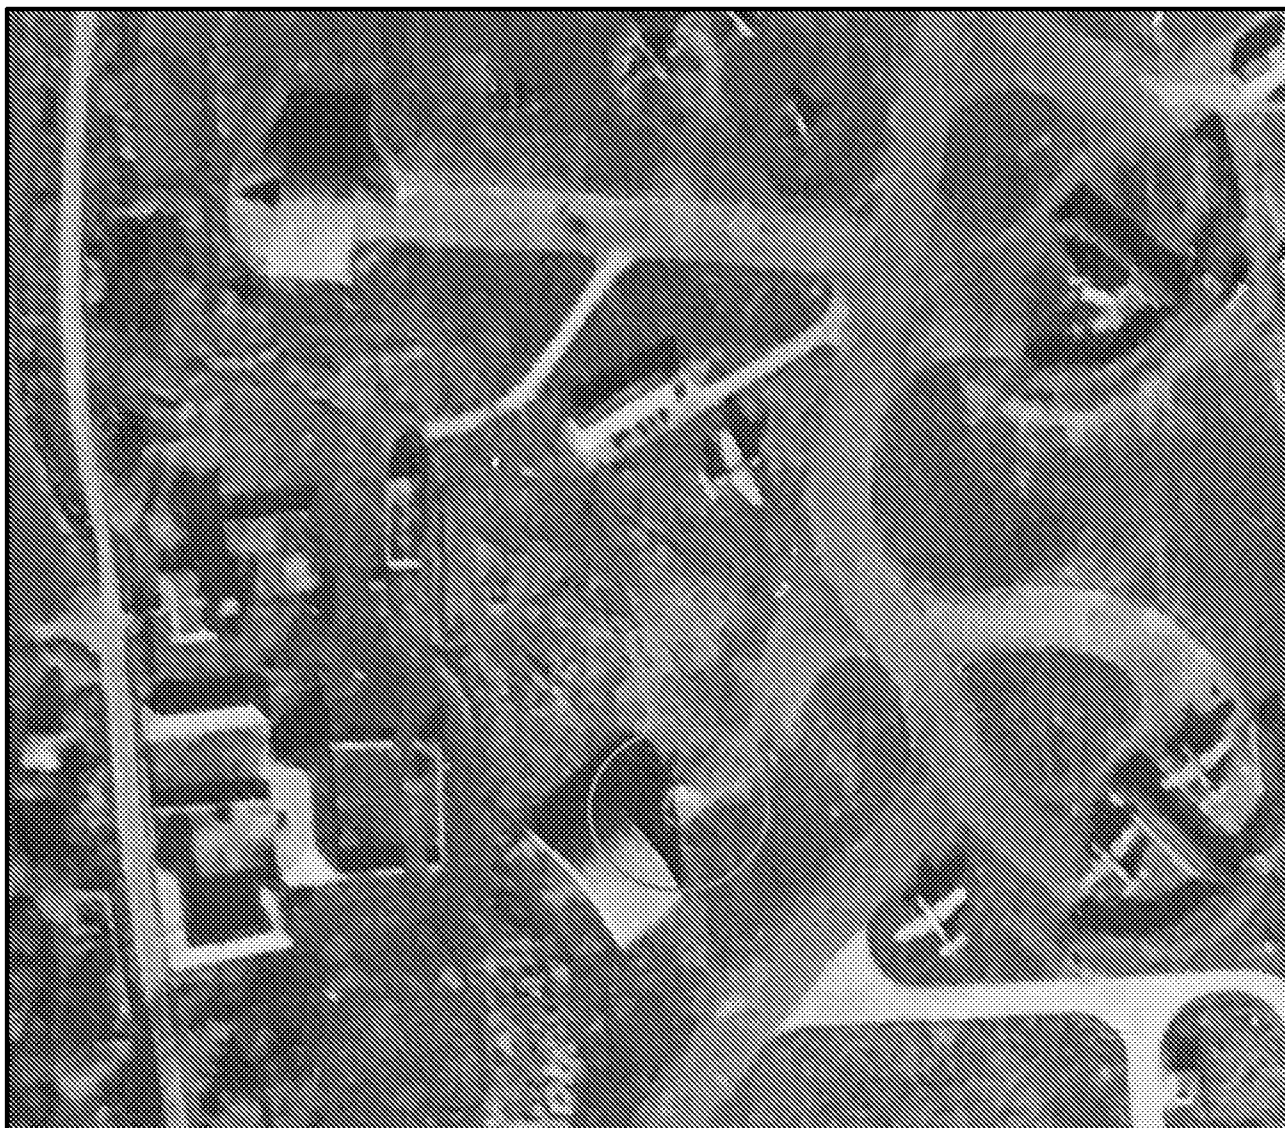
*Figure 3. Showing further bomb damage to areas near hangers.*

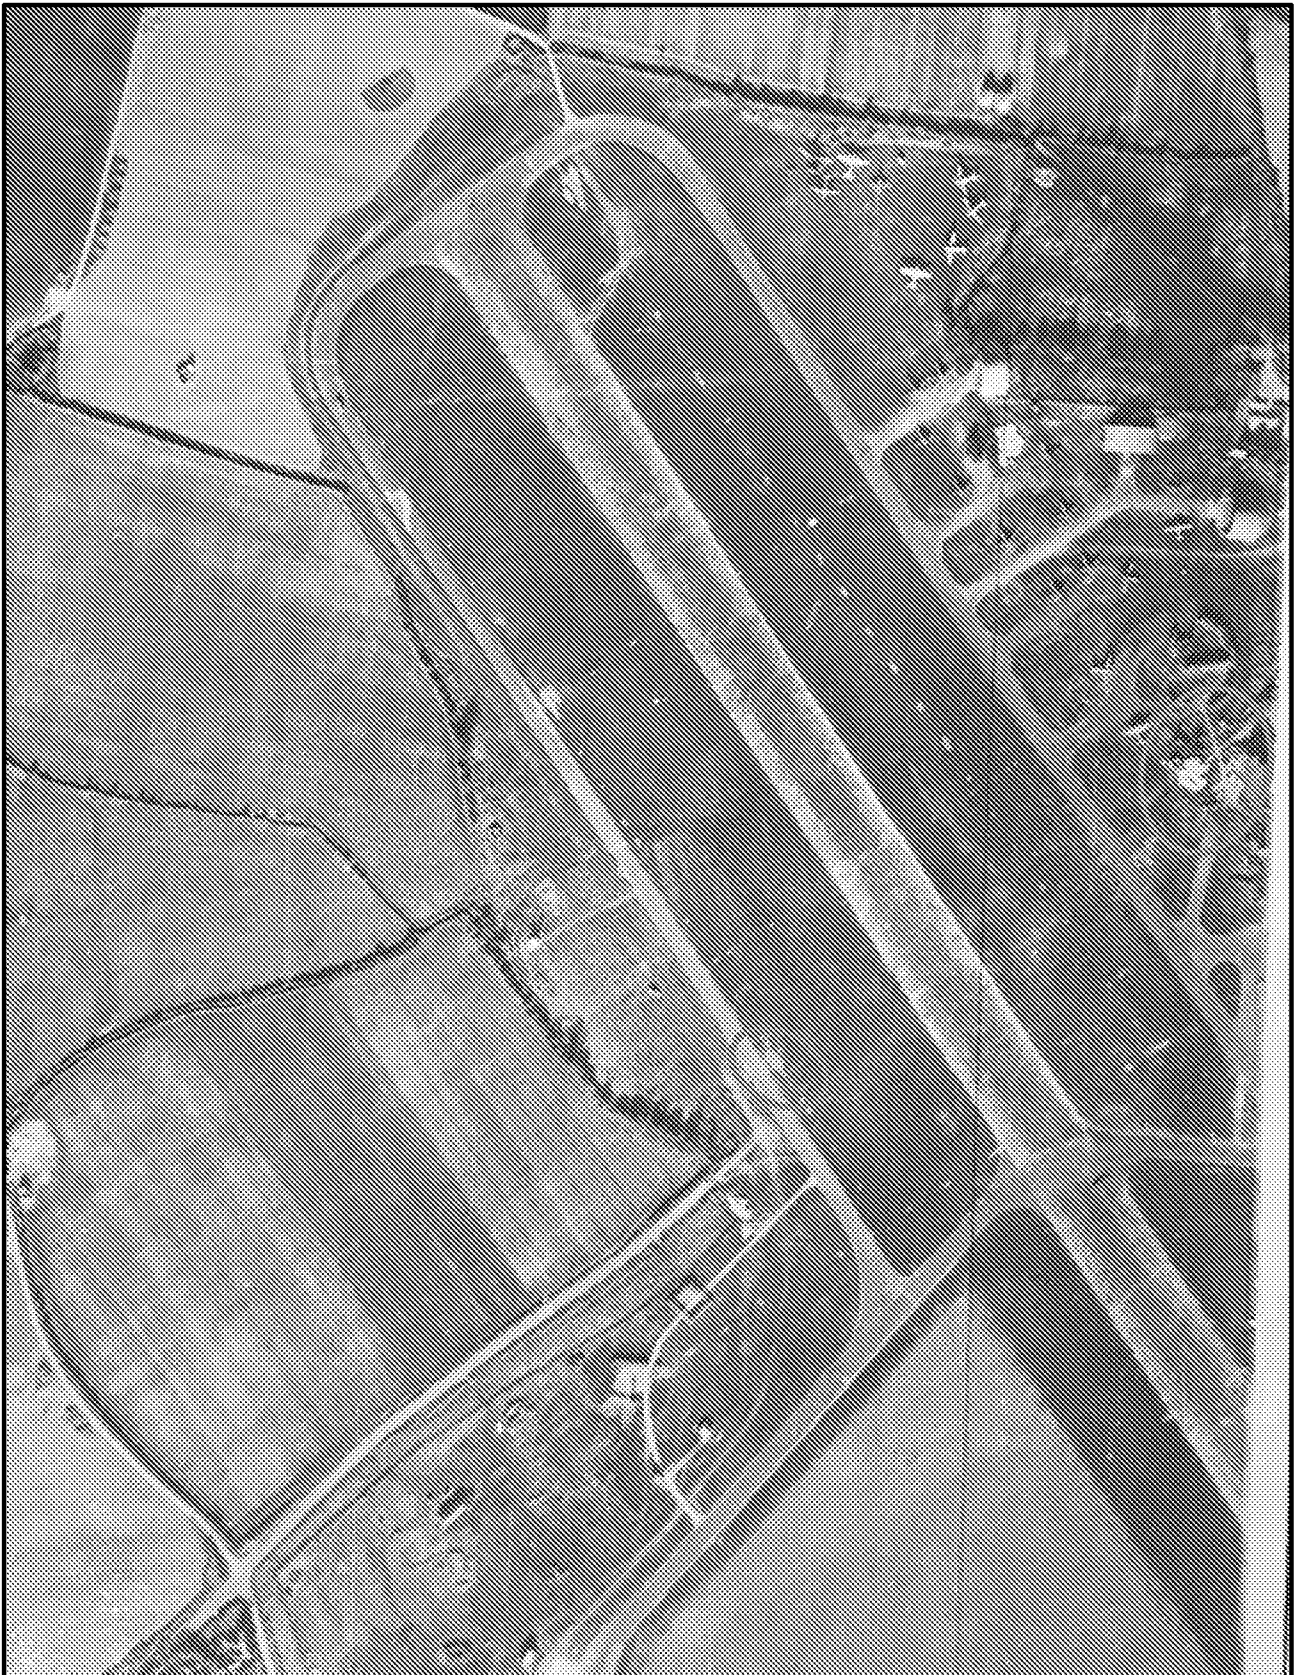
Figure 4. Showing further craters in the fields and buildings adjacent to one of the runways.

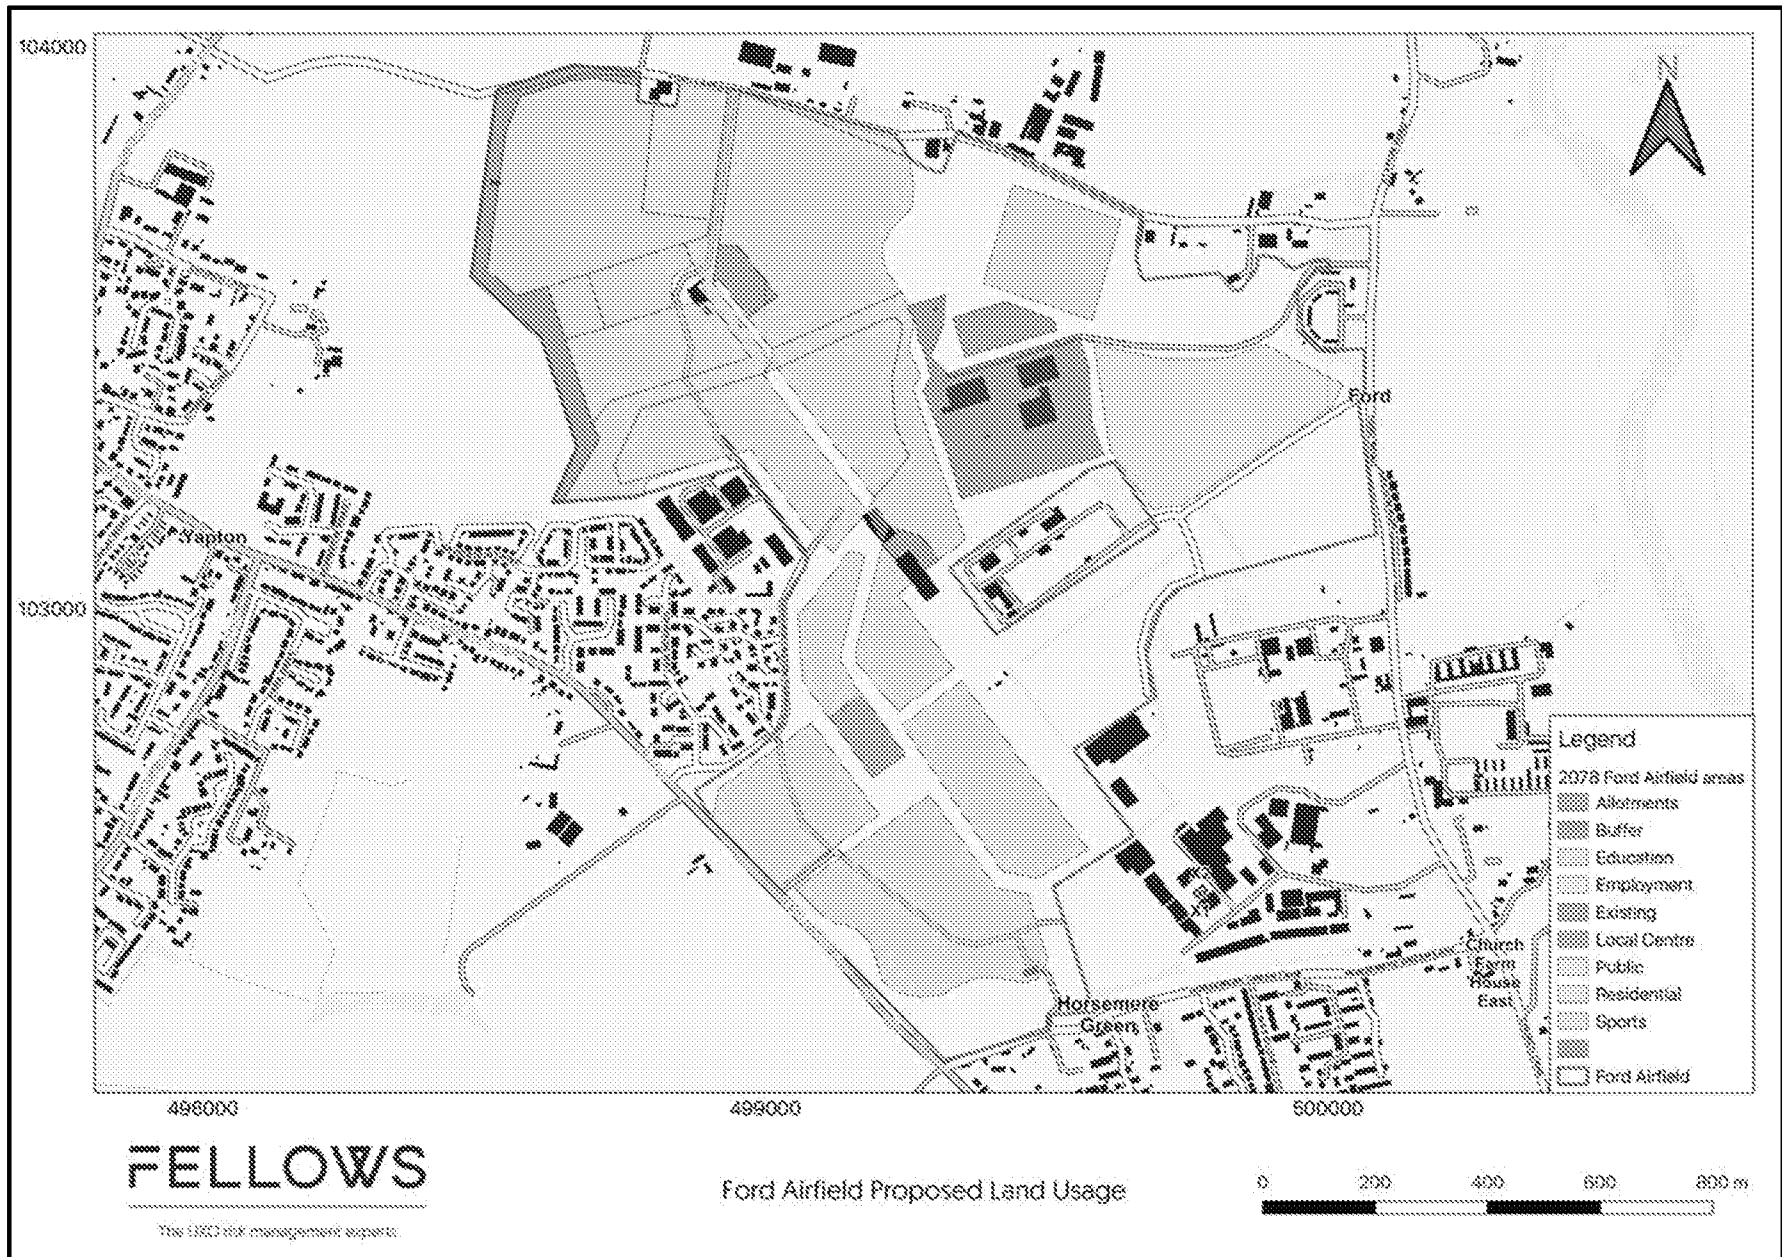
Figure 6. Showing mapping of the proposed areas of development areas.

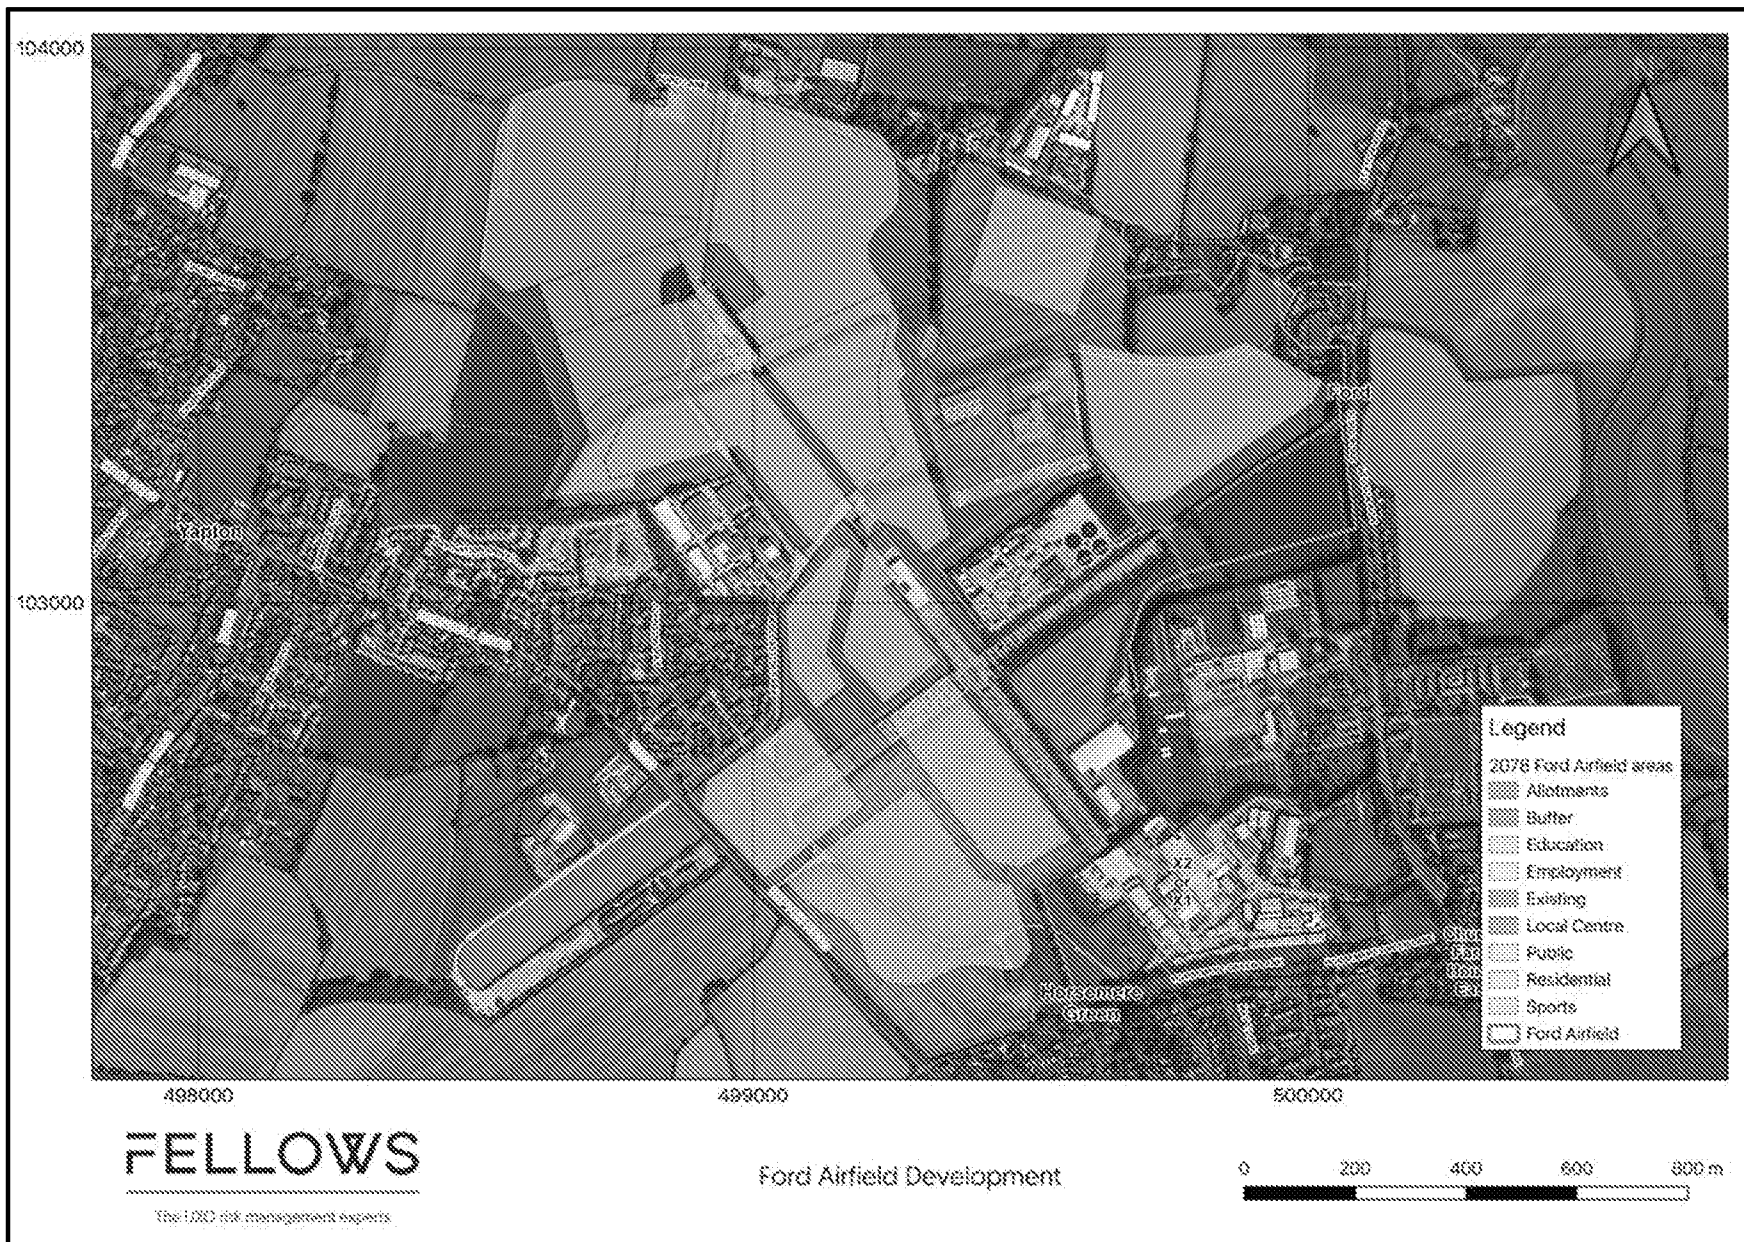
Figure 7. Showing aerial photography with proposed development are

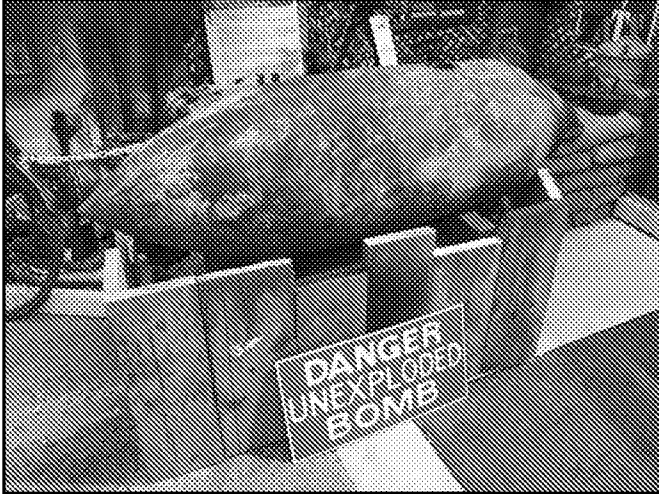
| Type | Description | |
|---|---|---|
| High Explosive (HE) Bombs | <p>German SC250 (recovered casing)</p> | <p>The SC series of HE Bombs were a thin cased general-purpose bomb used as general demolition bombs.</p> <p>Most bombs were 50kg, 250kg or 500kg, although larger bombs of up to 1,800kg were also used. About half the weight of these HE bombs comprised of explosive fill.</p> |

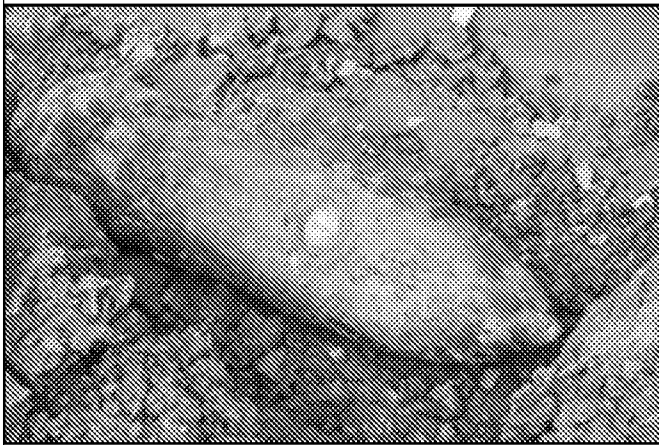
| Type | Description | |
|---|---|---|
| | <p>German SC50 (London 2015)</p> | <p>The SC50 had a one-piece drawn steel body and its total weight was 48 to 55 kg.[1] It was dropped on targets across the UK.</p> <p>The SD series of bombs were thicker cased, with a lower charge weight used against hardened targets.</p> |

When bombs strike but do not detonate, they can easily remain undetected. Note that the entry hole of an SC50 (the most commonly deployed German HE bomb) could have been as small as 20cm in diameter and therefore easily obscured within dense crops, or unmaintained vegetation, rough soil or rubble from previous damage.

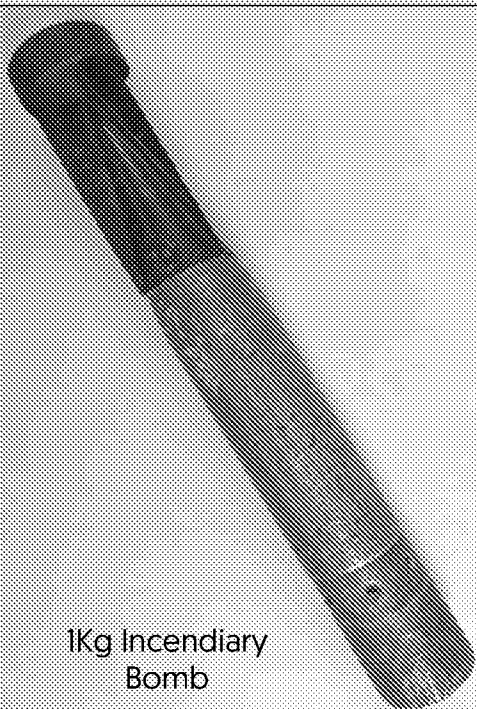
| Type | | Description |
|---|---|---|
| Incendiary bombs | <p>1kg Incendiary Bomb</p> | <p>The 1 kg B1E incendiary bomb consisted of a cylinder of magnesium alloy, with an incendiary filling of thermite. Rivetted to the body was a steel tail with three fins. These bombs did not explode but were ignited by a small percussion charge, fired upon impact. They were dropped in a variety of containers. Later an explosive head was incorporated into the IB.</p> |

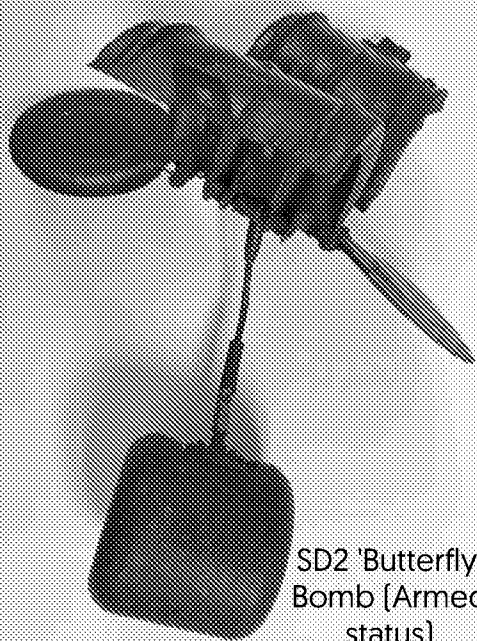
| Type | | Description |
|---|---|---|
| Anti-Personnel (AP) bombs | <p>SD2 'Butterfly' Bomb [Armed status]</p> | <p>A Butterfly Bomb (or <i>Sprengbombe Dickwandig</i> 2 kg or SD2) was a German 2 kilogram anti-personnel submunition used by the Luftwaffe during the Second World War. It was so named because the thin cylindrical metal outer shell which hinged open when the bomblet deployed gave it the superficial appearance of a large butterfly. The design was very distinctive and easy to recognise. SD2 bomblets were not dropped individually but were packed into containers holding between 6 and 108 submunitions. These broke open in air and scattered the sub-munitions.</p> |

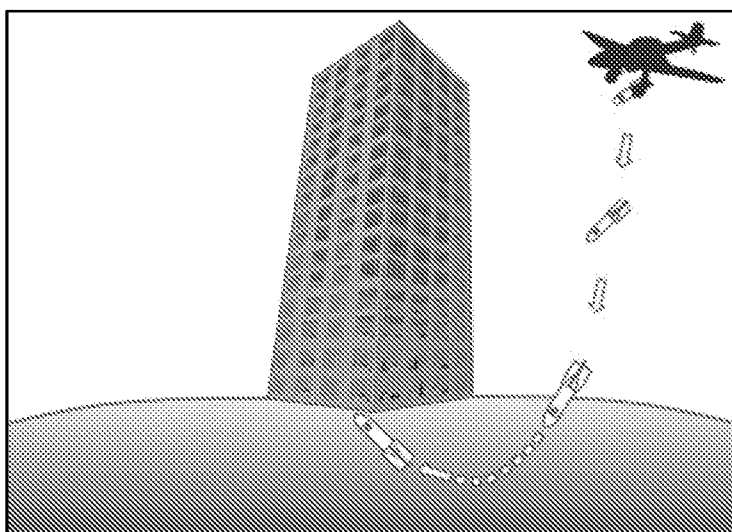
J-curve is the term used to describe the characteristic curve commonly followed by an air-delivered bomb dropped from height after it penetrates the ground. Typically, as the bomb is slowed by its passage through underlying soils, its trajectory curves towards the surface.

Many UXBs are found with their nose cone pointing upwards as a result of this effect. More importantly however is the resulting horizontal offset from the point of entry. This is typically a distance of about one third of the bomb's penetration depth but can be up to 15m leading to bombs settling underneath undamaged buildings.

Figure 8. Demonstrating the J-Curve

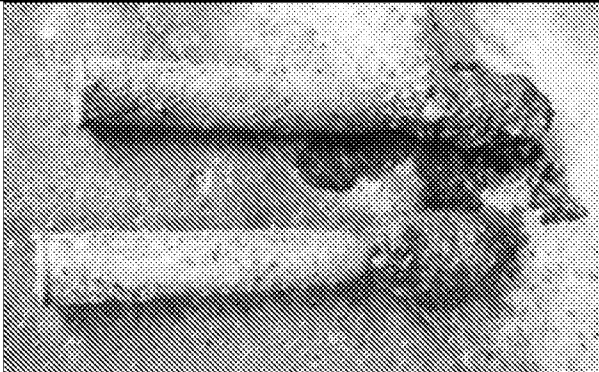
| Type | | Description |
|---|---|---|
| Anti-Aircraft Shells | <p>40mm AA Shells found at W Sussex site</p> | <p>Fixed (Heavy) Anti-Aircraft batteries were set up all around the country to defend potential targets from aerial attack. Size of guns and shells ranged from small, quick-firing 40mm Bofors guns to larger 3.7 or 4.5inch guns.</p> <p>3.7 Inch = 12.7kg 94mm x 438mm<br/> 40mm = 0.9kg 40mm x 311mm<br/> 4.5 Inch = 24.7kg 114mm x 578mm</p> |

LAA batteries were intended to engage fast, low flying aircraft and were typically deployed around military bases, RAF airfields or important installations. These batteries were mobile and could be moved to new positions with relative ease when required. The most numerous of these were the 40mm Bofors gun, which could fire up to 120 x 40mm HE shells per minute to over 1,800m.

HAA projectiles were high explosive shells, usually fitted with a time delay or a barometric pressure fuze to make them explode at a pre-determined height. If they failed to explode or strike an aircraft, they would eventually descend back to earth.

Although the larger unexploded fall-to-earth projectiles could enter beneath the ground surface, they did not have a great penetration ability and are therefore likely to be found close to WWII ground level. If encountered, the high explosive fill and fragmentation hazard of these items of UXO would present a significant risk.

The smaller 40mm projectiles are similar in appearance and effect to SAA and, although still dangerous, present a lower hazard due to its decreased explosive content.

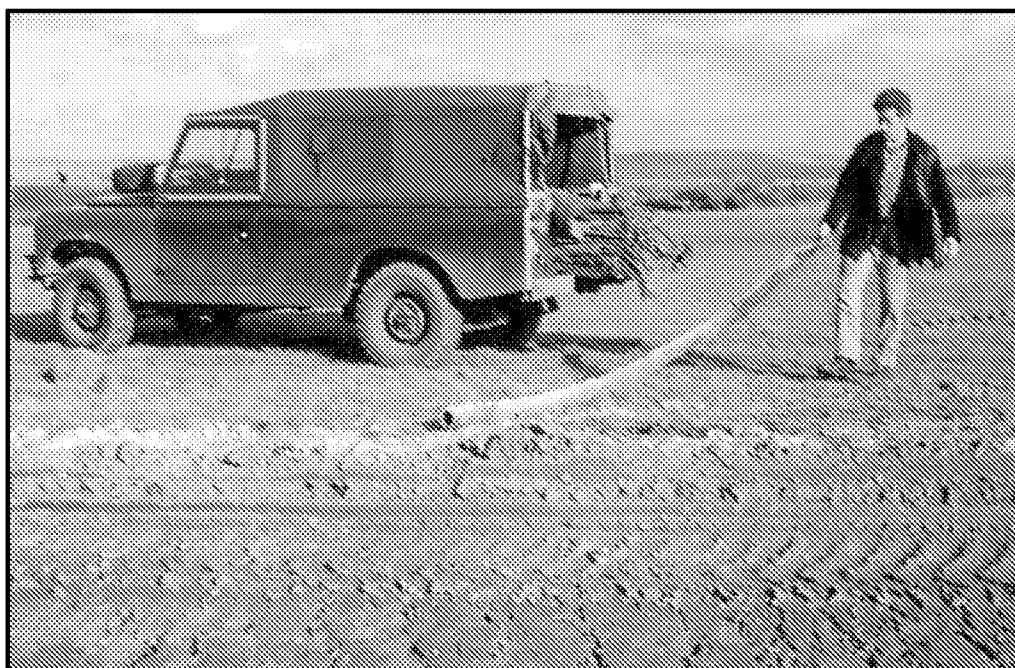
There is evidence that the airfield was mined during the war to prevent enemy forces from using the airfield in the case of a land invasion. Canadian Pipe Mines were used on the majority of southern airfields for this purpose and despite orders to remove these after the war, many remain to this day. Records show that Ford aerodrome had its minefield extended.

*Figure 9. Showing Canadian Pipe Mines.*

There is considered to be a risk of Canadian Pipe Mines on the site. It is common knowledge that southern airfields were mined to prevent use by invading forces and there is very limited evidence of their removal post-war. Pipe mines have been found on many airfields during recent developments, and no clearance appears to have been conducted on Ford Airfield.

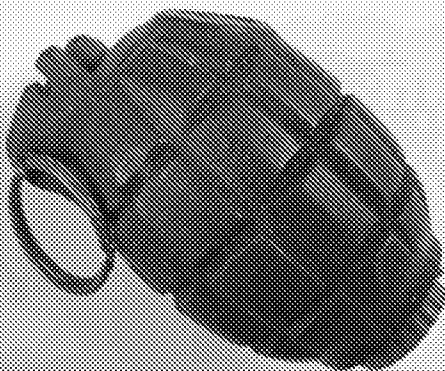
| Type | | Description |
|---|---|---|
| Hand Grenades | <p>British No36 'Mills' grenade</p> | <p>Contains a small amount of High Explosive and a rudimentary time delay fuze.</p> <p>The absence of a pin and fly-off handle indicate the item is potentially live.</p> <p>The distinctive segmented (Pineapple) casing gives the fragmentation effect on detonation.</p> |

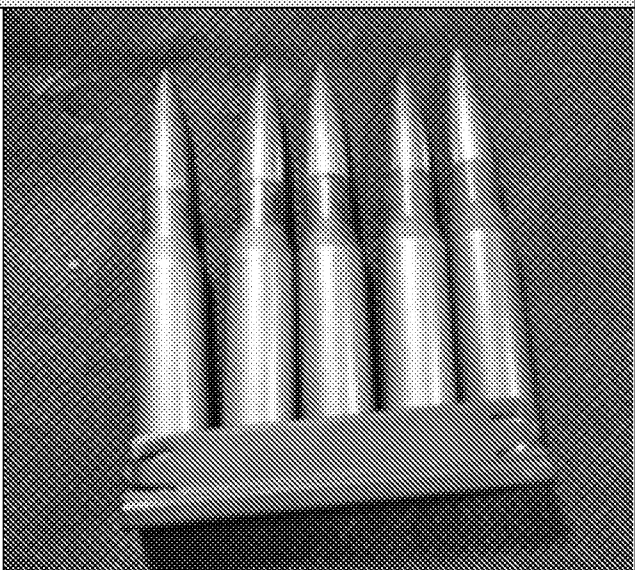
| Type | Description |
|---|---|
| Small Arms Ammunition | <p>Small arms of various sizes from 4 or 5mm calibre (diameter) up to 12 to 13mm.</p> <p>Generally, the head is inert and made of lead or similar dense material.</p> <p>Brass cases without the head pose no risk.</p> |

The most common type of ordnance encountered on land formerly used by the military are items of Small Arms Ammunition (SAA). SAA refers to the complete round or cartridge designed to be used with hand-held infantry weapons such as rifles, machine guns and pistols. SAA can include bullets, cartridge cases and primers/caps. Items of SAA can be accidentally initiated by striking the casing or coming into contact with fire. SAA presents only minimal risk although it must be disposed of correctly if found on-site.
