Bat Survey Report

Rest Harrow

**Middle Way
East Preston
Littlehampton
BN16 1SB**

**24-069
November 2024**

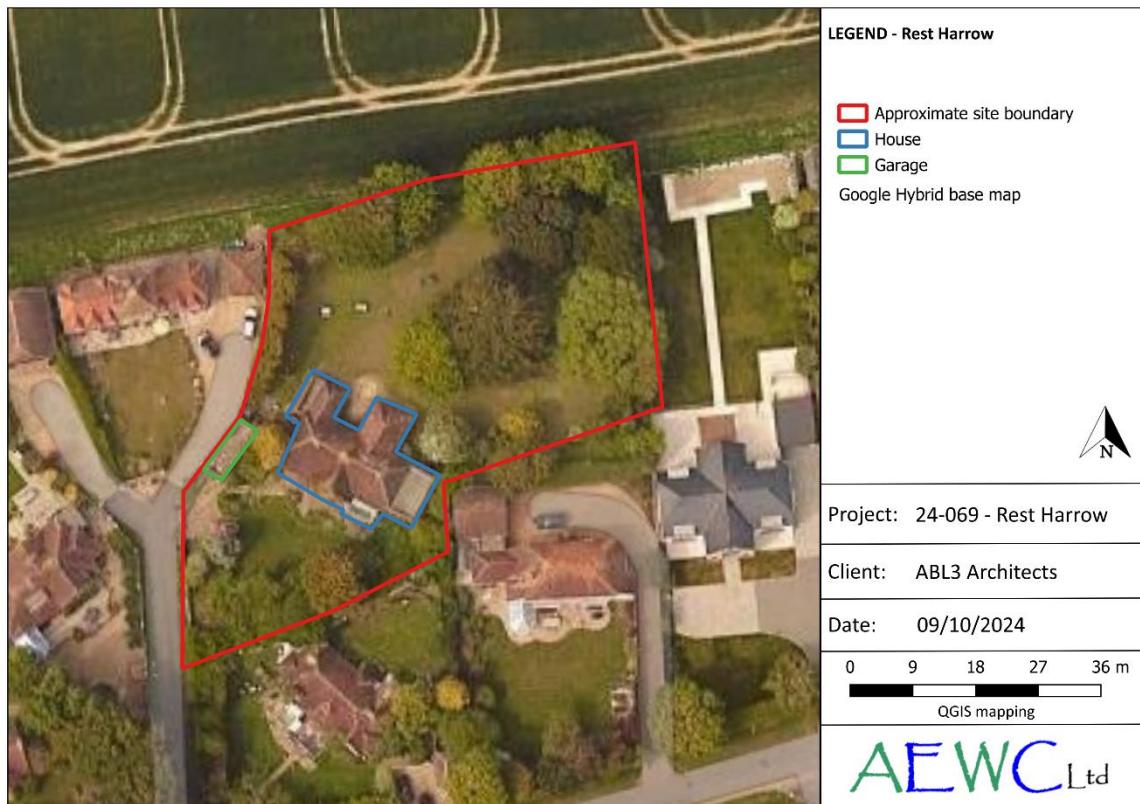
FIGURE 2: SHOWING THE BUILDINGS SUBJECT TO SURVEY

1.9 The site contains a detached single-storey residential dwelling and a garage building situated within an amenity garden.

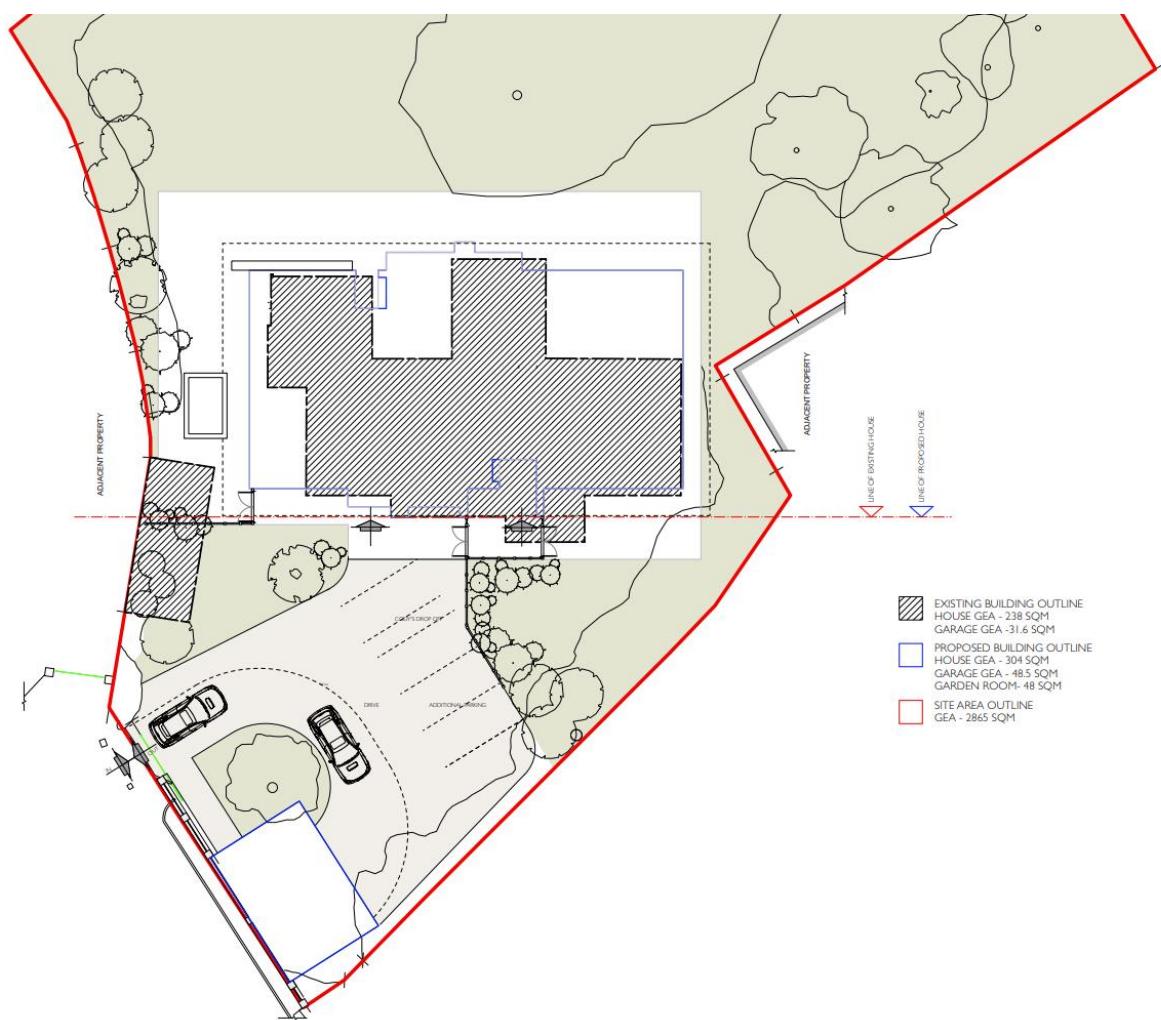
FIGURE 3: SHOWING THE EXISTING AND PROPOSED PLANS.

1.14 The proposal is for demolition of the existing house and the garage to make way for construction of a new residential dwelling on the existing footprint, as well as the construction of a new garage in the southern corner of the site.

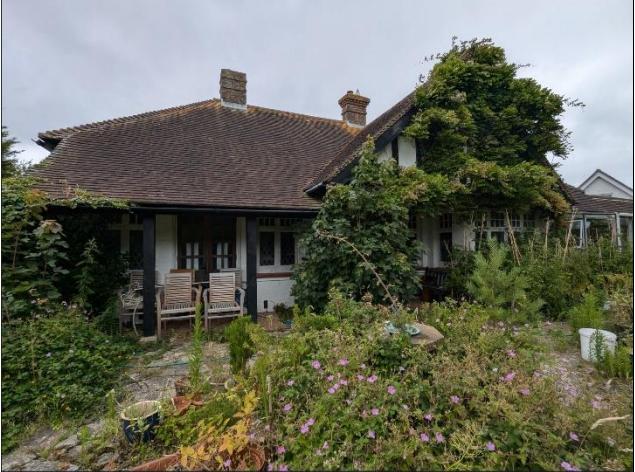
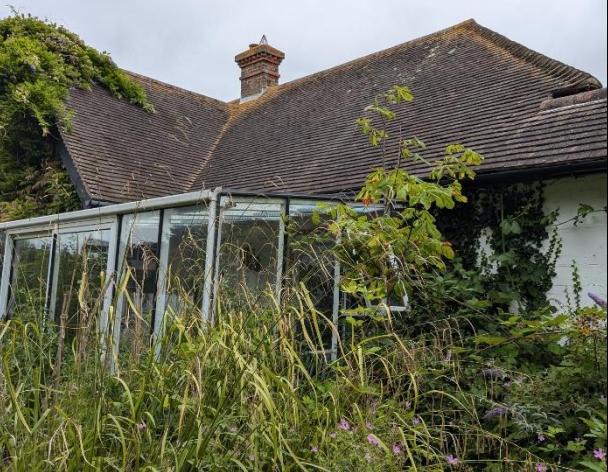
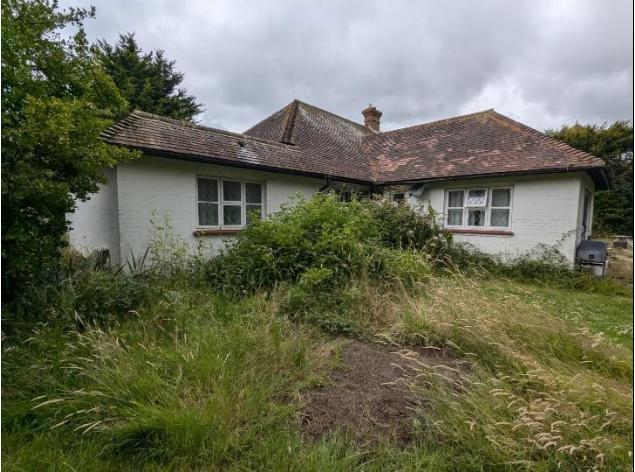
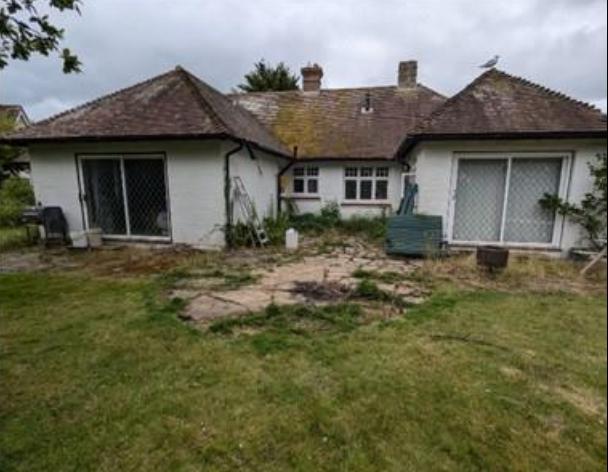
4.6 The house is a single-storey, brick-built detached residential dwelling with a hipped roof supporting clay roof tiles. Two intersecting extensions on the northeast elevation have hipped roofs, along with an intersecting gabled roof on the southwest elevation and a part-flat, part-pitched roof section at the southeast elevation. Two chimneys are located at the roof ridge.

| Photograph 1: West side of south elevation of house. | Photograph 2: East side of south elevation of house. |
| Photograph 3: Northeast corner of house. | Photograph 4: West side of north elevation of house. |

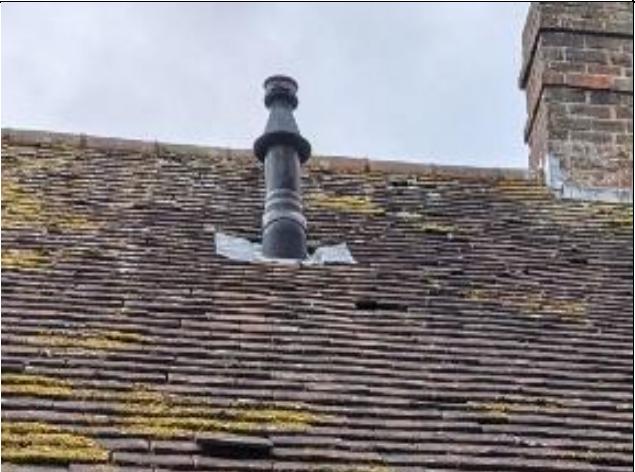
4.7 The roof was noted to have several lifted and missing tiles on all elevations, which provide potential access into the batten space of the roof for crevice-dwelling species.

An area of loose lead flashing around the roof vent also allows potential access into the batten space of the roof or roof void.

| Photograph 5: Loose lead flashing around the roof vent and lifted tiles. | Photograph 6: Uneven roof tiles on the north elevation. |

- 5.3 The daytime assessment identified moderate potential for the house to support roosting bats within the batten spaces of the roof tiles and within the roof void; however, bats were not found during the emergence surveys and, as such, there are no known constraints regarding these species and the proposed works.

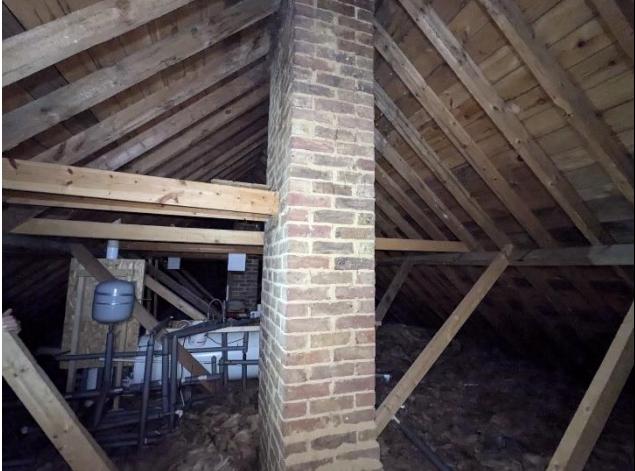
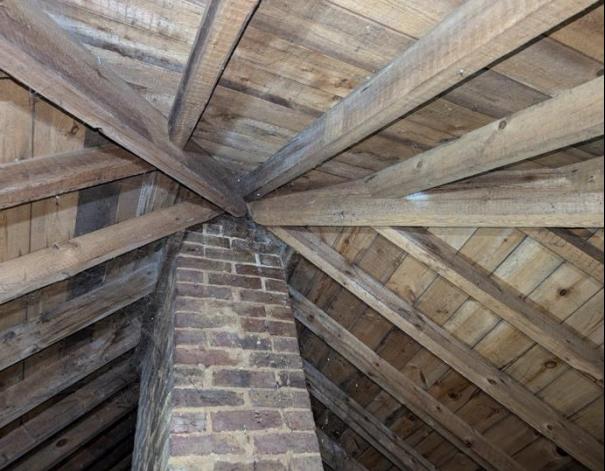
- 4.8 Internally, the roof is wood framed and lined with timber sarking, with fibreglass insulation present at the floor level. The chimneys, timbers, water tanks and associated pipework create a degree of clutter, however the void is tall and with good internal flight space for void-dwelling species. The roof void was heavily cobwebbed along the ridge, especially at the hip apices and around the chimneys. An old wasp nest was noted inside the roof void, in addition to evidence of small and large rodents. No evidence of bats was identified within or around the house.
- 4.9 Due to the features described, the house was identified to hold moderate potential to support roosting bats. As such, a minimum of two emergence surveys were required to be carried out in the active season of May to September.

| <p>Photograph 7: Roof void within the house.</p> | <p>Photograph 8: Heavy cobwebbing at the hip apices.</p> |

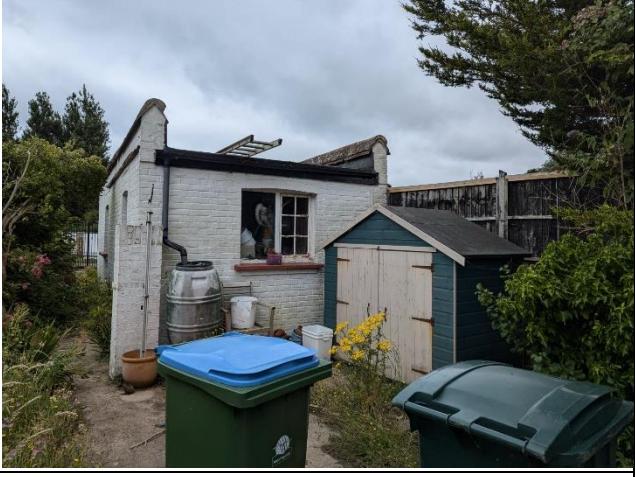
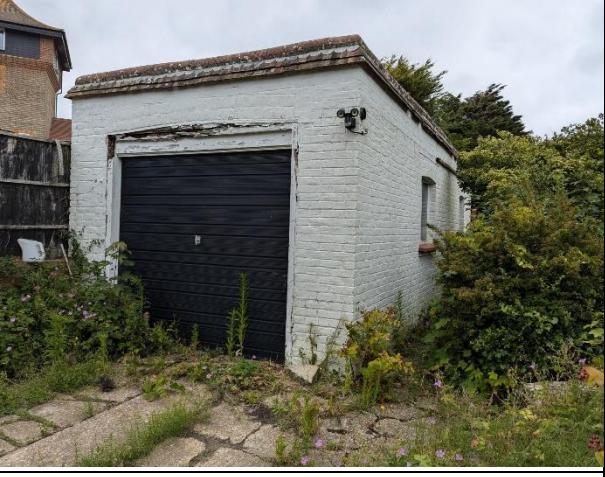
- 4.10 The garage building is a brick-built detached building with a flat timber roof covered in bitumen felt, which serves as a storage area. A parapet wall is present around all but the northeast elevation of the building, supporting a very small area of decorative clay tiling comprising a ridge and two tile courses.

| <p>Photograph 9: North elevation of the garage showing lack of roof void.</p> | <p>Photograph 10: South elevation of the garage with the flat roof.</p> |

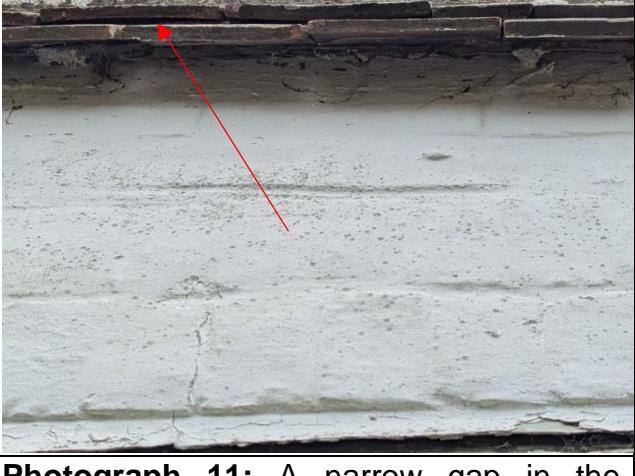
- 4.11 Externally, no gaps were noted that would provide suitable access into the garage with garage door, windows, and the roof felt largely tight fitting. The decorative clay tiles were largely tight-fitting; a low number of gaps were noted where the upper tile was slightly uneven, however these are mortared directly to the parapet with no batten space present, and these crevices are shallow and relatively exposed. Fine cobwebbing was also present across some of these gaps.

| <p>Photograph 11: A narrow gap in the decorative roof tile.</p> | <p>Photograph 12: The garage interior.</p> |

- 4.13 Due to the absence of suitable access points or roost features, the garage building was identified to hold negligible potential to support roosting bats. As such, no other surveys were required for this building.

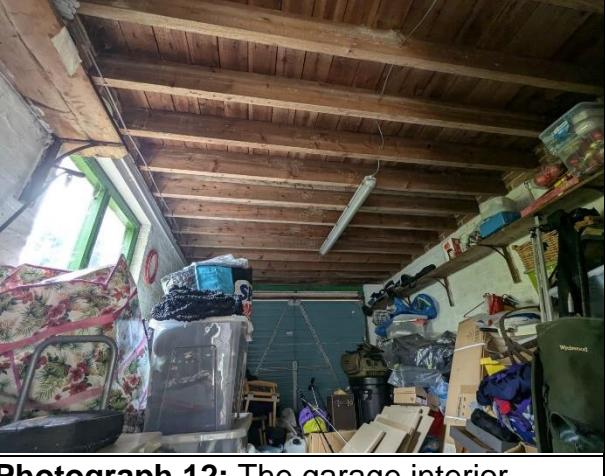
- 4.12 Internally, the roof is wood framed and lacks suitable tight roosting crevices for bats. Cobwebbing was noted at the window frames, garage door, and the beams. No evidence of bats was found externally or internally within the garage.

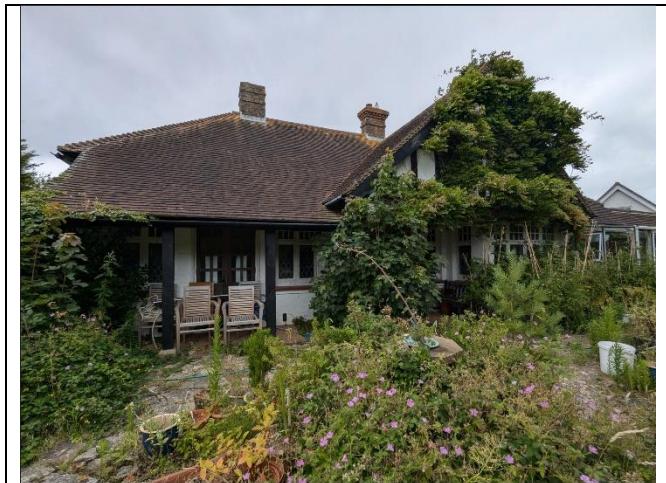
4.15 The climbing vegetation present on the west elevation of the house and larger shrubs immediately surrounding the house have potential for nesting birds.

Photograph 13: Climbing vegetation on the elevation of the house and shrubbery.

- 5.5 Vegetation clearance and building demolition should be undertaken outside the breeding bird period from March to August. Should any vegetation clearance or demolition be scheduled to take place between the beginning of March and the end of August, this must be immediately preceded by a survey to check for nesting birds by a suitably qualified ecologist. No vegetation can be cleared or building demolished whilst a nest is occupied, regardless of species.

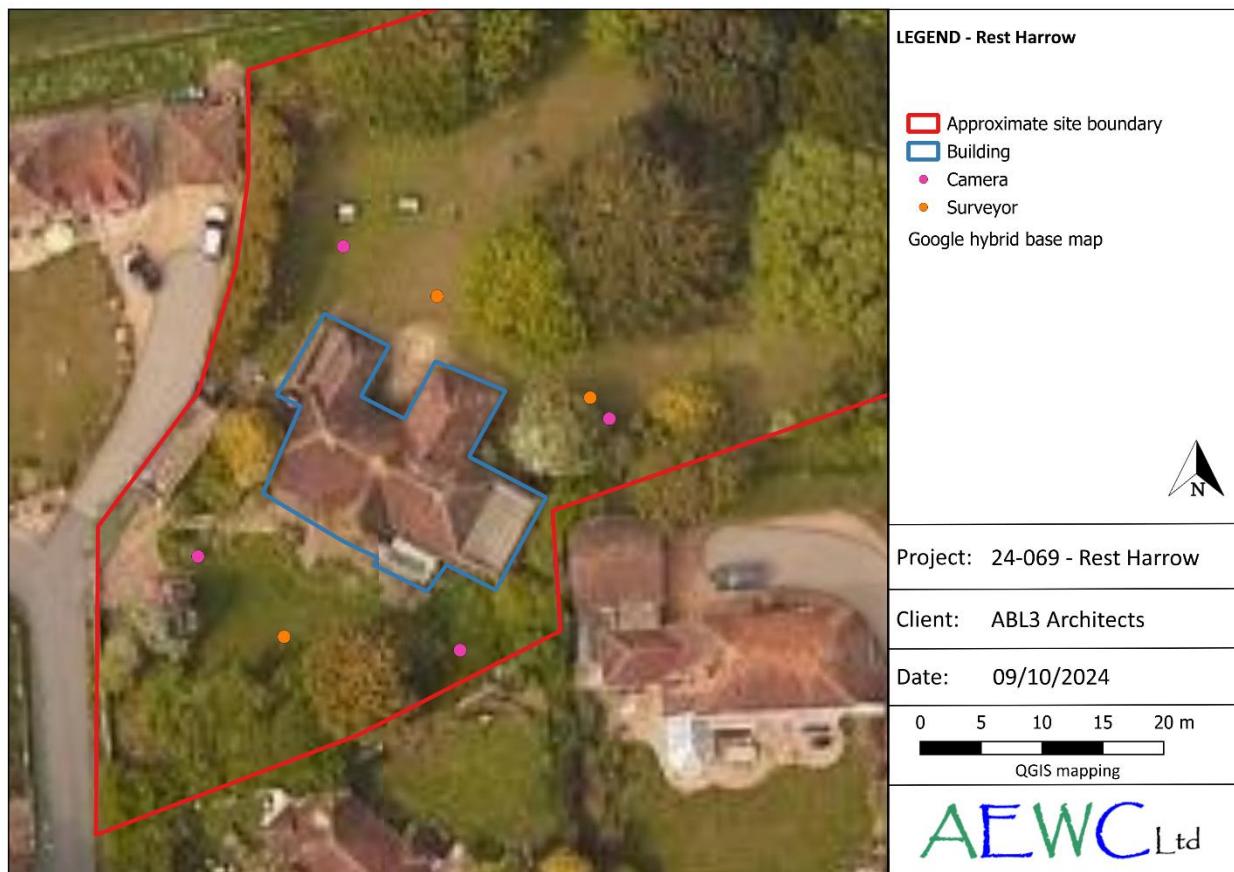
FIGURE 6: SHOWING POSITIONS OF SURVEYORS AND NIGHT VISION CAMERAS DURING THE 2ND AUGUST AND 27TH AUGUST EMERGENCE SURVEYS.

2.13 Three surveyors and four professional night vision cameras were used for both emergence surveys (Figure 6). The surveyors and four cameras were positioned to get a good all-round view of the building with a particular focus on the areas of impact and where potential roost features were identified present.

4.18 A diagram showing the locations of the surveyors and night vision cameras during the evening surveys can be seen in Figure 6 below.
