**GROUND INVESTIGATION REPORT**

**KINGSTON CORNER ANNEX, BROKSID ROAD, EAST PRESTON,  
WEST SUSSEX BN16 1SE**

**DAVID STATION C/O NICO WARR ARCHITECTS**

| Report Reference: GWPR2607/GIR/July 2018 | | Status: FINAL |

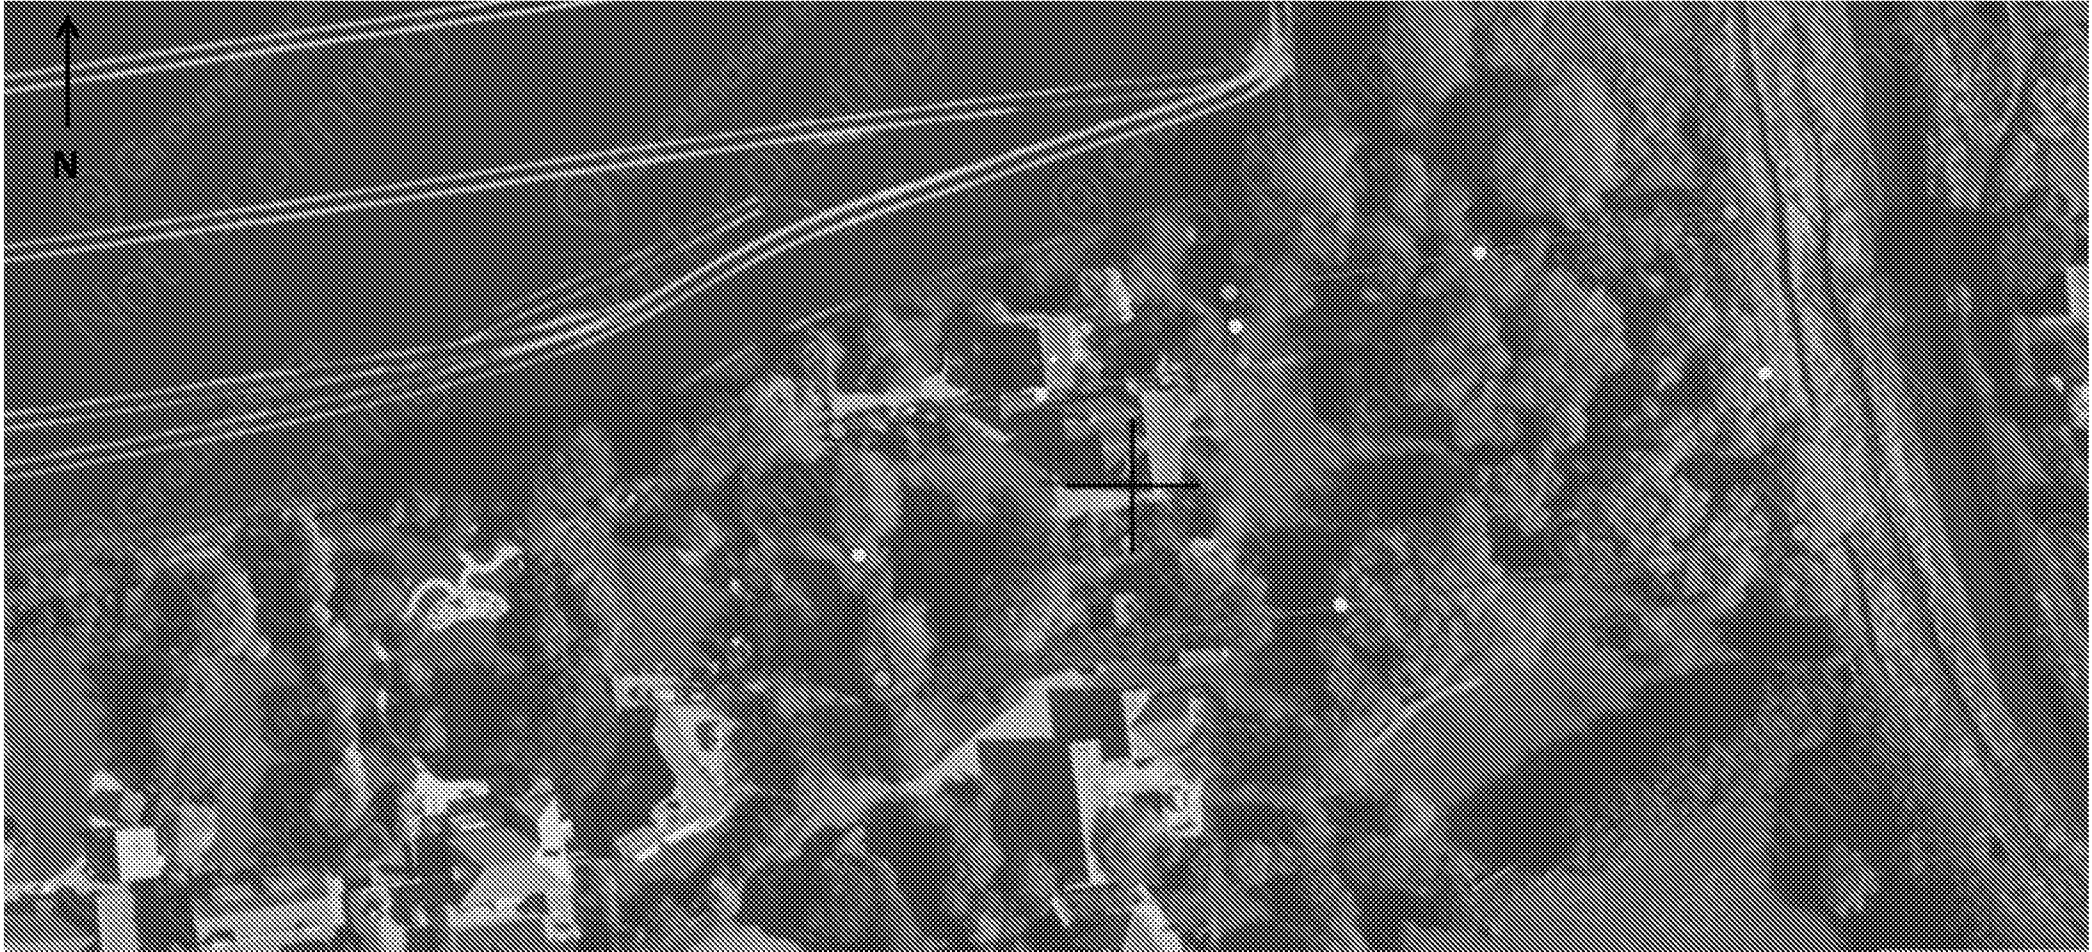
**Figure 2**

----- APPROXIMATE SITE BOUNDARY

The approximate O.S. National Grid Reference for the centre of the site was TQ 08924 01754. A site location plan can be seen in Figure 1 with a plan showing the site area presented in Figure 2.
