## **Arboricultural Survey**

Hollyacre

Littlehampton

PJC Ref No: PJC/3117/12

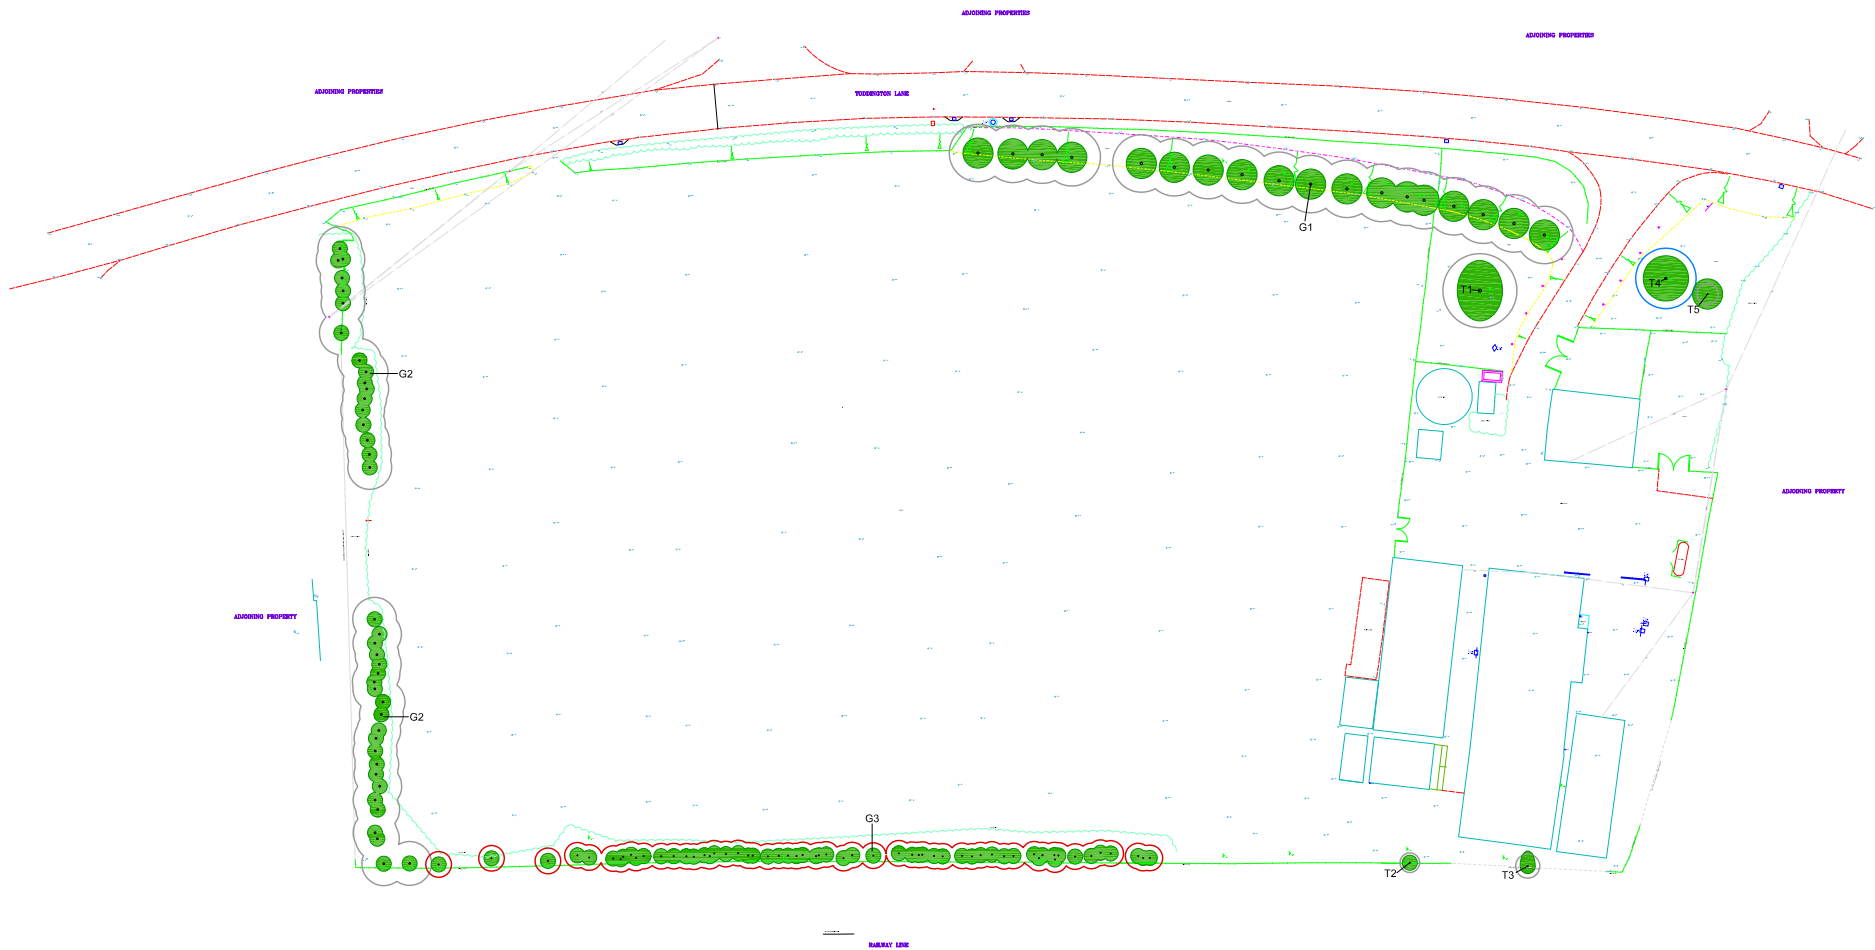
**Drawing Title:** Tree Constraints Plan

4.1 Each tree's DBH was recorded, and applied to the formula found in Appendix 4. The resulting dimensions equal each tree's Root Protection Areas that are plotted on to the Tree Constraints Plan in Appendix 1, and added to the Tree Survey Schedule in Appendix 2. These are represented as a circle on the plan, and are colour coded depending on the category they were classed in using the cascade chart in Appendix 3.

4.3 The root protection areas must be left free from excavation and disturbance, and protected during any proposed works. Protection should be in the form of fencing as defined in Appendix 5, and signs affixed as shown in Appendix 6.

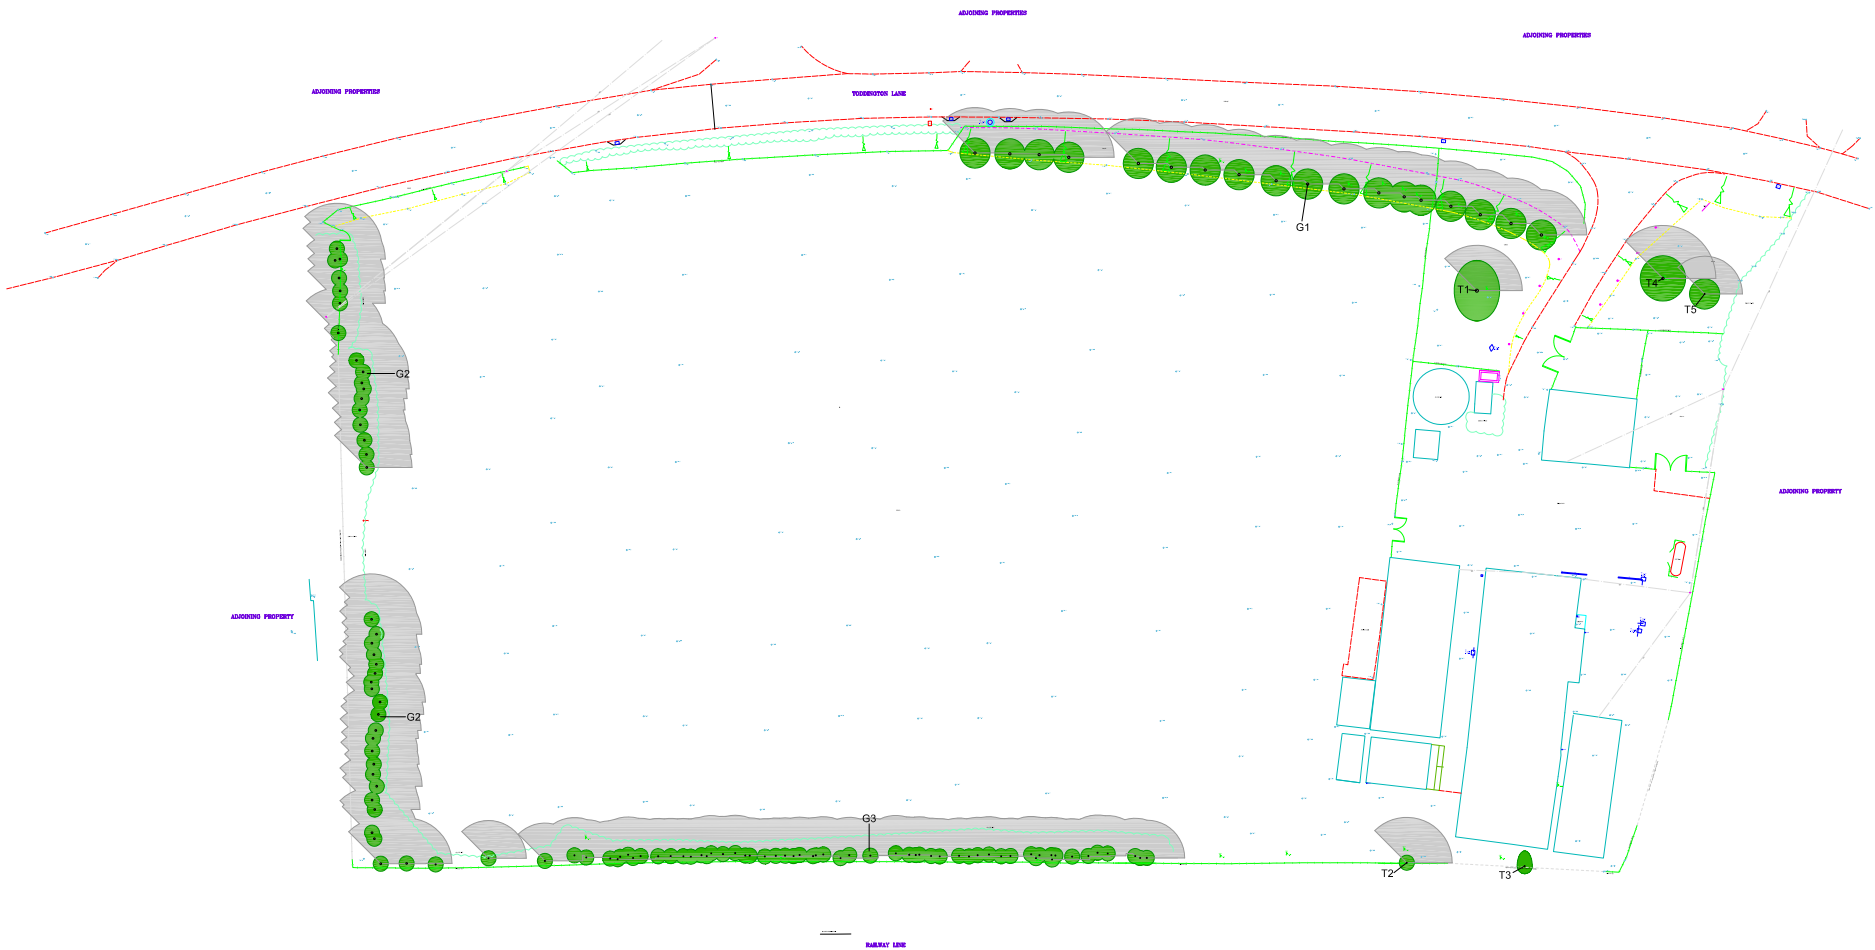
**Drawing Title:** Tree Shadow Plan

Tree shadows plotted using guidance set out in BS5837: 2012 - Trees in relation to design, demolition and construction - Recommendations. The trees existing height is used to calculate the radius of the shadow segment, plotted from north west to east as an arc.

**Please note the plotted shadows represent shadow cast throughout the typical day, and not the total shadow cast at a given moment.**

4.7 Shade cast by existing trees should be considered when finalising the proposed site layout. Existing shadows are shown on the Tree Shadow Plan in Appendix 1. Shade should also be considered when selecting species for further planting, as should factors such as autumnal leaf litter and tree sap on cars.

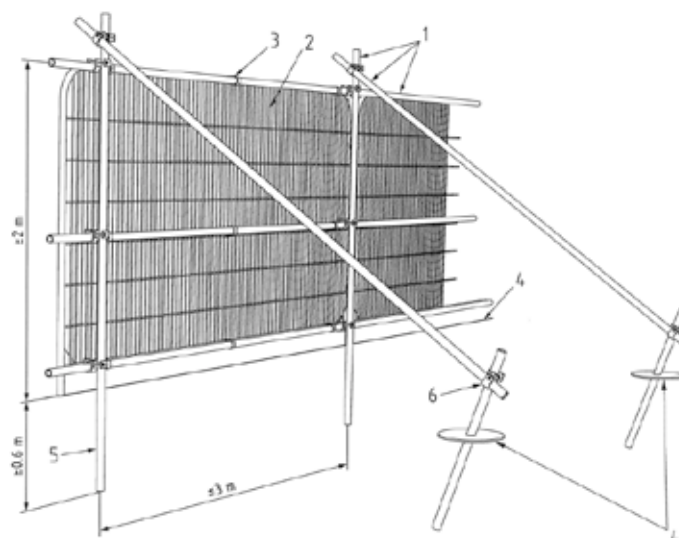
## APPENDIX 5 Tree Protection Fencing Specification

- 1 Standard scaffold poles
- 2 Heavy gauge 2 m tall galvanized tube and welded mesh infill panels
- 3 Panels secured to uprights and cross-members with wire ties
- 4 Ground level
- 5 Uprights driven into the ground until secure (minimum depth 0.6 m)
- 6 Standard scaffold clamps

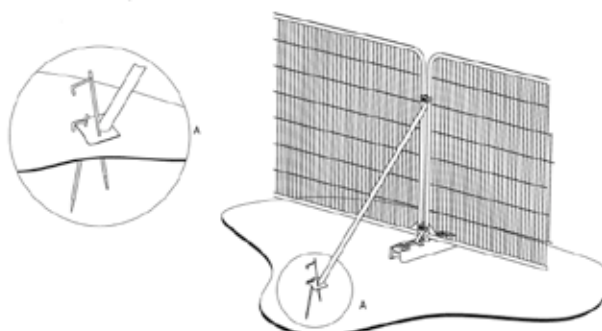
a) Stabilizer strut with base plate secured with ground pins

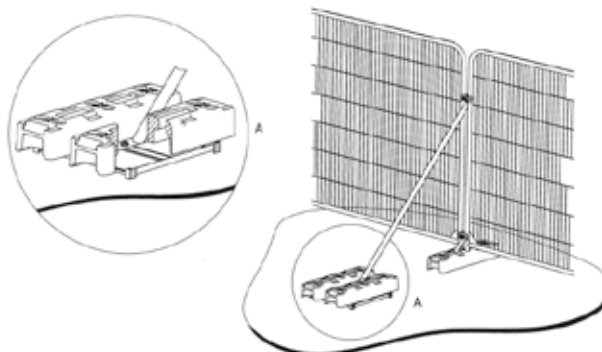
b) Stabilizer strut mounted on block tray

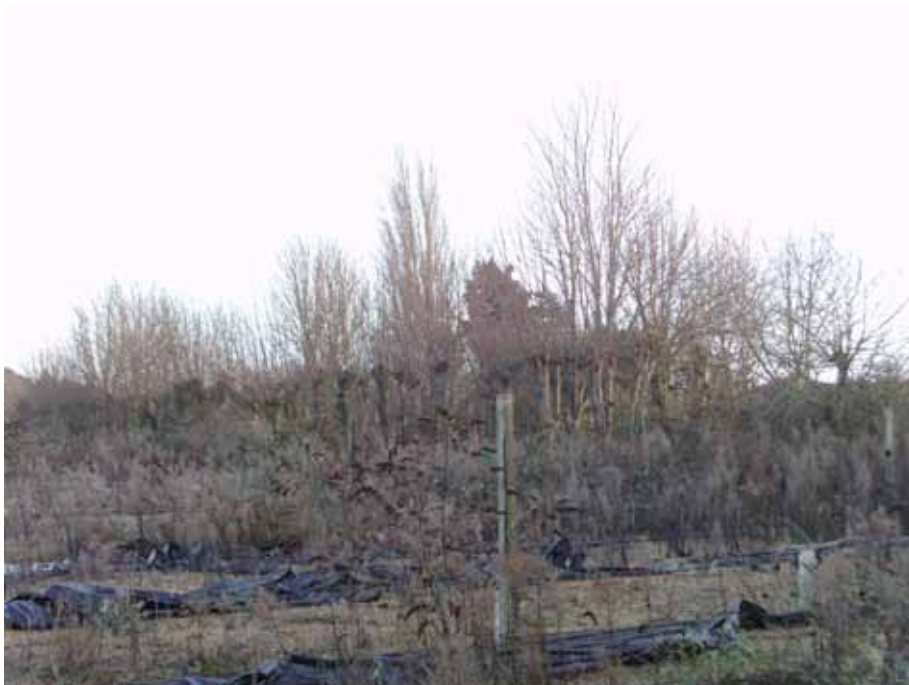
**Photograph 1 – Group G3**

3.5 Group G3 comprises a line of densely planted sycamore (*Acer pseudoplatanus*) located along the southern site boundary. This tree line, which was likely planted as a shelterbelt, has previously been pollarded. As a result of the previous pruning, the trees have weak branch unions. The pollard points have become decayed and have a high chance of failure. These trees provide limited screening benefits from the adjacent railway, and due to their poor condition, form and vigour have been categorised as U.

4.4 It is suggested that group G3 be removed and replaced with better quality trees or hedging to screen the proposed development from the railway. Group G3 consists of poor quality specimens with limited potential for future growth. It is suggested that native species be used (refer to Extended Phase 1 Habitat Survey provided by PJC Ecology) to provide a visual and sound barrier from the railway.

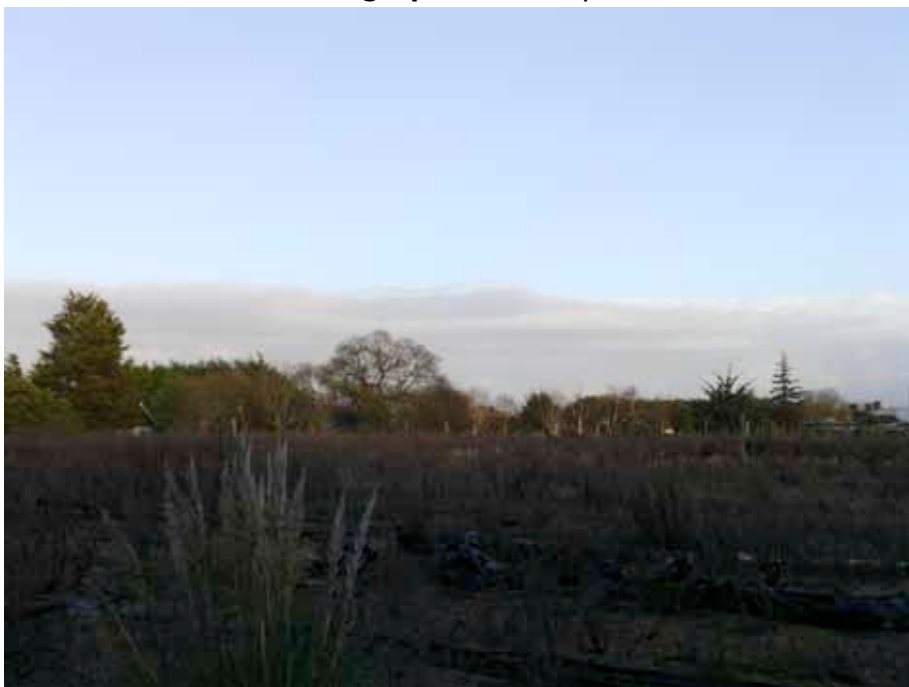
**Photograph 2 – Group G1**

3.5 Group G1 is a tree line situated on the road frontage along the northern site boundary. Species include Silver birch (*Betula pendula*), cherry (*Prunus avium*) and maple (*Acer spp.*). The trees are of poor condition, form and vigour. Poor pruning practice has been employed in the past and the trees possess abundant deadwood. Despite their prominent location on Toddington Lane, the poor condition of the trees affords them limited landscape value.
