Our ref. KT/21/LP2466v2

## **Re: LP2466 Elmgrove Road Additional Investigation and Testing**

Leap Environmental Ltd (hereafter referred to as **LEAP**) has been appointed by BoKlok Housing Ltd to undertake an additional investigation and testing of the ground at land off Elmgrove Road, Littlehampton, BN17 6AH.

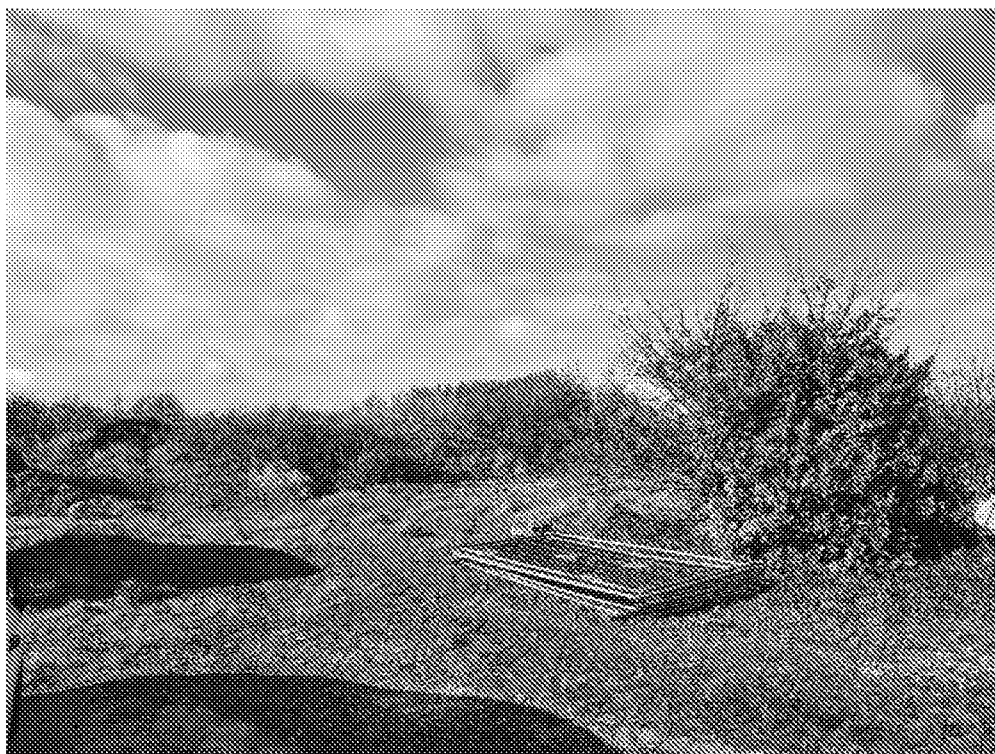
The western quadrant of the site is predominantly occupied by a large stockpile that is also covered by grass and scrub vegetation. The approximate dimensions of the western stockpile are ~83 m long by ~55 m wide and ~3.50 m high in places. 2No. trial pits were undertaken into this stockpile during LEAP's previous investigation. Ground conditions in the excavated areas comprised varying mixtures of clay, sand, and gravel. The gravel comprised flint, brick, and concrete, with rare asphalt, wood, tile, rubber seals, and plastic fragments. Organic odours were noted occasionally.

Plate 2: View of part of western stockpiles, facing west

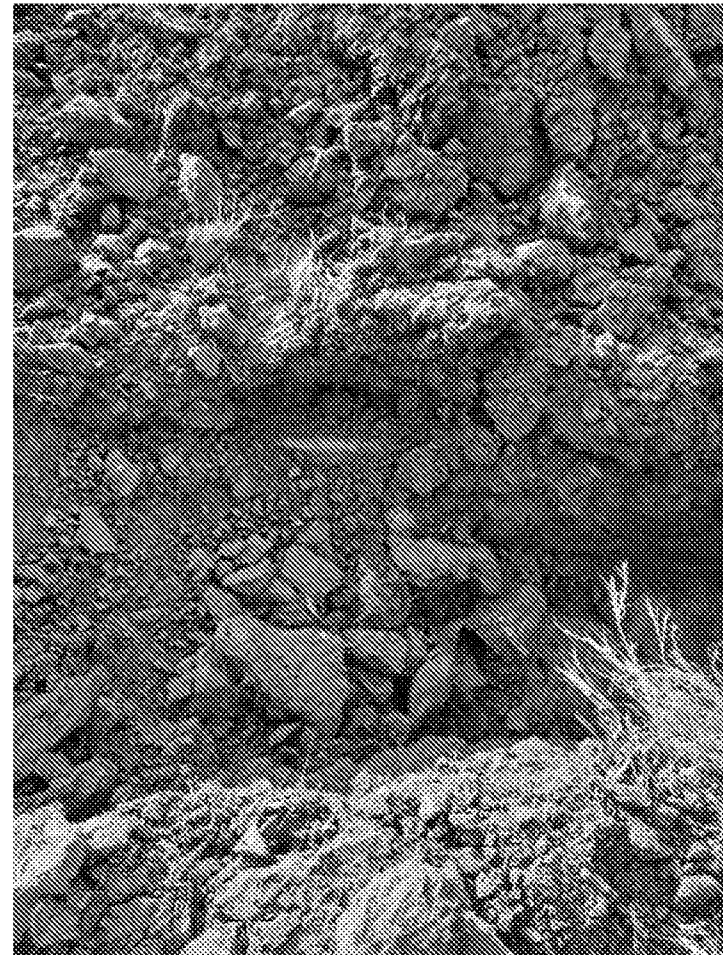
| Job Number | Trial Hole ID | Depth of Obstruction/Service | Comments |
|---|---|---|---|
| | TP227 | 0.3 | E-W oriented plastic pipe at 0.3m (50mm thick) |

Plate 6: Pipe encountered in TP227

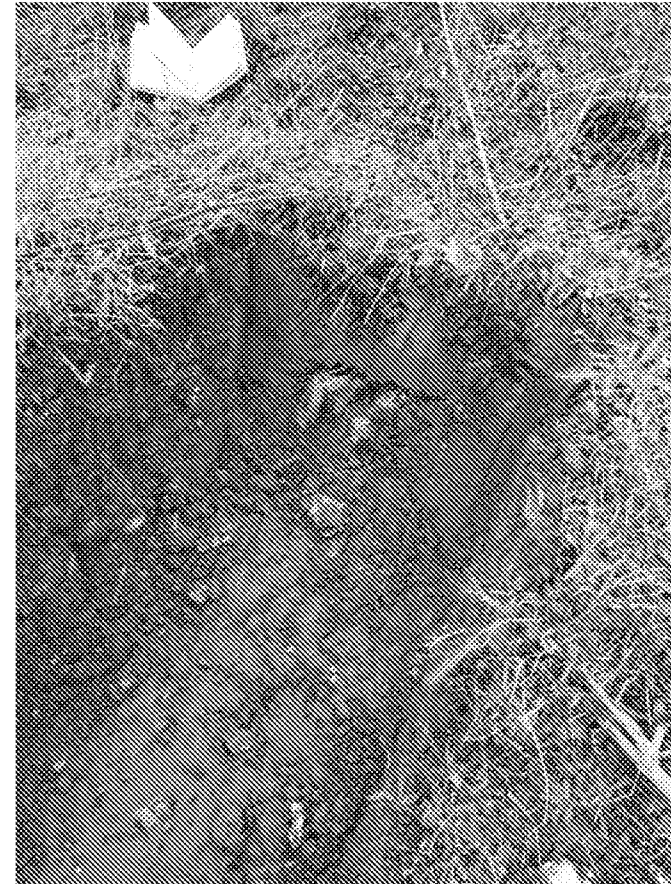
| Job Number | Trial Hole ID | Depth of Obstruction/Service | Comments |
|---|---|---|---|
| | TP207 | 0.25 | Electrical cable warning tape |

Plate 8: Electrical warning tape in TP207

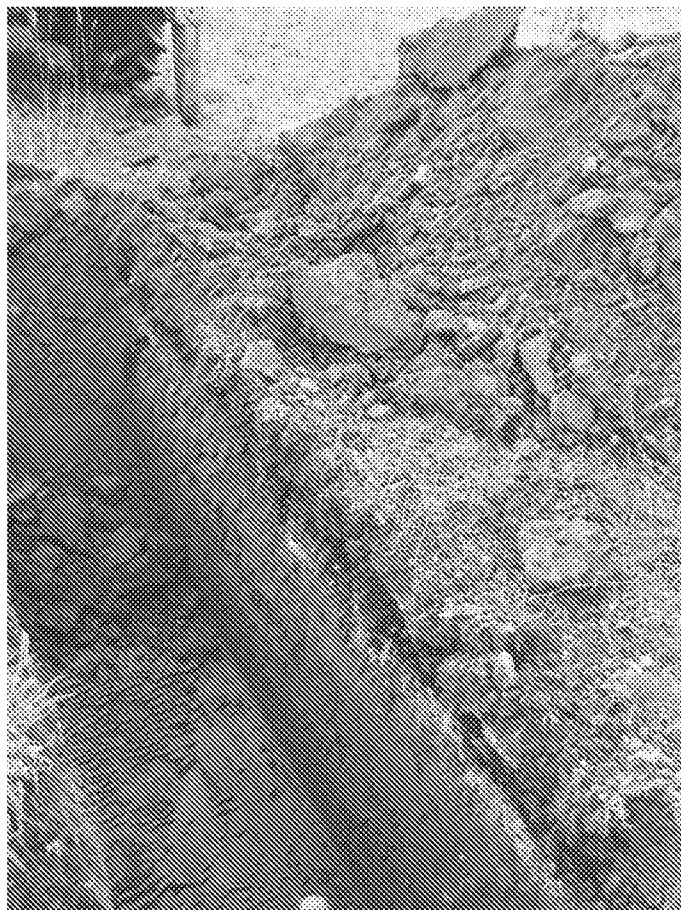
Plate 9: TP204

Blacktop was encountered at surface in TP2 and FP1 and beneath topsoil/made ground in TP204 (between 0.1 and 0.18mBGL) and 225 (between 0.4 and 0.5mBGL).

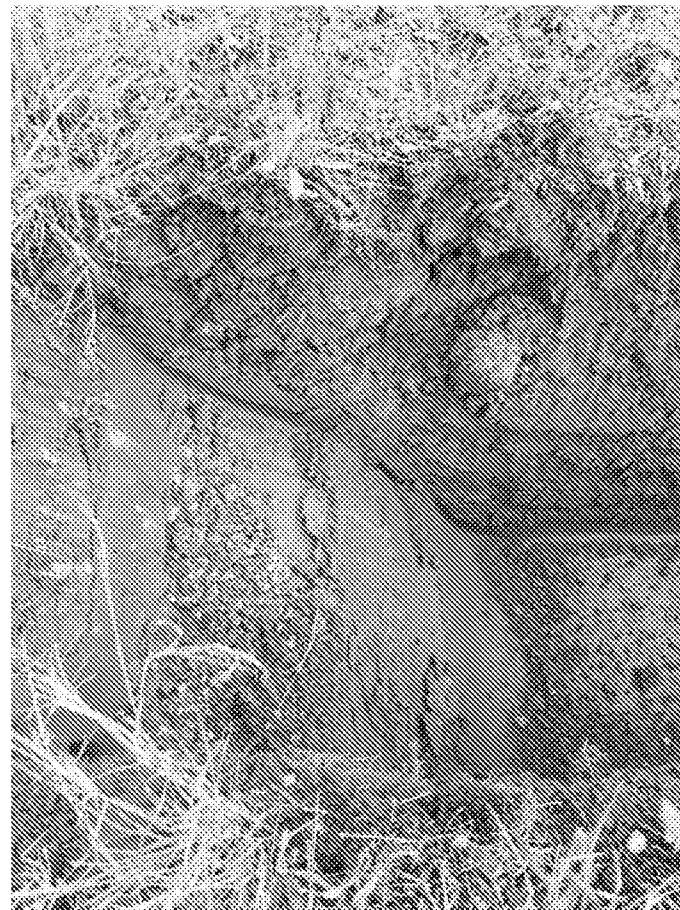
| Job Number | Trial Hole ID | Depth of Obstruction/Service | Comments |
|---|---|---|---|
| | TP206 | 0.3-0.45 | Shingle on northern side of pit |

Plate 10: Shingle in TP206

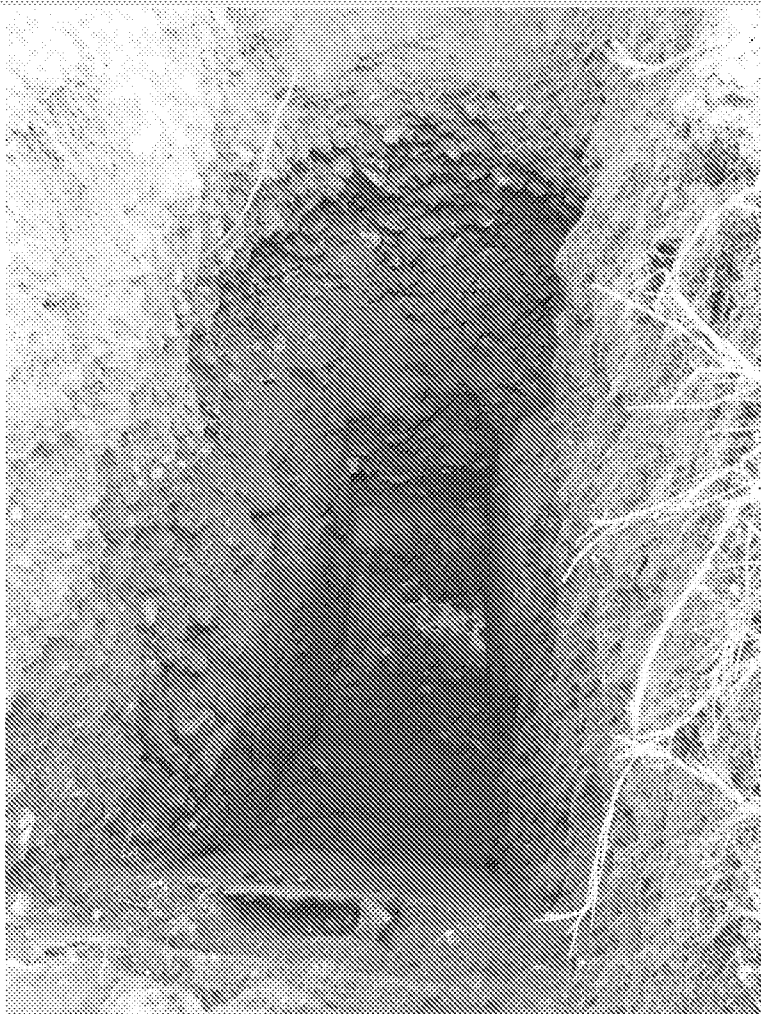
Plate 11: TP218

The deepest made ground (over 1m and up to 2.15m deep) was generally encountered in the central portion of the site, particularly in the vicinity of POS2. This deeper made ground is broadly located beneath the footprint of the previous school structures with shallow made ground encountered to the north (previous open space). Deep made in FP1 is considered likely to be due to a service which was encountered at 1.5m although this excavation was also targeted on the location of old foundations and their removal is likely to have disturbed the ground further. Based on service plans that LEAP has available, the service may be either BT or UKPN – these are both shown on the plans as being a few metres further east than where FP1 was excavated. The deep made ground in FP3 is due to a possible pad footing, which was encountered at 1.1mBGL. This was 300mm thick and 700x700mm wide. Deep made ground was also encountered within FP4 and TP218. FP4 was targeted on the location of potential historical foundations whilst TP218 is located within the footprint of the school structure.

| Job Number | Trial Hole ID | Date of Strike | Depth of Strike (mBGL) | Comments |
|---|---|---|---|---|
| | TP218 | 12/02/2021 | 1.4 | Fast seepage within made ground, accompanied by minor collapse. Water level rose by 5cm in approximately 5 minutes. |

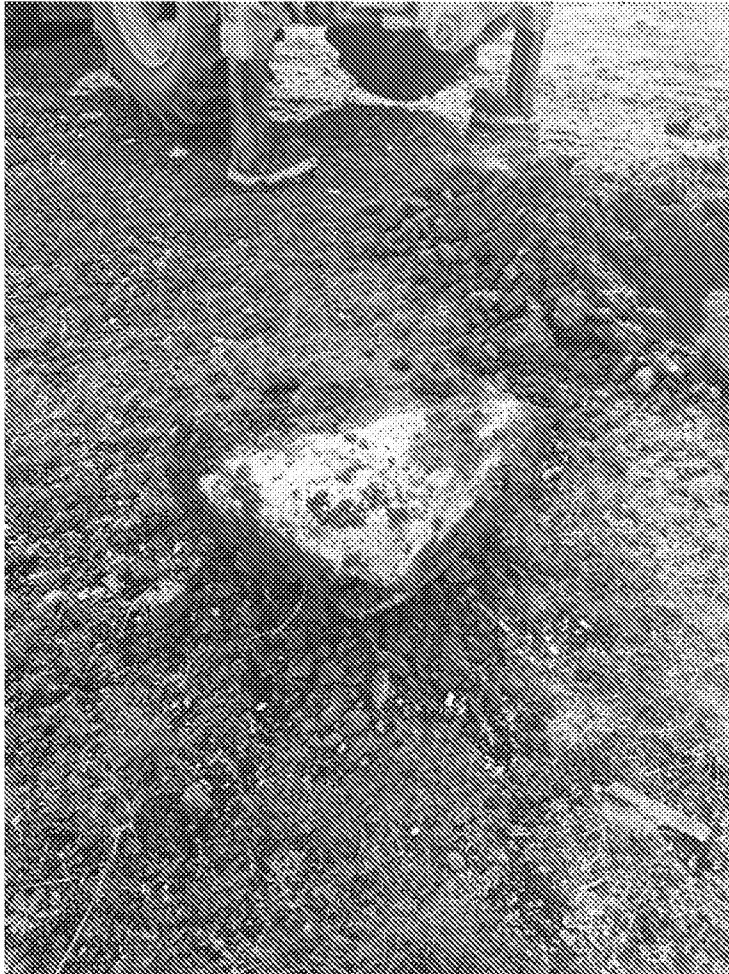
| Job Number | Trial Hole ID | Depth of Obstruction/Service | Comments |
|---|---|---|---|
| LP2466 | FP3 | 1.1 | Possible relict concrete pad footing (0.7x0.7x0.3m) |

Plate 13: Suspected footing recovered from FP3

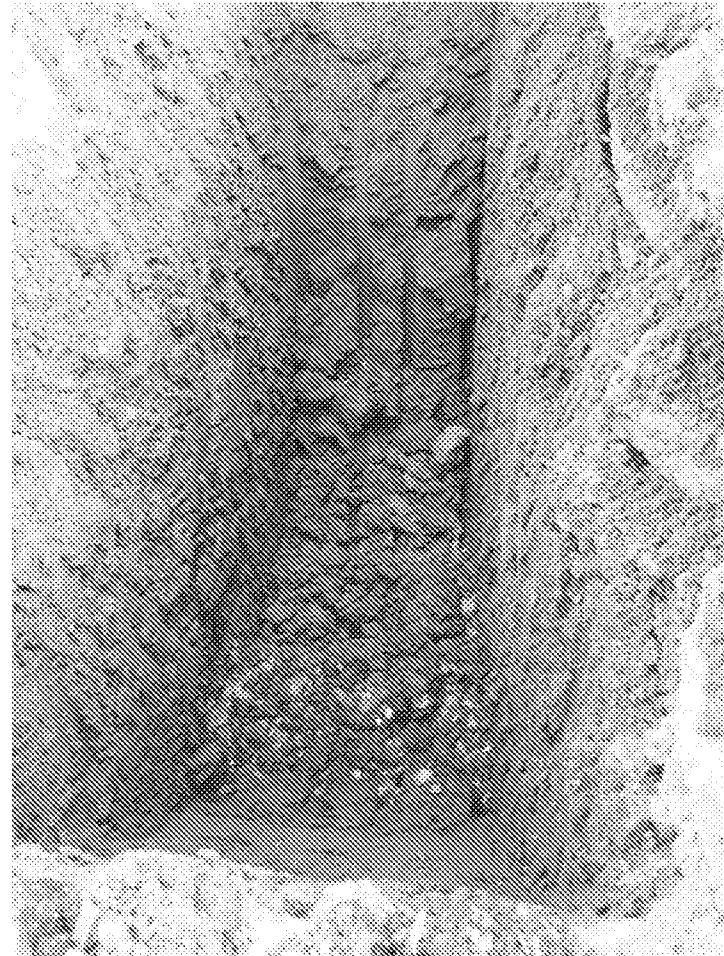
| Job Number | Trial Hole ID | Depth of Obstruction/Service | Comments |
|---|---|---|---|
| | FP1 | 1.5 | Concrete – possibly BT or UKPN |

Plate 14: Concrete obstruction in FP1
