## Re: LP2688 Elmgrove Road, Littlehampton - Additional Infiltration Testing

Leap Environmental Ltd (hereafter referred to as LEAP) was appointed by BoKlok Housing Ltd to undertake an additional investigation and testing of the ground at land off Elmgrove Road, Littlehampton, BN17 6AH. This was as per purchase order reference number PO-0603 dated 11 Aug 2021.

The proposed development comprises 80 No. modular residential dwellings and an apartment block consisting of 32 No. residential units. Residential houses include private rear gardens and there are two areas of public open space, one adjacent to the apartments (POS1) and one in the centre of the site (POS2). The development layout is shown in drawing ref LTH-ECE-ZZ-ZZ-SK-A-SL-5000 Rev P09, Appendix B.

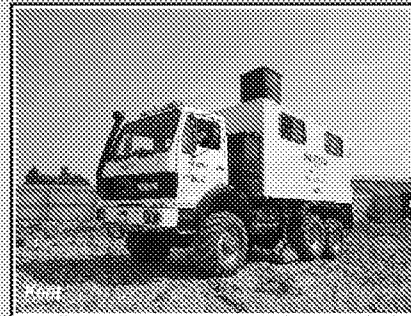
#### CPT RIG DIMENSIONS

This 6 x 6 wheeled drive CPT rig is ideal for geotechnical testing on hardstanding sites such as roads and car parks. It can also be used on dry non-hardstanding sites making it one of our versatile rigs as it can be deployed to many different types of site. It weighs 22 tonnes and can push up to 100-150 metres per day, depending on the ground conditions.
