Reference: 20241127P1

## **HYDROGEOLOGICAL ASSESSMENT AND GROUNDWATER MONITORING AT LAND WEST OF THE BRIDGE ROAD ROUNDABOUT, LITTLEHAMPTON, BN17 5DF.**

The site is located at Land West of the Bridge Road Roundabout, Littlehampton, West Sussex, BN17 5DF.

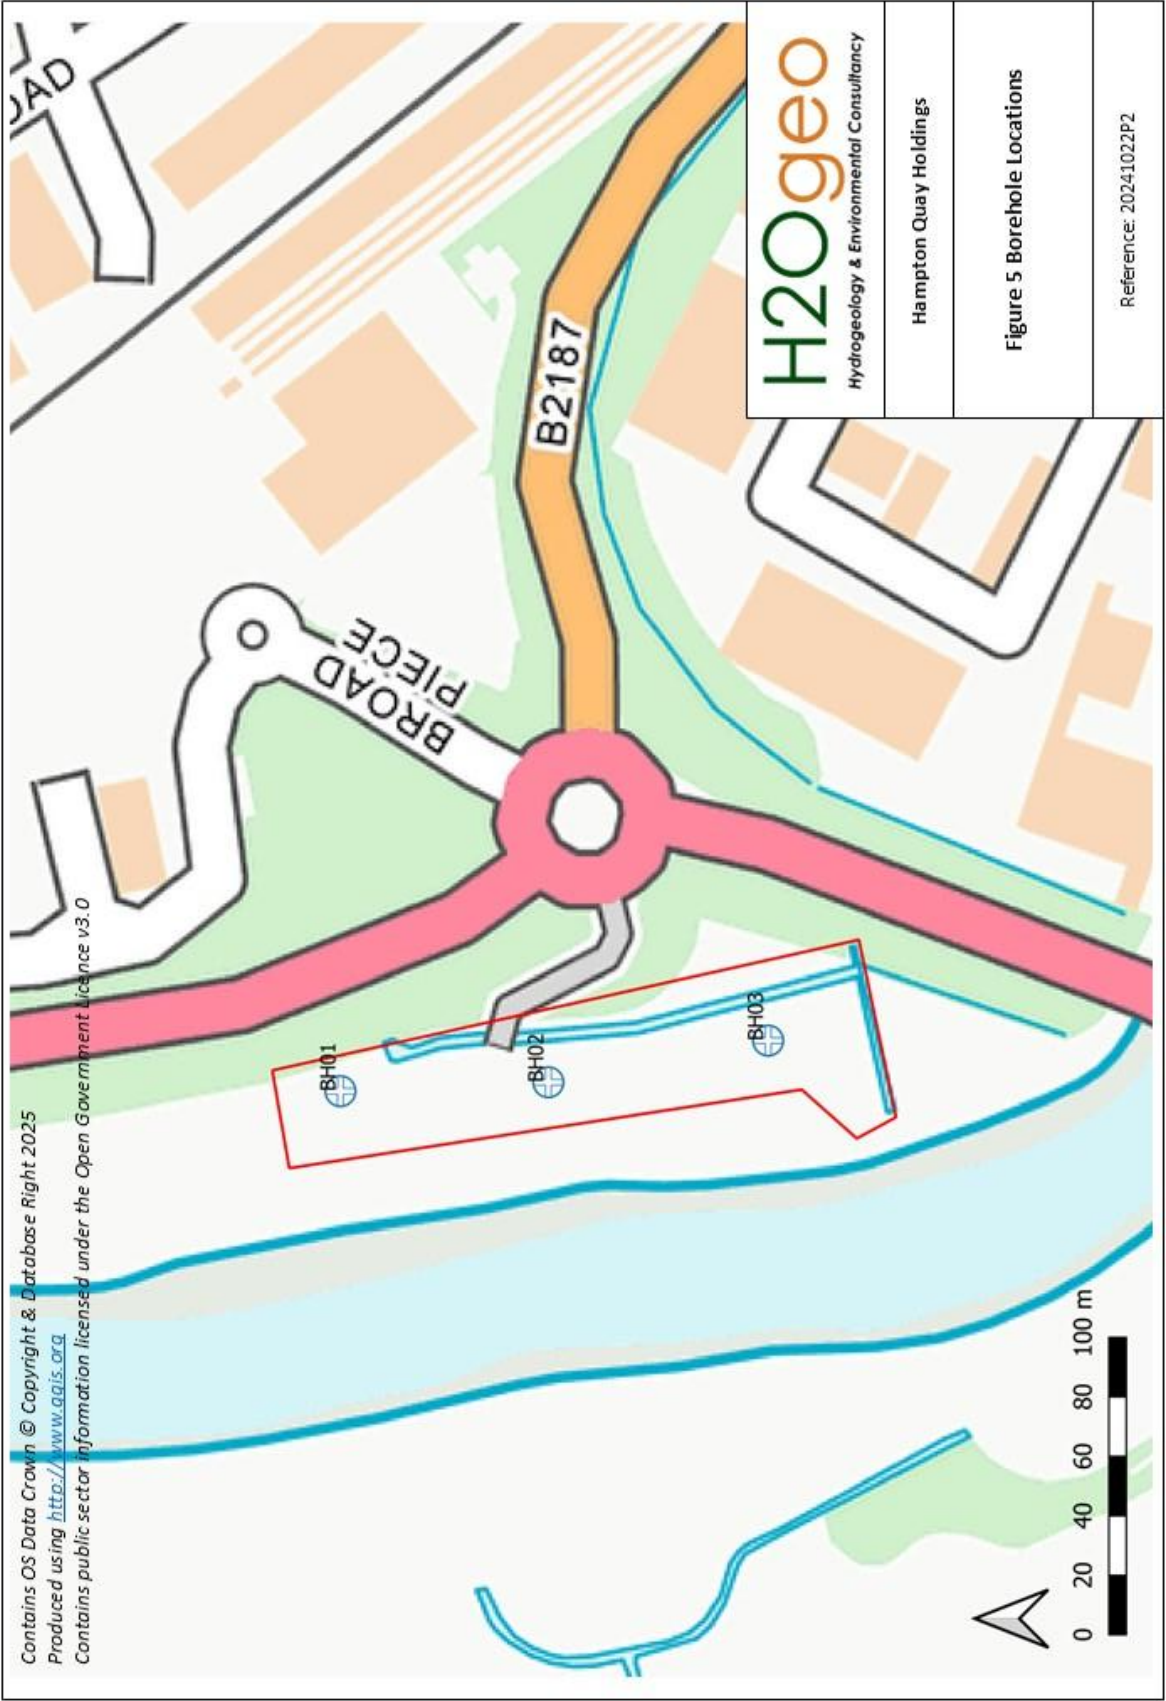
Figure 5 Borehole Locations

A 1.2m hand-dug pit was excavated to check for services/utilities at each location, none were encountered. A windowless sampling rig was used to progress each borehole to 5.0mbgl that were then installed with 2 metres of 50mm slotted casing and up to three metres of plain casing.

BH01 collapsed to 4.3mbgl and was installed with 2.3m plain casing and 2m slotted whilst Borehole 2 and 3 collapsed to 4.7mbgl so only 2.7m of plain casing installed with 2m slotted at the toe.

Borehole details are presented in the following table and locations in Figure 5:

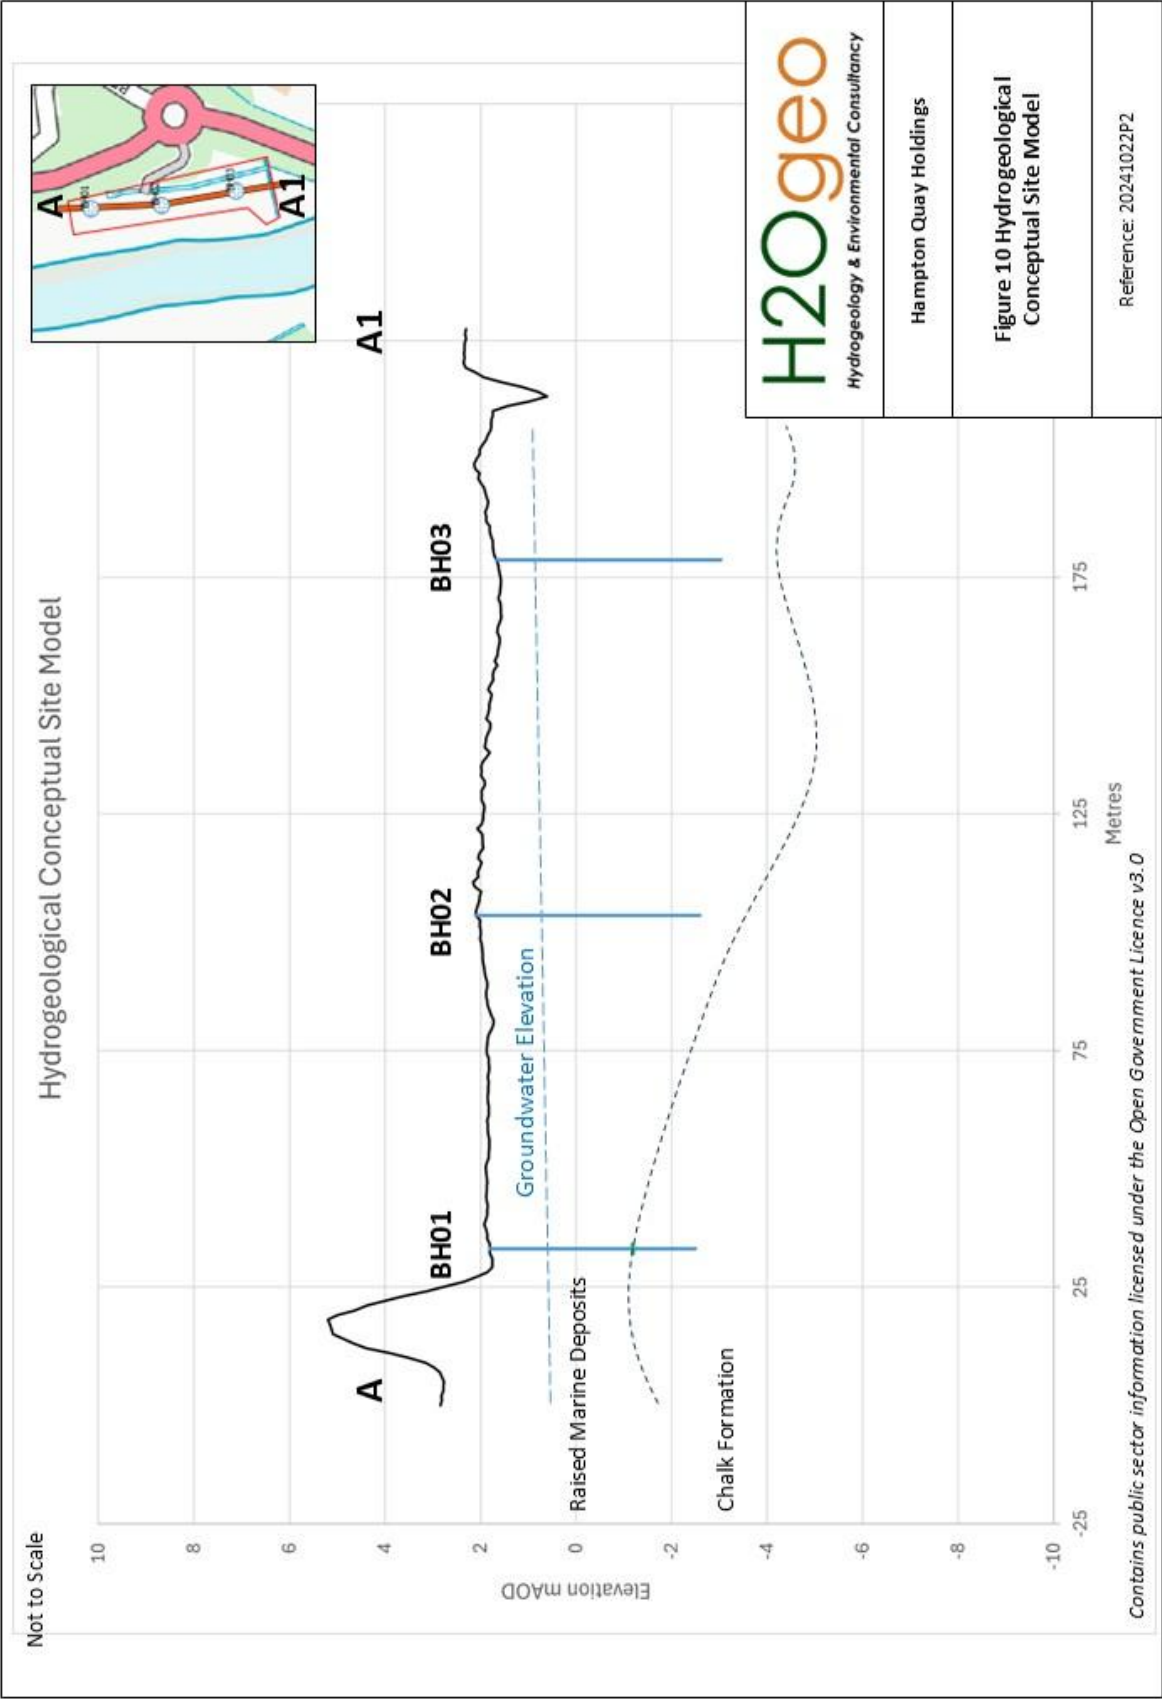
Figure 10 Hydrogeological Conceptual Site Model

The HCSM is presented in Figure 10 and discussed in the following section.
