# **Verification Report – Volume I**

**SGN Littlehampton Holder Station at Harwood Road,  
Littlehampton**

Document No. Rev 0: 415001-00022\_09704  
June 2026

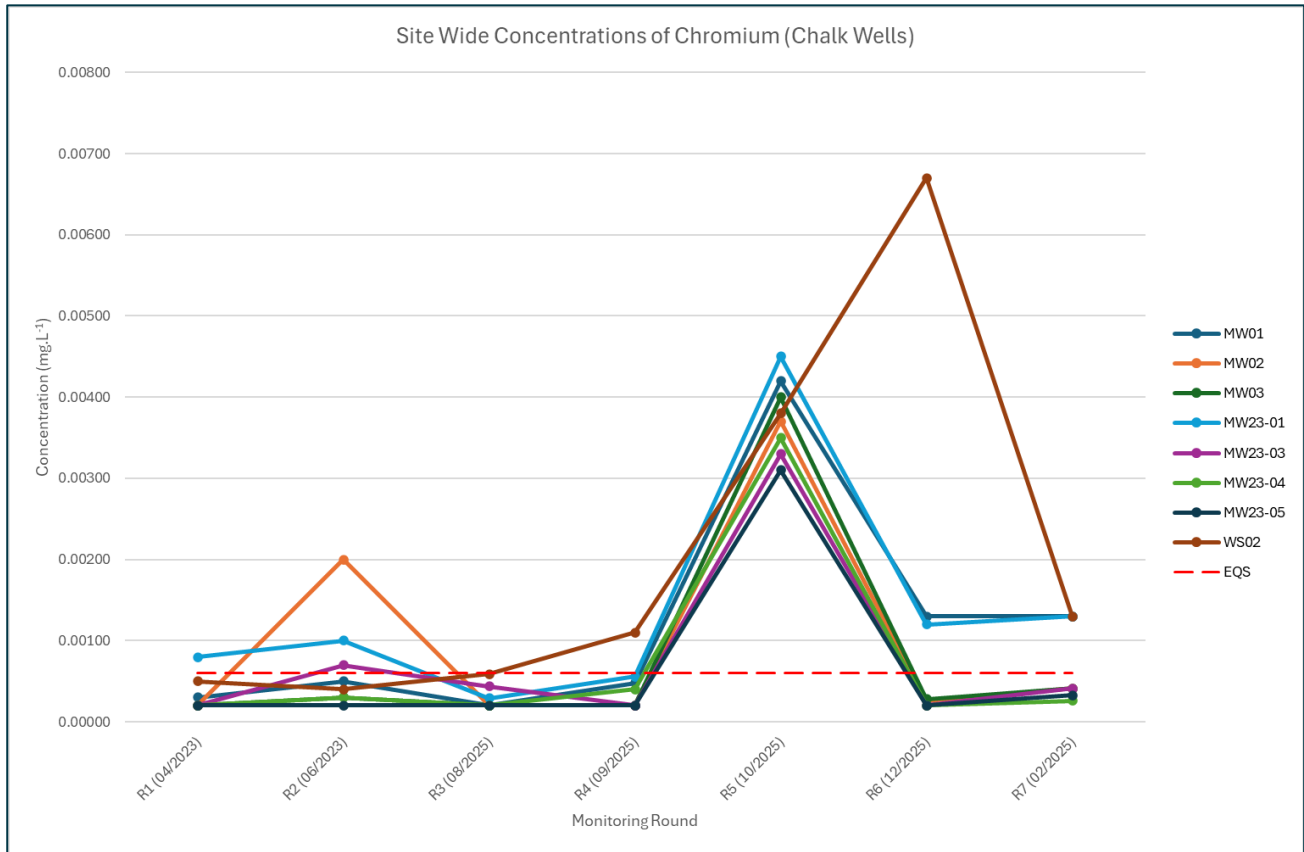
Following the site wide peak in R5, recorded concentrations at each of the monitoring well locations have returned to within  $0.0002 \text{ mg.L}^{-1}$  of recorded concentrations in 2023, with the

exception of MW01 (within  $0.001 \text{ mg.L}^{-1}$ ), MW23-01 ( $0.0005 \text{ mg.L}^{-1}$ ) and WS02 ( $0.0008 \text{ mg.L}^{-1}$ ).

Figure 1 Recorded Concentrations of Chromium in Chalk Wells across the Site

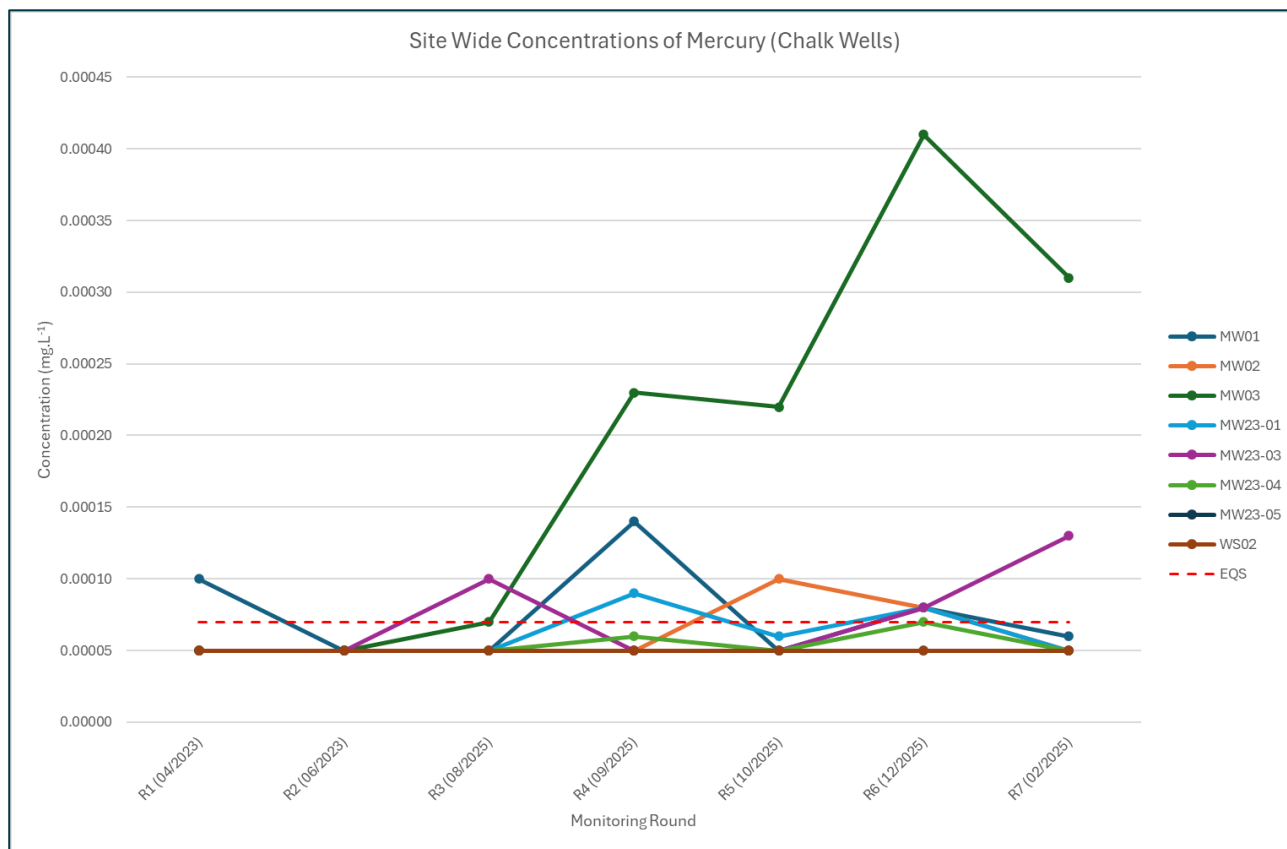
Fluctuations in recorded concentrations are also noted to be similar across the site, with increases observed in R4 and R6 in the majority of wells at the site, with a general fall in concentration recorded site wide in R7.

These site wide trends in concentration indicate that the variability in the dissolved phase concentrations is unlikely to be associated with the works undertaken at the site, but reflect changes within the wider aquifer.

Figure 2 Recorded Concentrations of Mercury in Chalk Wells across the Site

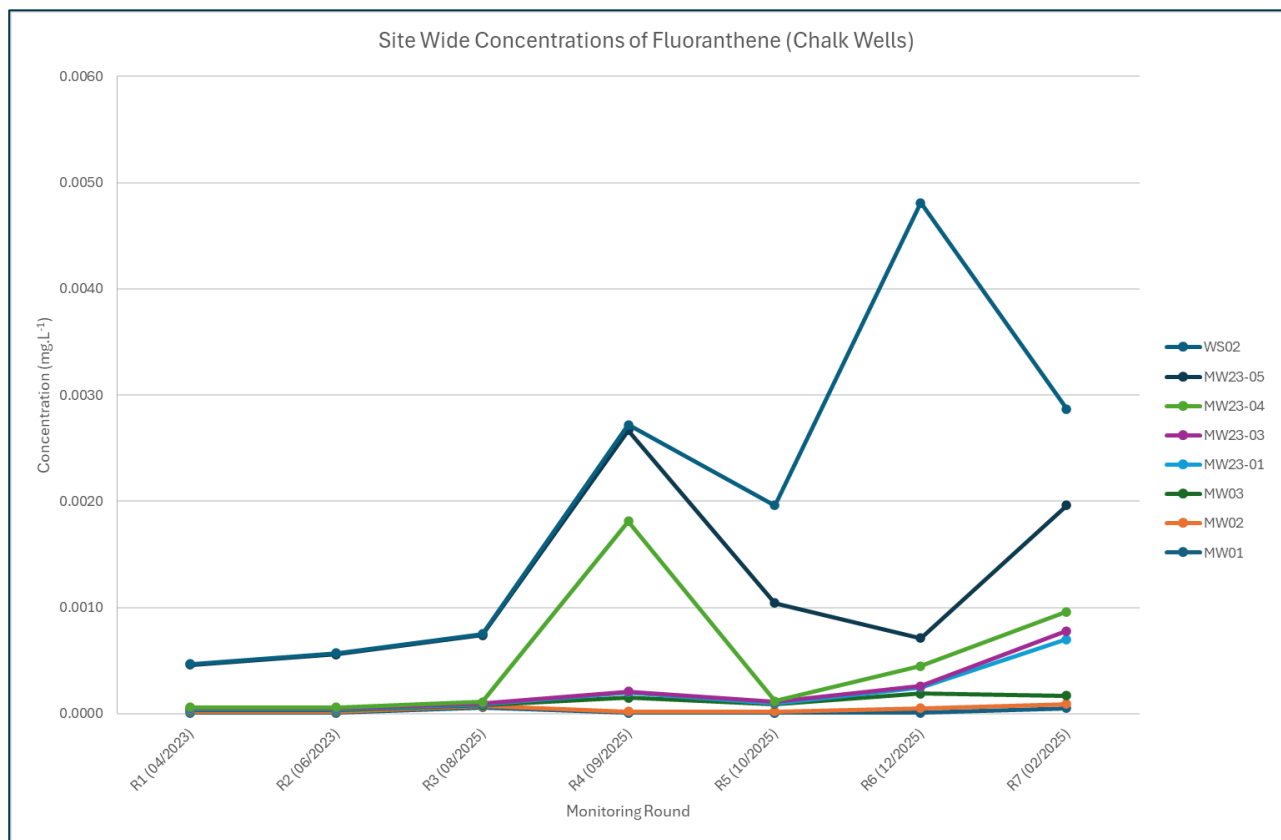
Concentrations of fluoranthene are also noted to have a similar trend in each of the monitoring wells across the site (Figure 3 below), with changes in concentration mirrored across the site. Changes are more marked in WS02, MW23-05 and MW23-04. WS02 is located to the south of the above ground gasholder and MW23-05 and MW23-04 are located on the eastern site boundary, proximal to the off site wider former gasworks.

Figure 3 Recorded concentrations of Fluoranthene in Chalk Wells across the Site

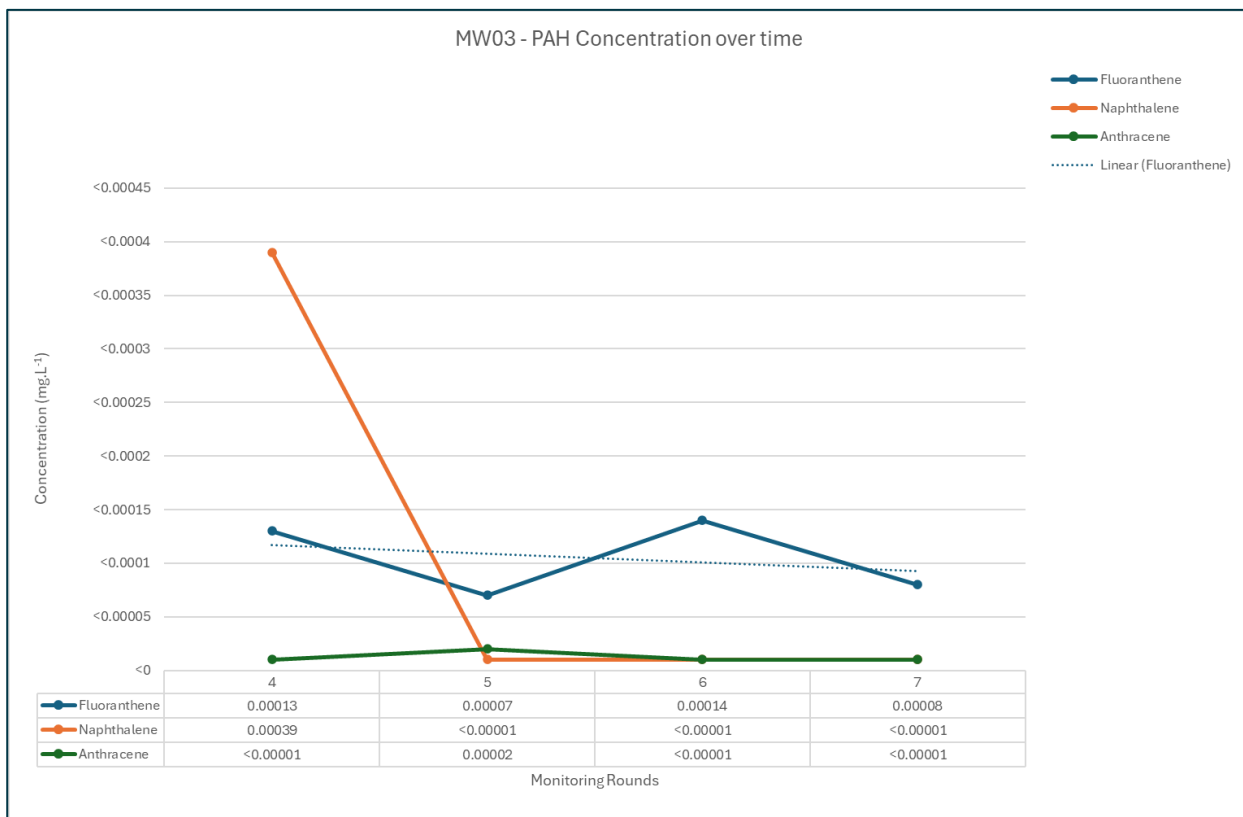
- **MW03 (Chalk)**
  - **PAH**
    - Exceedances of fluoranthene recorded in R4 to R7. Concentrations were below the Laboratory Limit of Detection (LOD) in all other rounds.

- Recorded concentrations of naphthalene are also recorded in excess of the EQS in rounds R1 and R3. All other rounds report the concentrations below the LOD.
- Recorded concentrations of naphthalene have decreased over time, with concentrations below the LOD in R4 to R7. Recorded concentrations of fluoranthene, whilst in excess of the EQS are also noted to decrease through R3 (pre-works) to R7 (post-works), as illustrated in Figure 5 below.

Figure 5 MW03 (Chalk) Recorded Concentrations of PAHs

- As noted above, fluoranthene has low mobility within groundwater, therefore the recorded concentrations in MW03 are unlikely to pose an unacceptable risk to the River Arun within a reasonable timeframe.

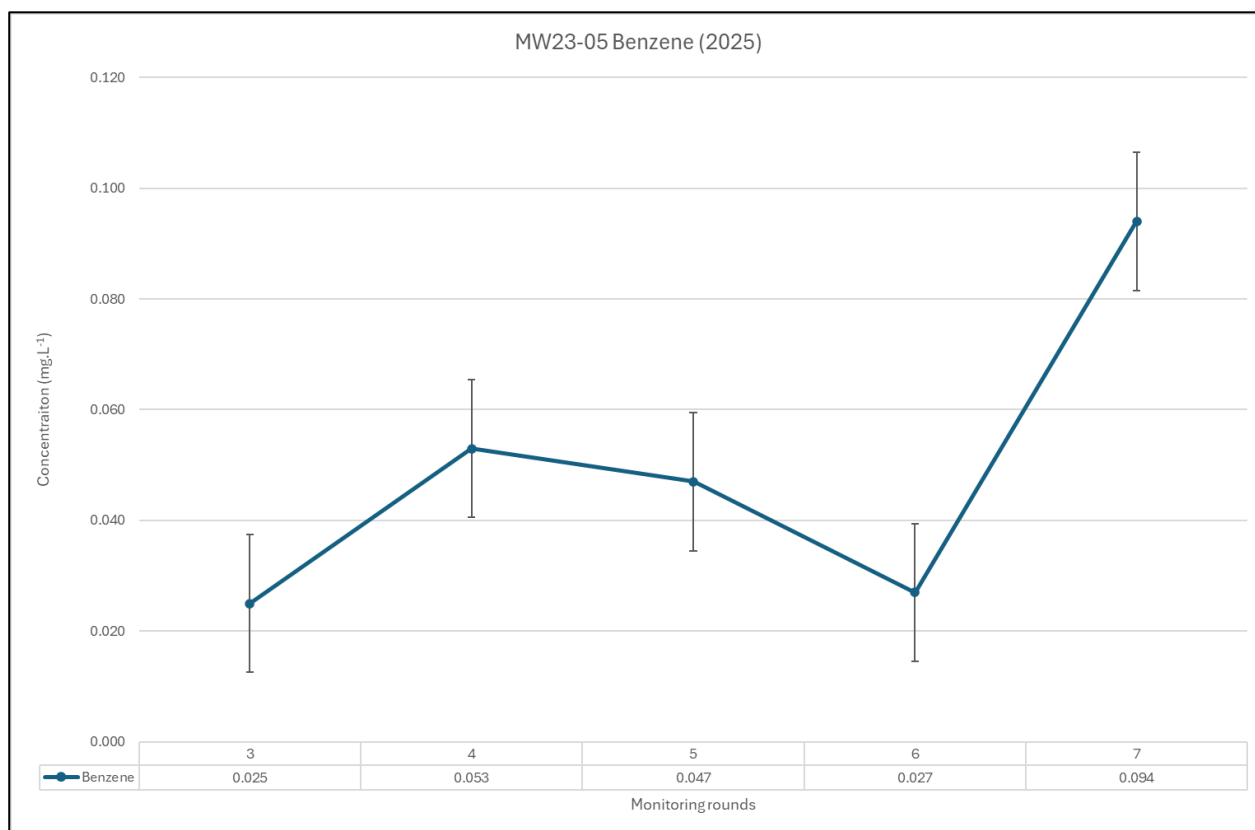
- Recorded concentrations of benzene exceed the EQS in all seven monitoring rounds. Concentrations are noted to increase between R1 and R4, but then fall between R4 and R6. An uncharacteristic peak is noted in R7.

Figure 6 MW23-05 (Chalk) Recorded Concentrations of Benzene R3-R7

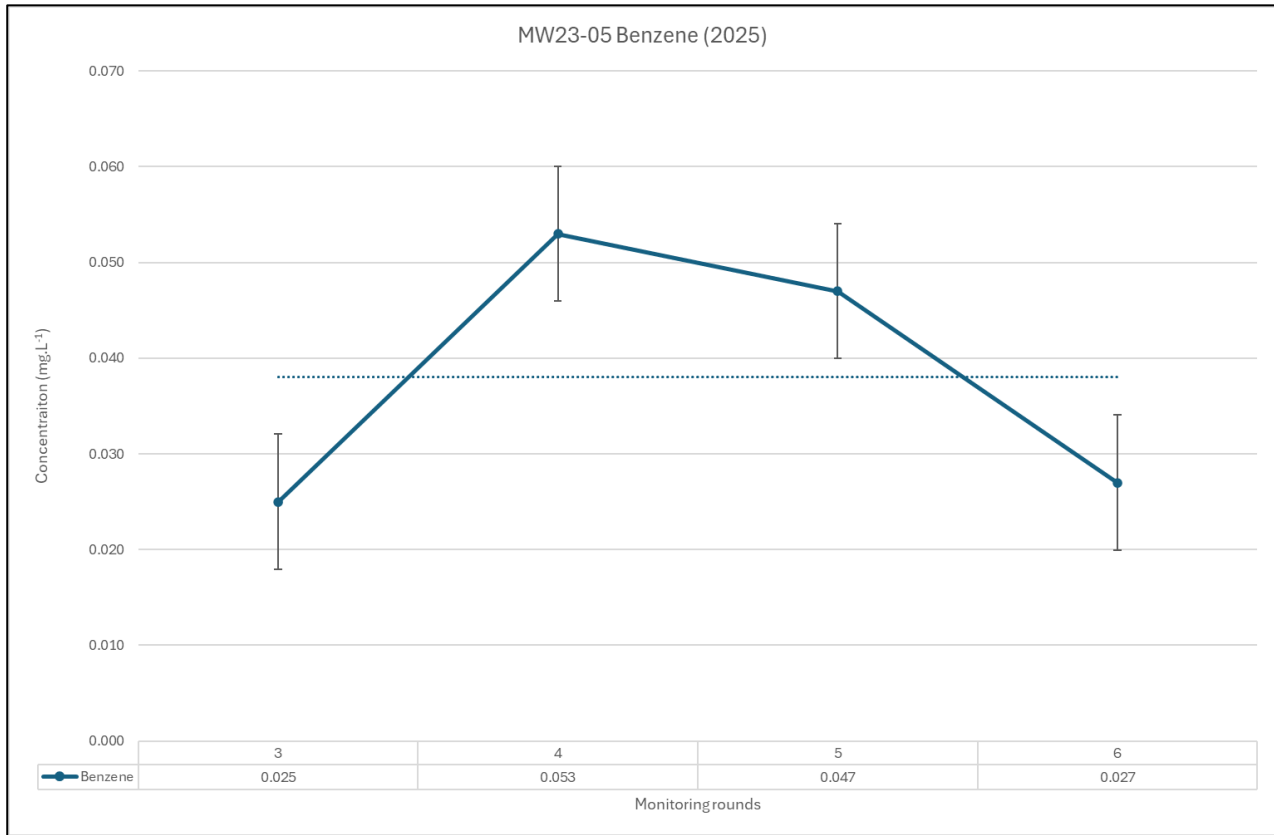
- Using data from 2025 and excluding the anomalously high concentration in R7 the data indicates a flat trendline, with some variability in concentration, but a consistent trend.

Figure 7 MW23-05 (Chalk) Recorded Concentrations of Benzene R3-R6 (with trendline)

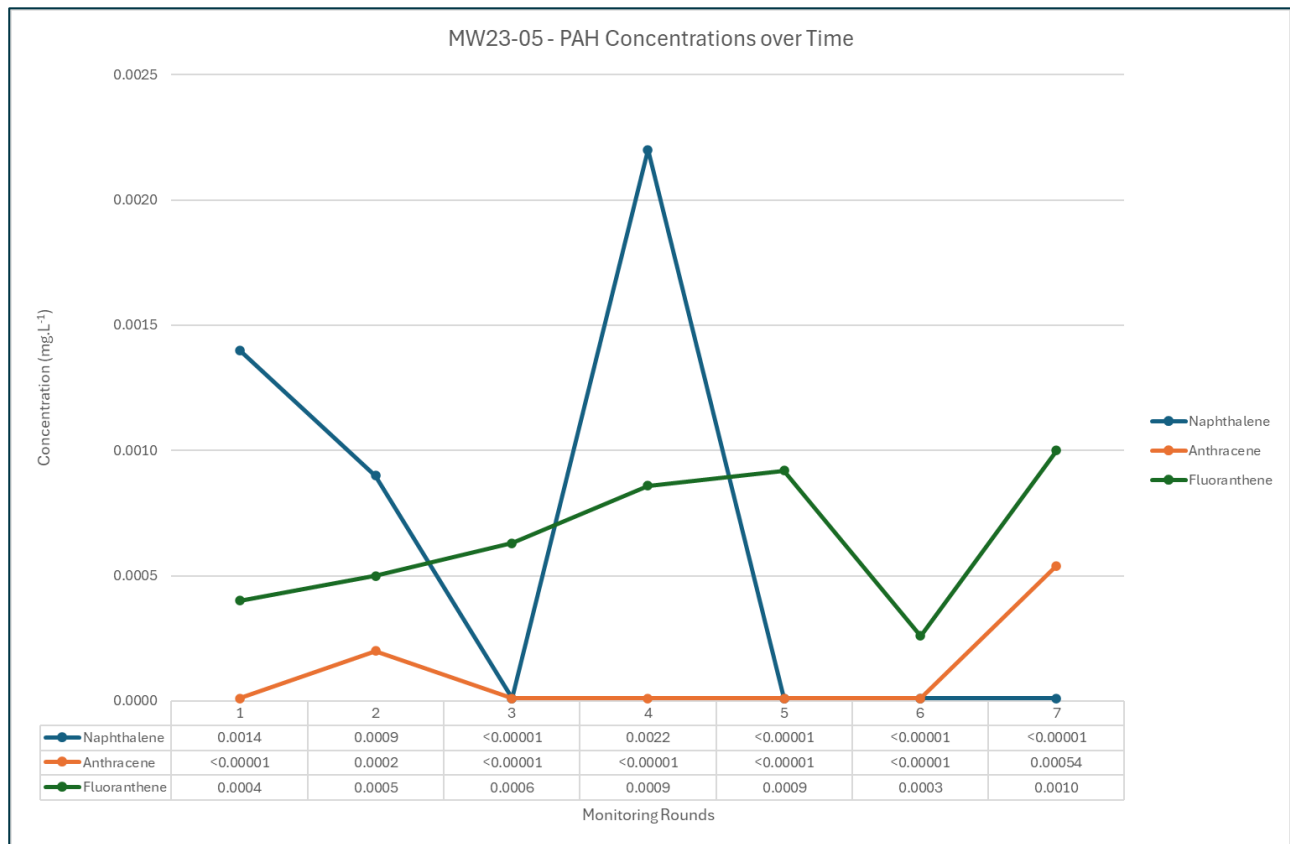
- Recorded concentrations of naphthalene, anthracene and fluoranthene exceed the EQS within MW23-05.
- A single exceedance of naphthalene was recorded in R4. This exceedance ( $0.0022 \text{ mg.L}^{-1}$ ) is only marginally in excess of the EQS ( $0.002 \text{ mg.L}^{-1}$ ). Recorded concentrations in R5 to R7 are all below the LOD ( $<0.00001 \text{ mg.L}^{-1}$ ).
- Two exceedances of the EQS for anthracene ( $0.0001 \text{ mg.L}^{-1}$ ) are recorded, in R2 and R7. All other rounds are noted to be below the LOD. Recorded concentrations of anthracene in R7 are anomalously elevated with respect to the dataset.
- Concentrations of fluoranthene are recorded in excess of the EQS in each of the monitoring rounds. Concentrations are noted to decrease between R5 and R6, with a spike in concentration in R7.

Figure 8 MW23-05 (Chalk) Recorded Concentrations of PAHs

- Based on the decreased trend in concentration of naphthalene and the low mobility of the PAH in groundwater, the recorded concentrations of PAH at MW23-05 are unlikely to pose a risk to the River Arun within a reasonable timeframe.
- Metals
  - There is a single exceedance of the EQS for chromium in R5, with concentrations falling by an order of magnitude by R7.
  - Given the low level and occasional exceedances, recorded concentration of the chromium are unlikely to pose an unacceptable risk to the River Arun.
- **WS02 (Chalk)**
  - PAH
    - Recorded concentration of fluoranthene, benzo(b)fluoranthene, benzo(k)fluoranthene, benzo(a)pyrene and benzo(ghi)perylene were in excess of the EQS at WS02. These exceedances are predominantly recorded in R5, R6 and R7. Concentrations of the PAH are noted to peak in R6.

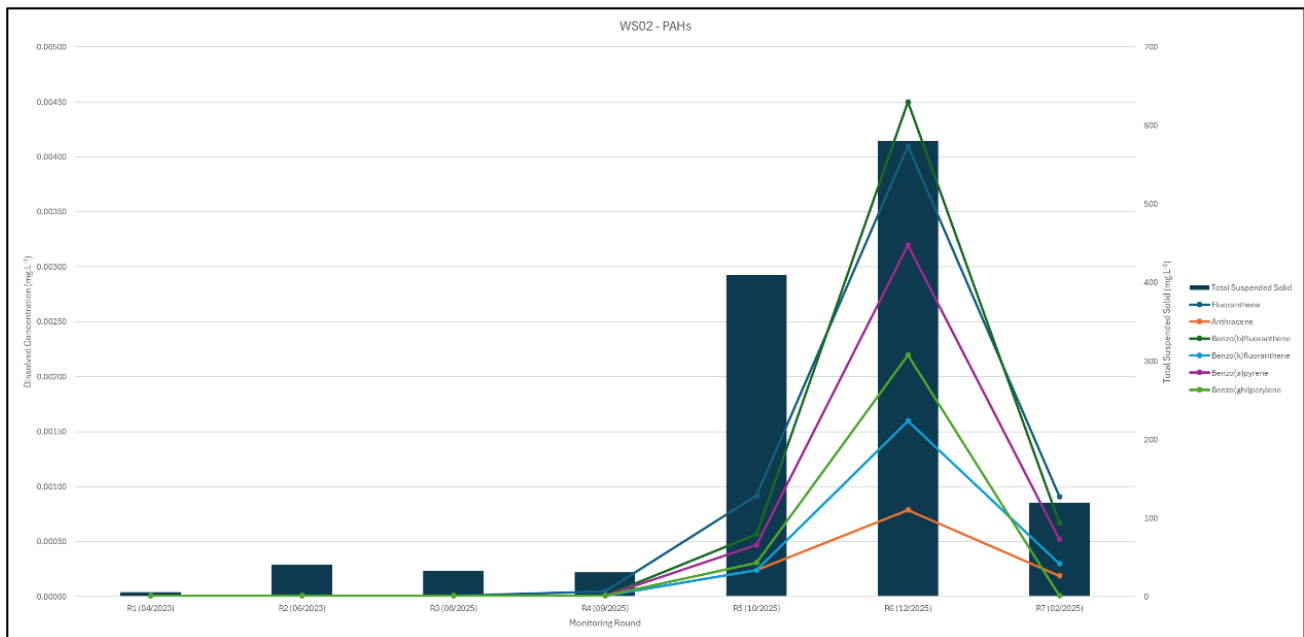
Figure 9 WS02 (Chalk) Recorded Concentrations of PAHs

- Visual observations during these groundwater monitoring rounds recorded that the purged waters contained sediment or were opaque. Total Suspended Solids (TSS) were recorded in excess of  $120 \text{ mg.L}^{-1}$  in each of the rounds, with R6 recording concentrations of  $580 \text{ mg.L}^{-1}$ . The levels of TSS in the recovered samples from R5 to R7 indicate a high degree of turbidity/ sediment load.

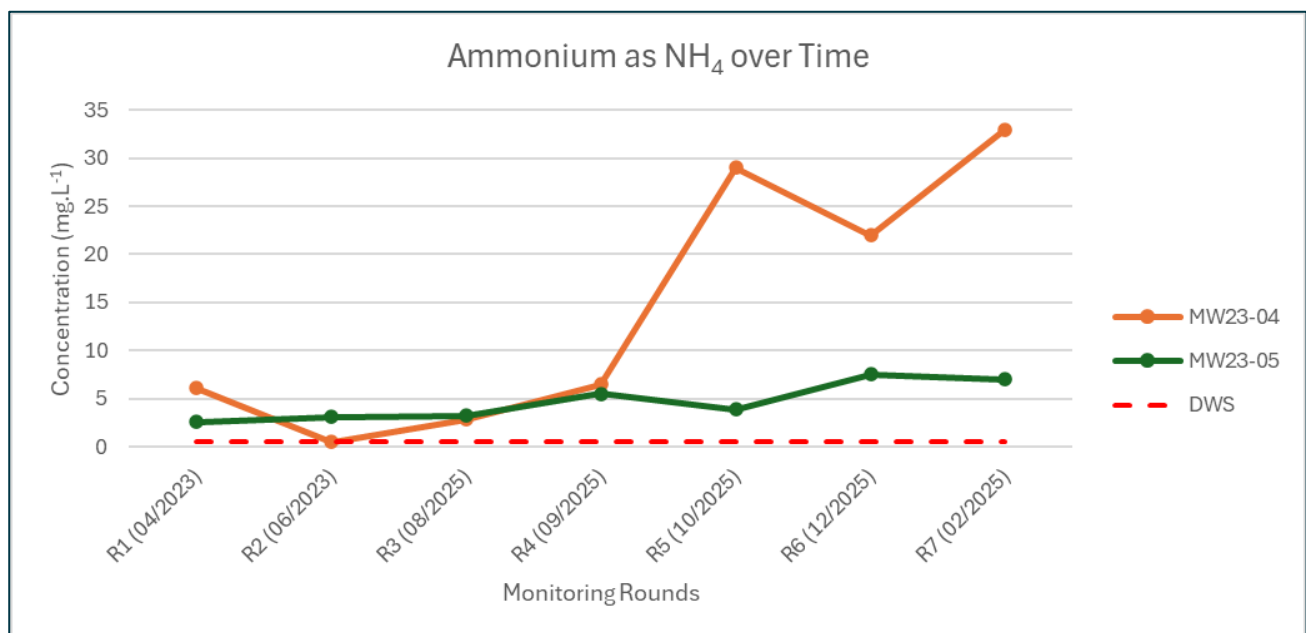
Figure 10 Recorded Concentrations of Ammonium as  $\text{NH}_4$  in MW23-04 and MW23-05

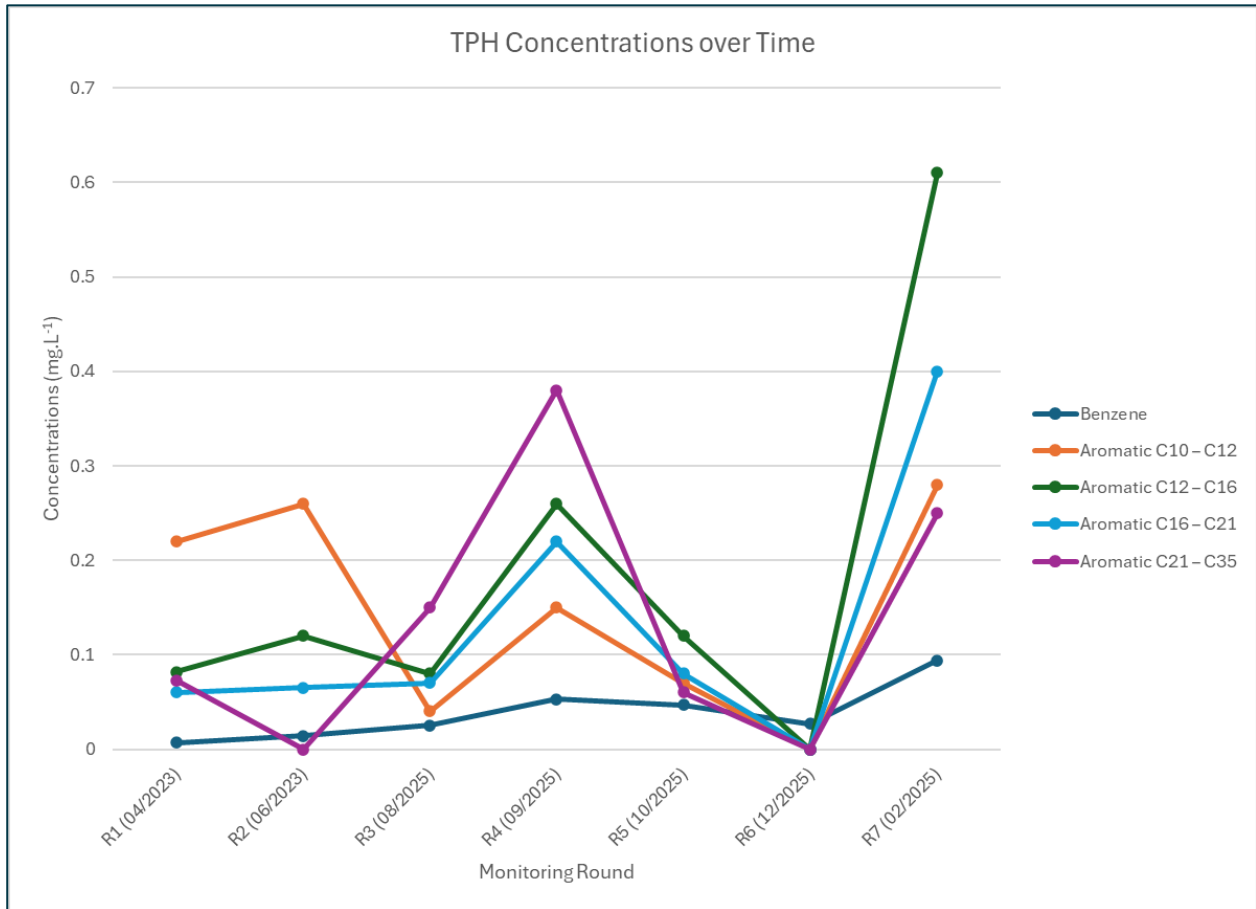
- Concentrations of TPH aromatic C10-12 exceed the DWS in four monitoring rounds (R1, R2, R4 and R7), TPH aromatic C12-16 in four monitoring rounds (R2, R4, R5 and R7), TPH aromatic C16-21 in three monitoring rounds (R2, R4 and R7) and TPH aromatic C21-35 in three monitoring rounds (R3, R4 and R7). All TPH fraction are noted to have decreased to below the LOD in R6, with a spike noted in R7 (Figure 11 below).

Figure 11 Recorded Concentrations of TPH Fractions and Benzene in MW23-05 (R1 to R7)

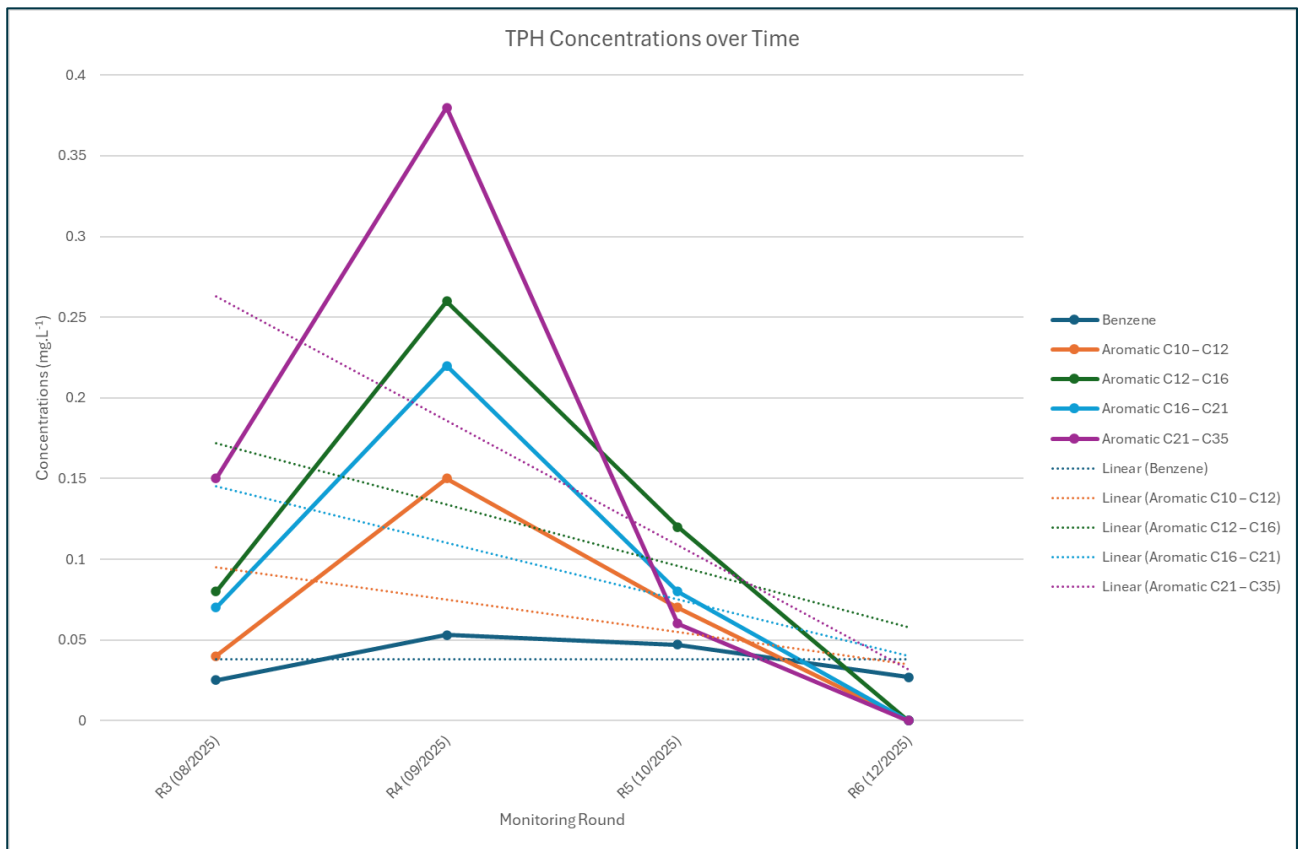
- A similar trend is noted for all TPH, with concentrations peaking in R4, before falling in R5 and R6 and spiking in R7. Pre (R3) and post works (R5) concentrations (2025) are noted to be comparable for the majority of fractions, with decreasing trendlines through R5 and R6 (Figure 12 below).

Figure 12 Recorded Concentrations of TPH Fractions and Benzene in MW23-05 (R3 to R6)
