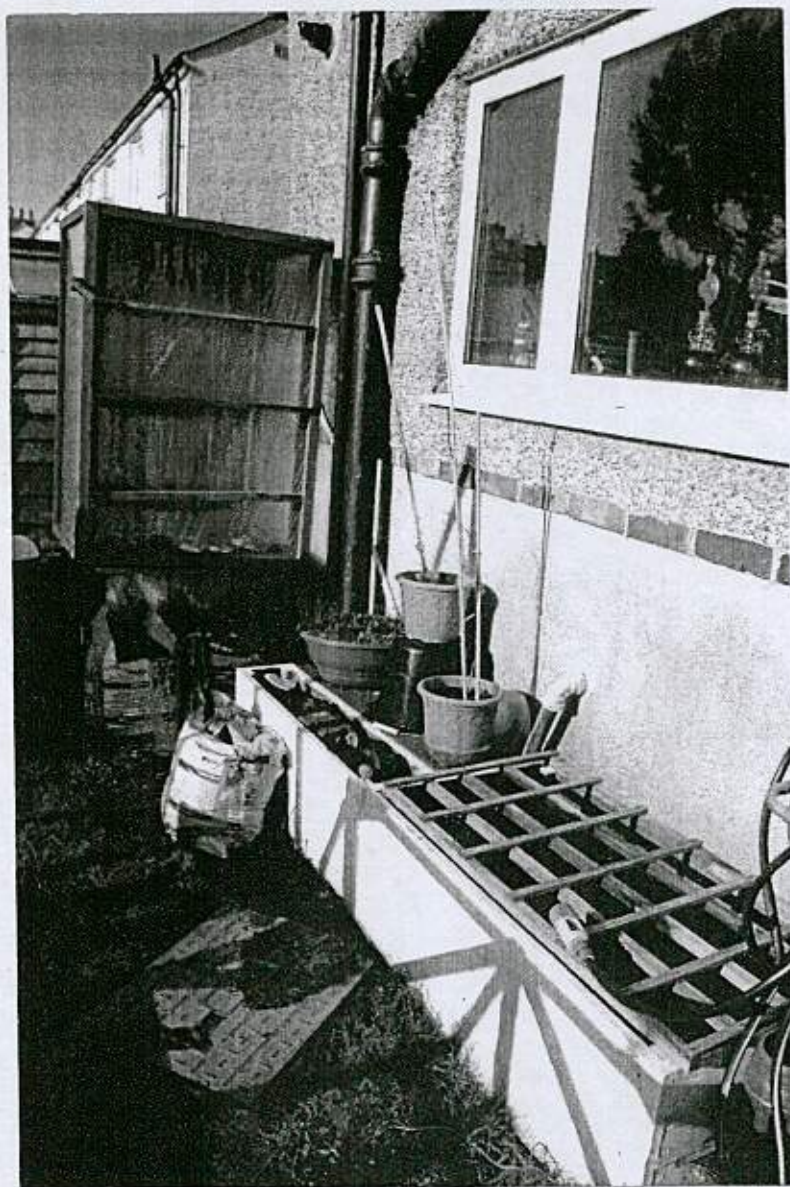
Photo taken in the back garden of No 44 North St. looking towards No 42 showing relationship of MH to back of house and soil and waste pipes.

Note location of soil pipes of No 42 which discharge into a MH in a similar relationship to that shown below but with drain flowing towards Sussex St.

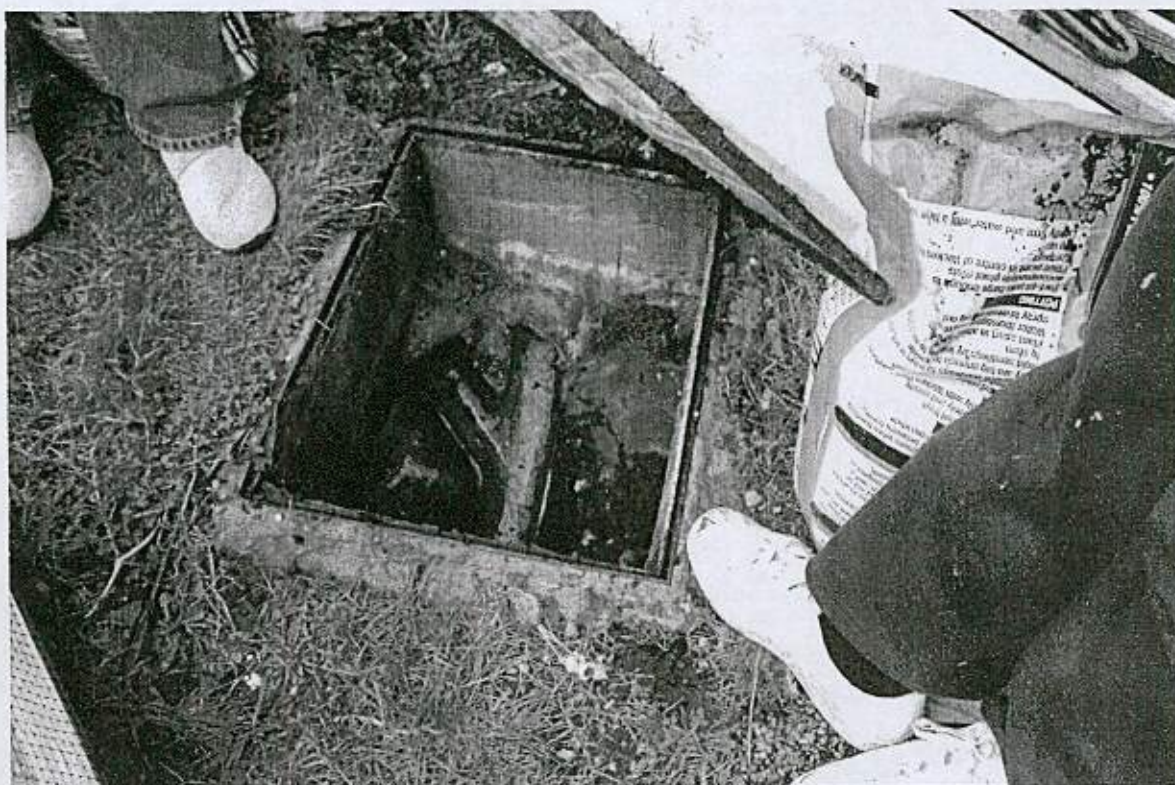
MH at the back of No 44, with the cover off, showing clearly the direction of flow down the back of the terrace to discharge into the sewer at the side of No.50
