**PHASE I GEO-ENVIRONMENTAL ASSESSMENT**  
**for the site at**  
**THE LAND AT TODDINGTON LANE, WICK, WEST SUSSEX, BN17 7PP**  
**on behalf of**  
**RABBIT WASTE MANAGEMENT LTD**

| <b>Development:</b> | <b>RESIDENTIAL DEVELOPMENT</b> |
| <b>Date:</b> | <b>11<sup>th</sup> MAY 2017</b> |
| <b>Reference:</b> | <b>LS 2711</b> |

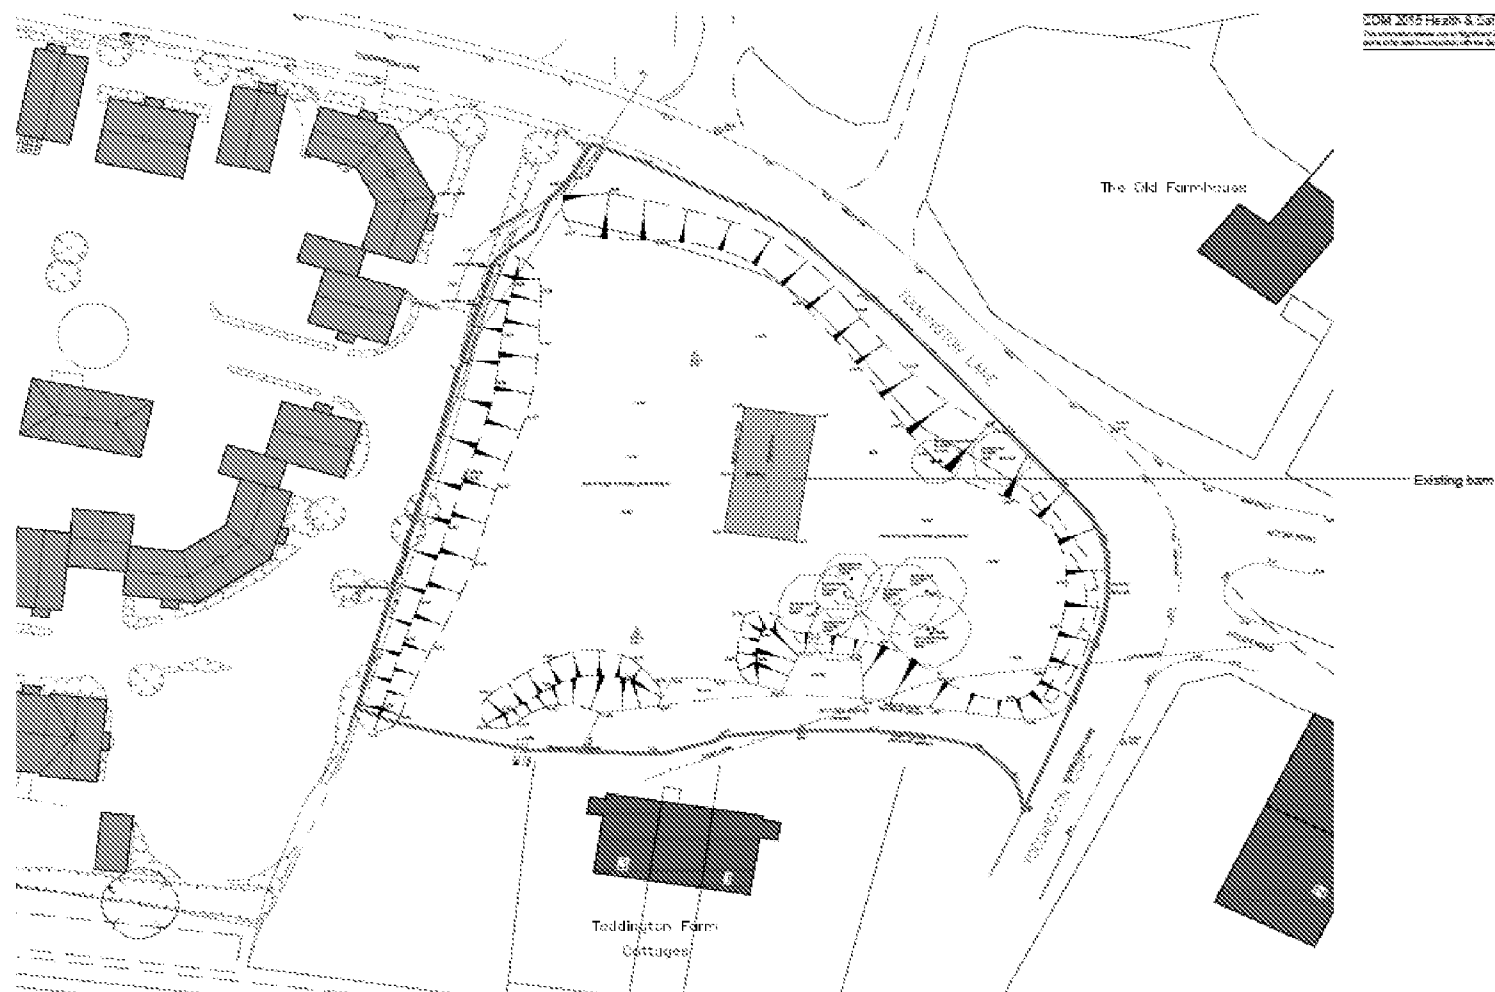
| <b>CLIENT:</b> | Rabbit Waste Management Ltd | <b>FIGURE:</b> | 2 | <b>DATE:</b> | 11/05/2017 |

The area under investigation comprised a two-storey warehouse and a large yard area. The layout of the existing site is indicated on Figure 2, and a walkover survey is presented in section 3.0. The area was approximately 0.36 hectares. It was understood that the Client was in ownership of the site, and that this investigation was not a pre-purchase appraisal.
