**INTERIM VERIFICATION REPORT (SOIL COVER SYSTEM)**

**PLOTS 40-41, CORNFIELD CLOSE,**

**THAKEHAM CLIENT LTD**

| <b>Reference:</b> | <b>GE18103/INTVR-SOIL/PLOTS 40-41/MAR21</b> |

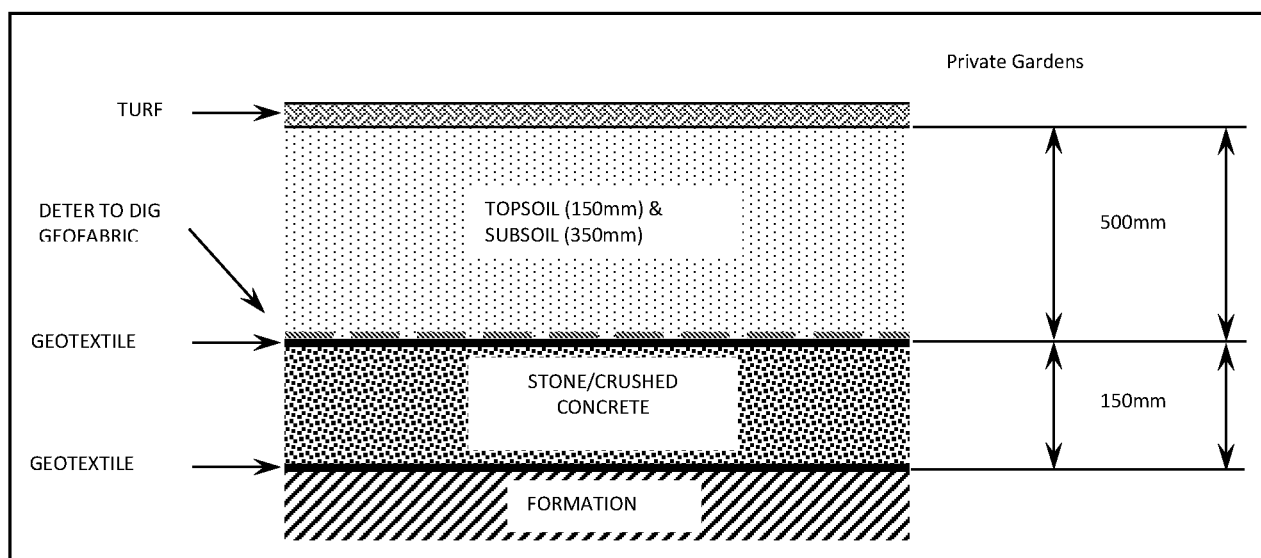
In areas remote from those designated for tree root protection it was recommended that the Made Ground beneath be removed or the site raised to a depth of 650mm and be replaced with chemically and geotechnically suitable material with a high visibility marker geotextile layer such as Terram High-Vis placed at the base between the imported soils and a capillary break layer comprising crushed stone or hardcore of 150mm and underlain by a further layer of Terram.

An example of the cover system for use in private gardens is provided below:

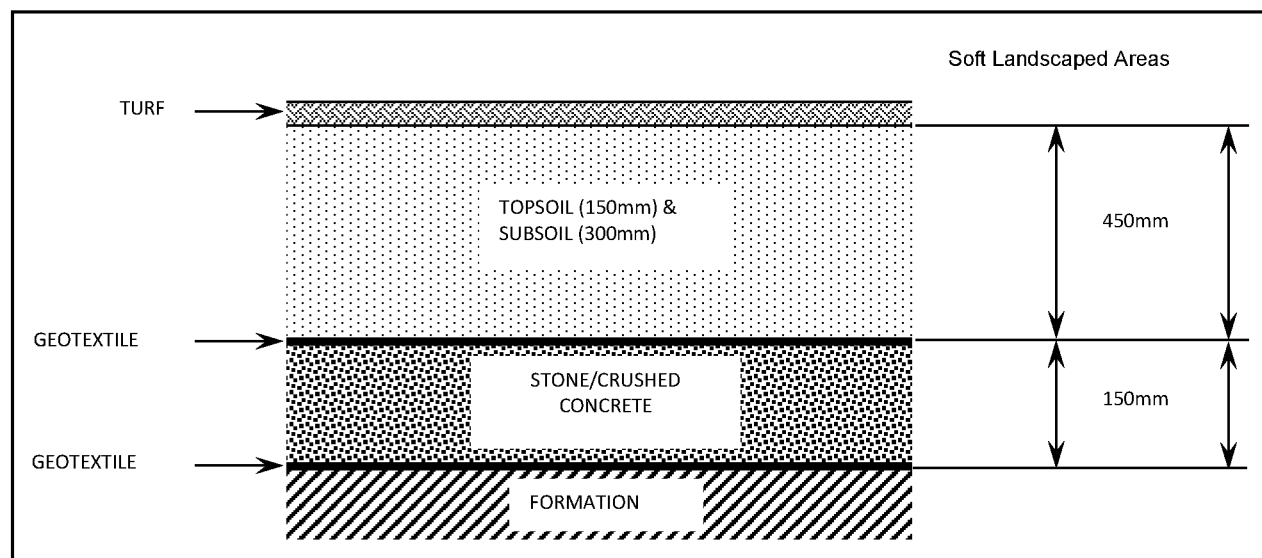
An example of the cover system for use in areas of soft landscaping is provided below:
