## **7.0 VERIFICATION**

| <b>Project:</b> | Cornfield Close, Littlehampton | | | <b>Title</b> | Site Location Plan | |

Project Title: Cornfield Close, Littlehampton

Title : Figure 2 - Exploratory Hole Location Plan

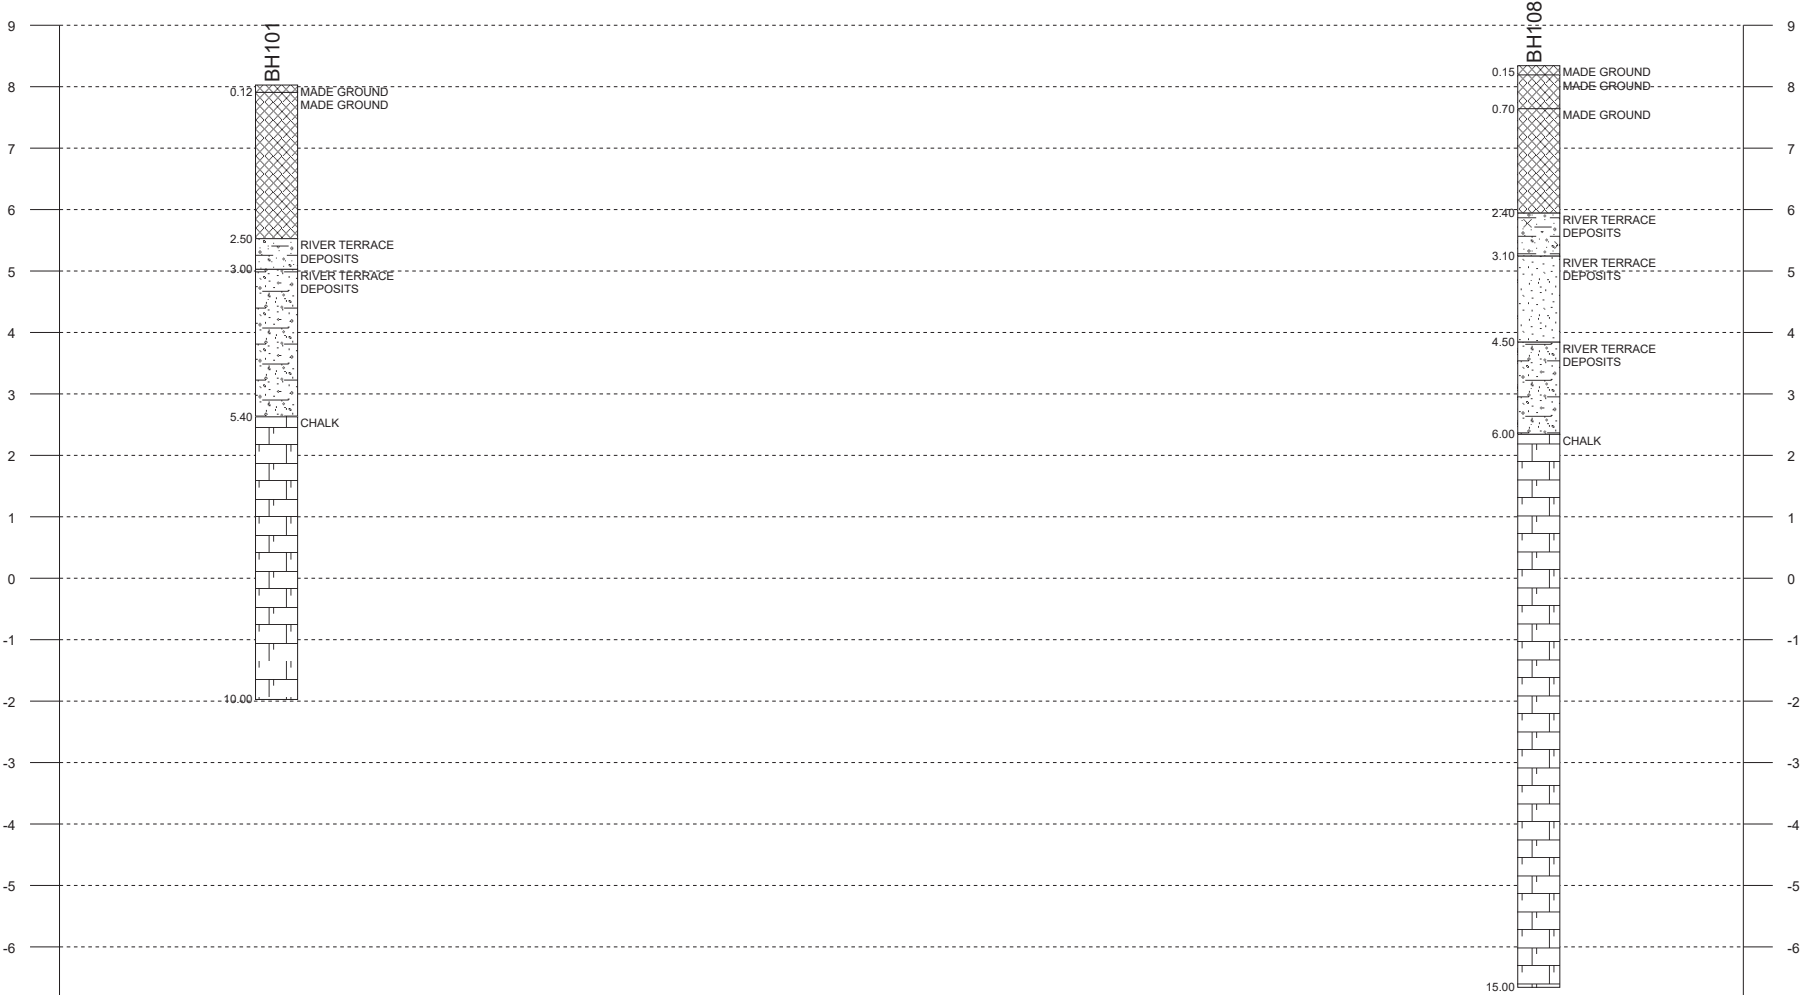
Title: Section line 4  
Vertical Scale: 1:123  
Horizontal Scale: 1:562  
Engineer: Anthony

- MADE GROUND
- Silty sandy gravelly CLAY
- Sandy gravelly CLAY
- SAND
- Clayey gravelly SAND
- CHALK
