**WATER QUALITY MANAGEMENT PLAN**

**CORNFIELD CLOSE, LITTLEHAMPTON**

**THAKEHAM CLIENT LIMITED**

| Reference: | GE18103-WQMP-NOV19 |

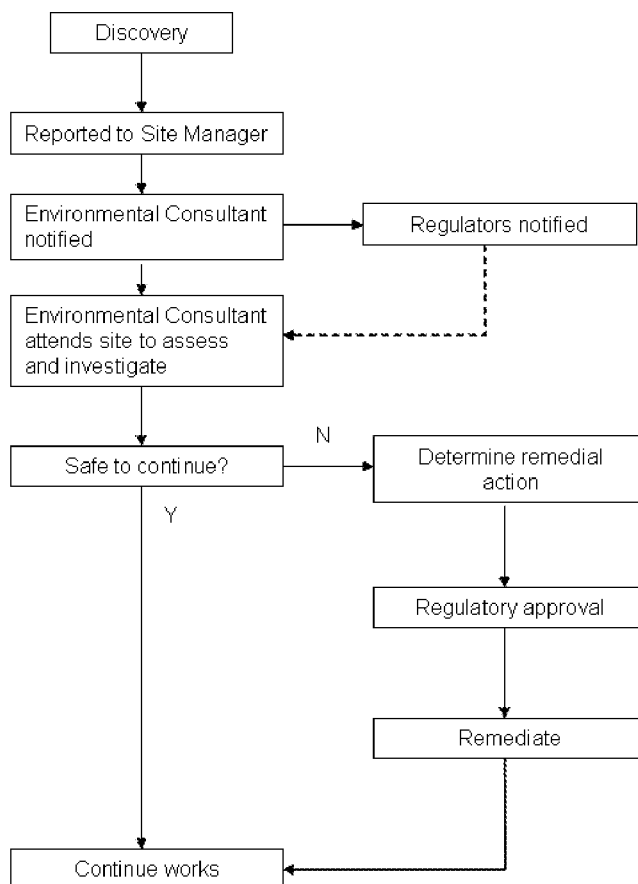
The process is summarised overleaf:

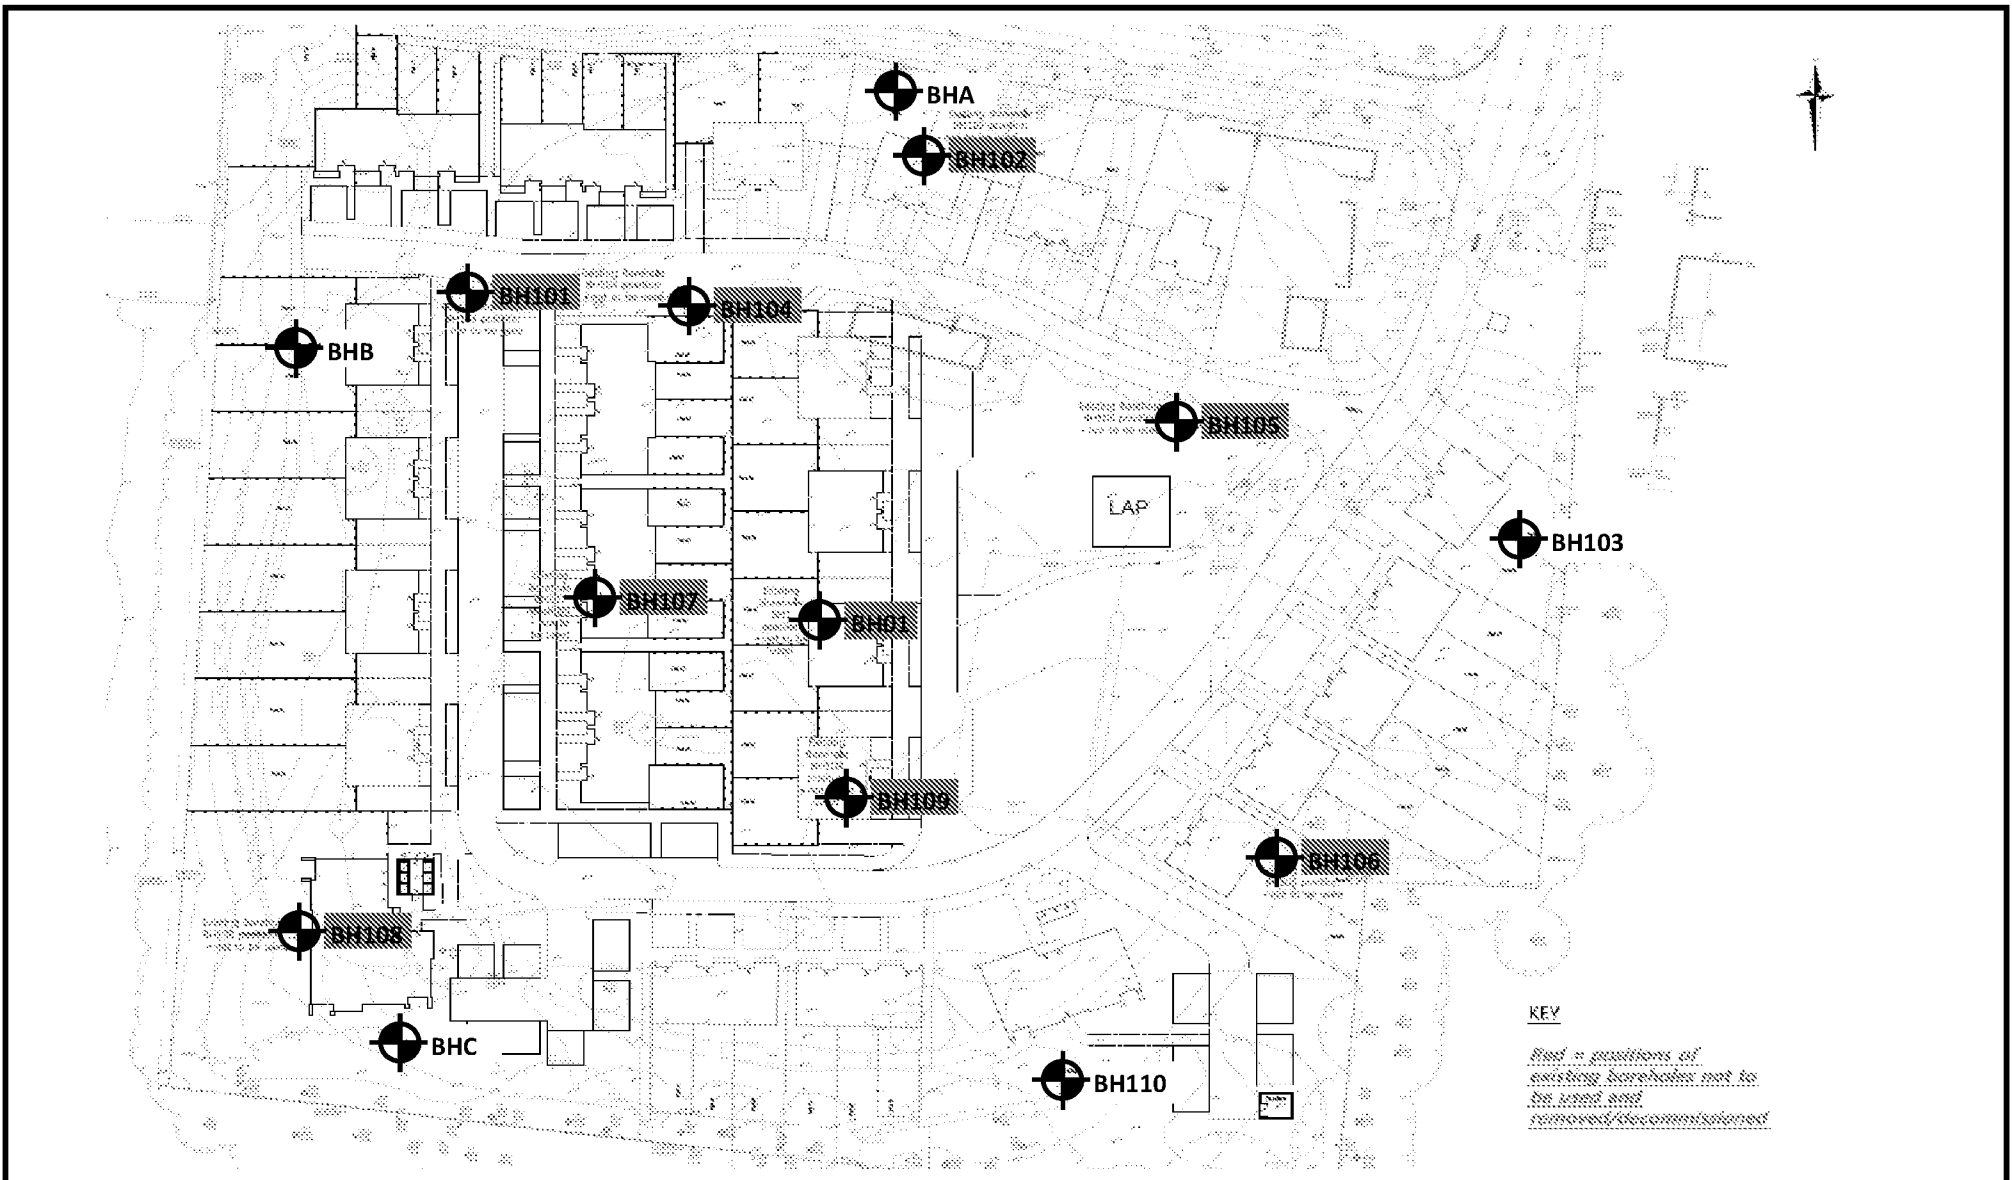
| <b>Project:</b> | Cornfield Close, Littlehampton, West Sussex | | | <b>Title</b> | Site Investigation Locations (GW Monitoring Locations) | |

In order to refine the conceptual site model for the site ten groundwater monitoring wells were installed on the site between the 13<sup>th</sup> August and the 24<sup>th</sup> August 2018 (BH101-BH110) to depths of between 10.0m and 15.0m bgl. A further three monitoring wells (BHA-BHC) were installed on the 23<sup>rd</sup> to the 27<sup>th</sup> May 2019 to depths of 10m bgl.

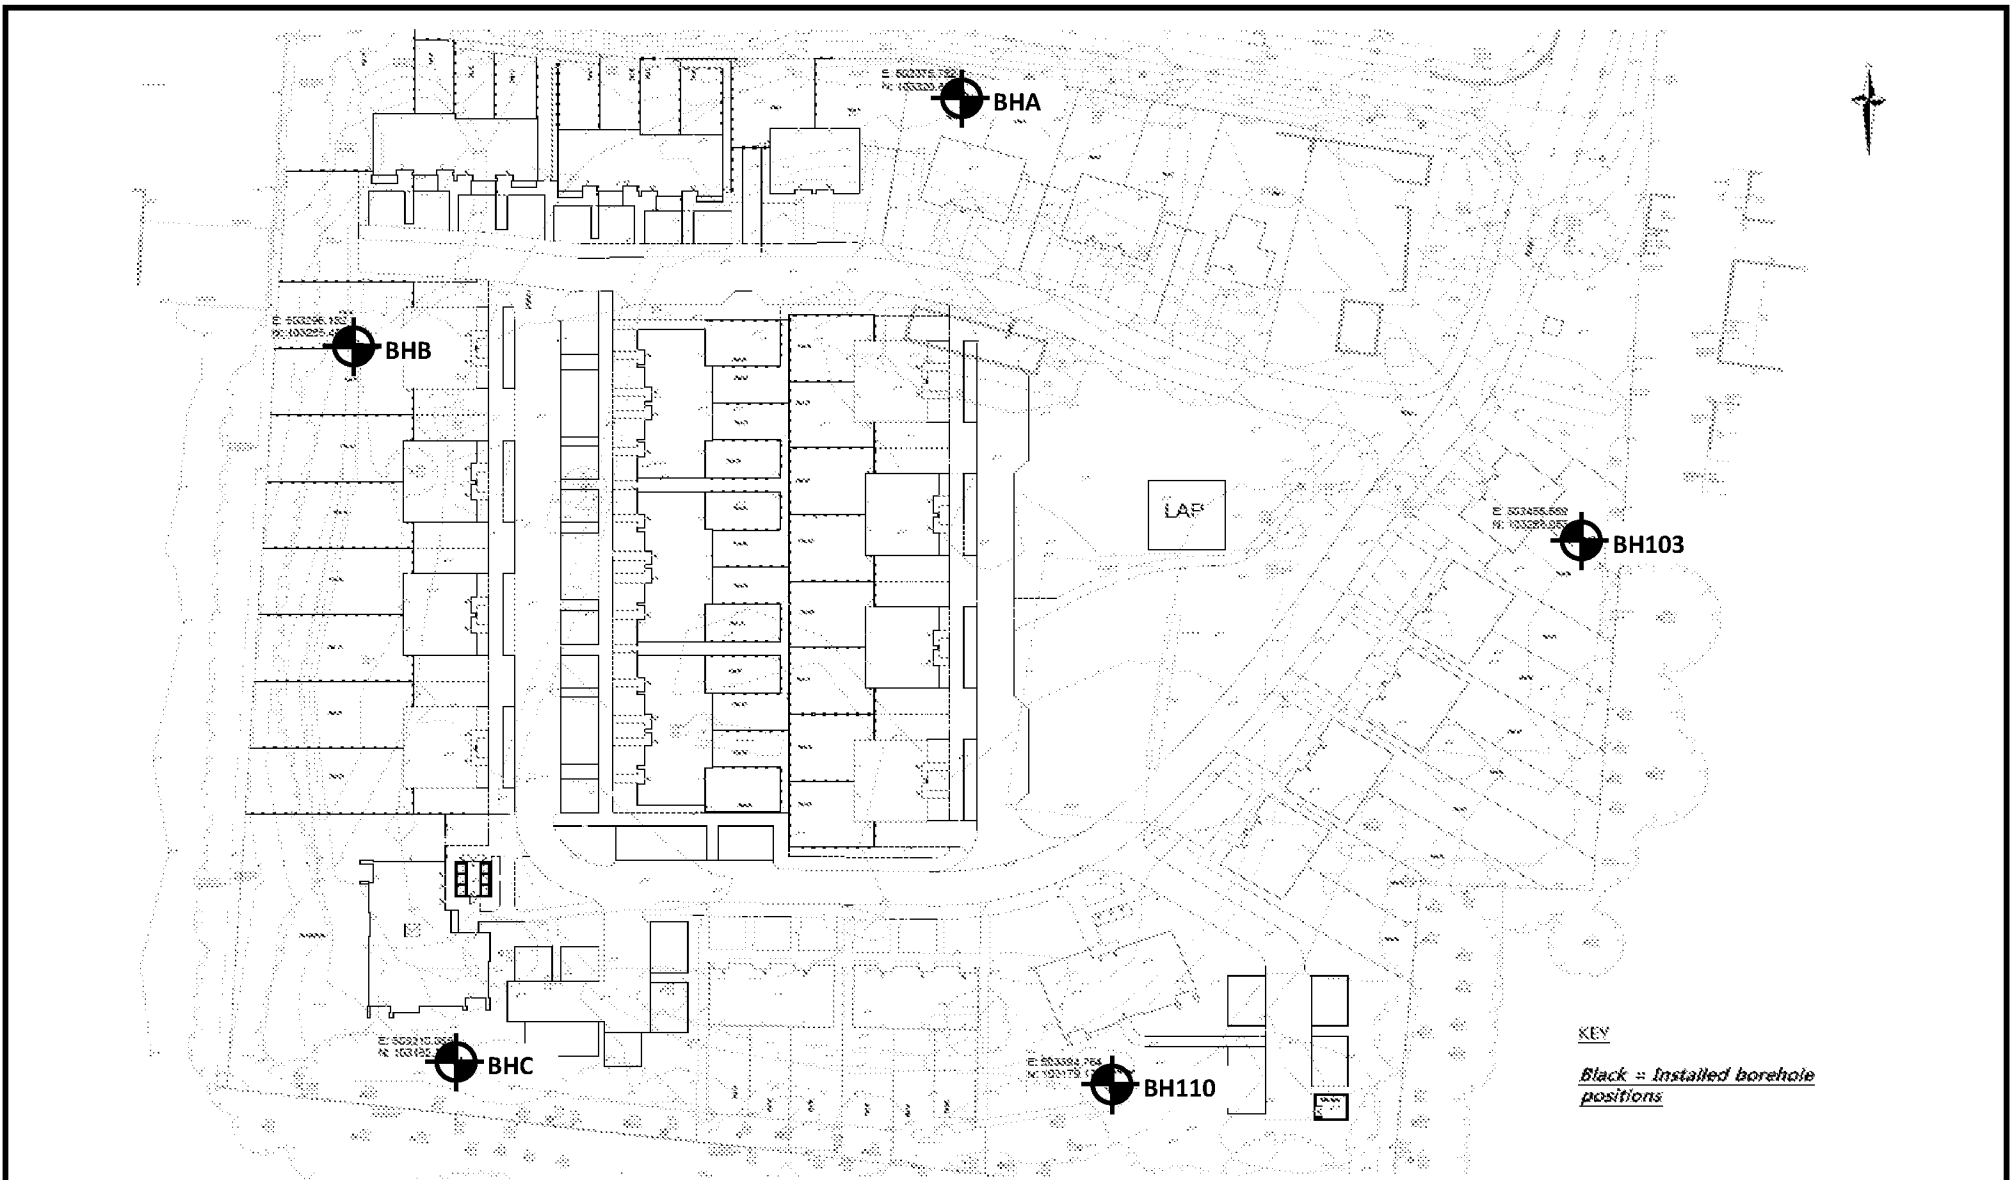
| <b>Project:</b> | Cornfield Close, Littlehampton, West Sussex | | | <b>Title</b> | Monitoring Well Locations (to remain during development) | |

Monitoring should be undertaken to include BH101 to BH110 and BHA-BHC which have been located in areas where access should remain possible in relation to the proposed development. Whilst it is appreciated that monitoring wells can get damaged on the site measures should be put in place to protect the wells. Where wells are located in the proximity of development works it is essential that the monitoring wells are protected and subsequently decommissioned in line with Environment Agency best practice to negate potential introduction of pathways for contaminate migration. To date BH1, BH101, BH01, BH105, BH106 and BH109 have been decommissioned. BH104, BH107 and BH108 are still to be decommissioned.

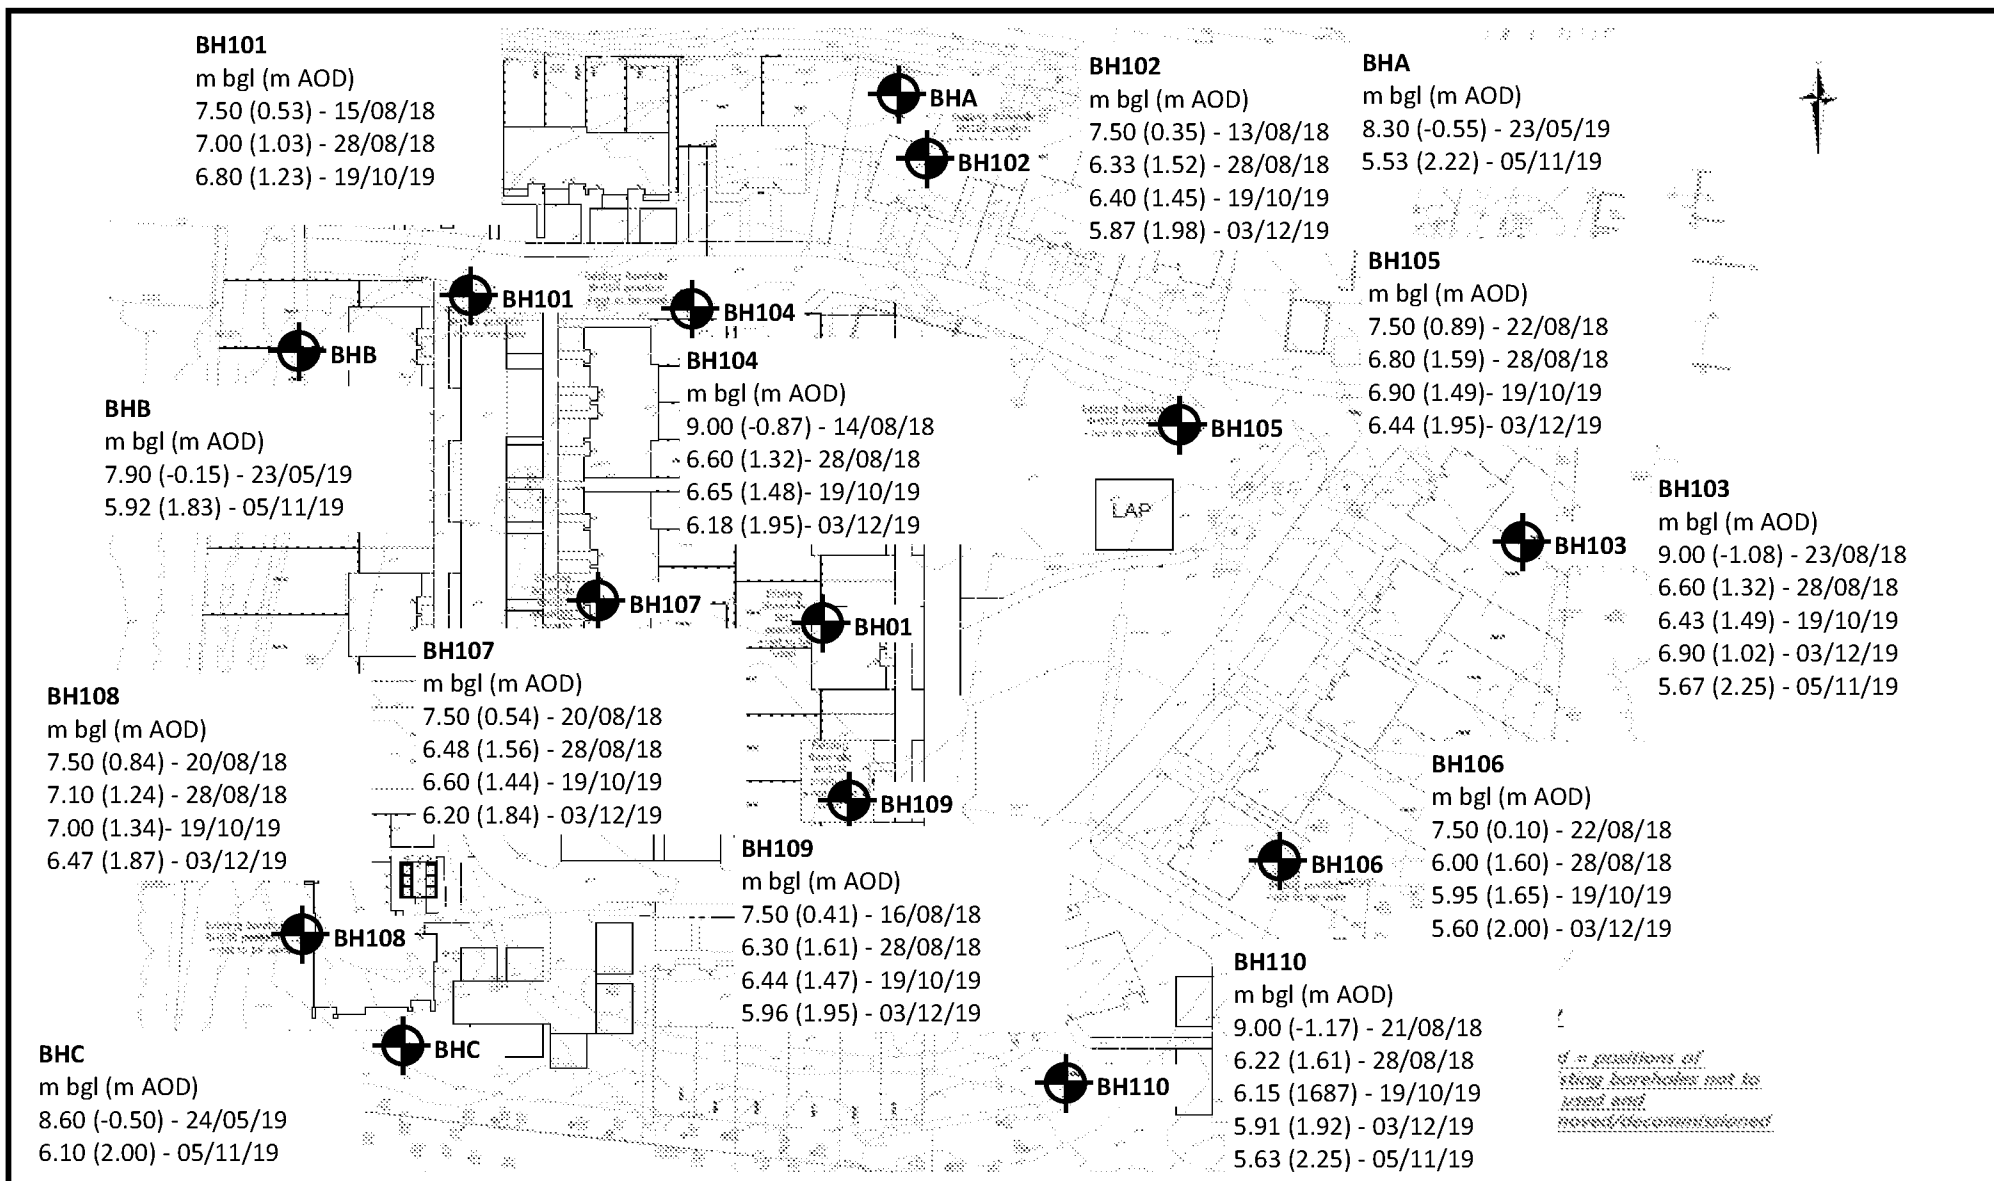
| <b>Project:</b> | Cornfield Close, Littlehampton, West Sussex | | | <b>Title</b> | Groundwater Levels | |

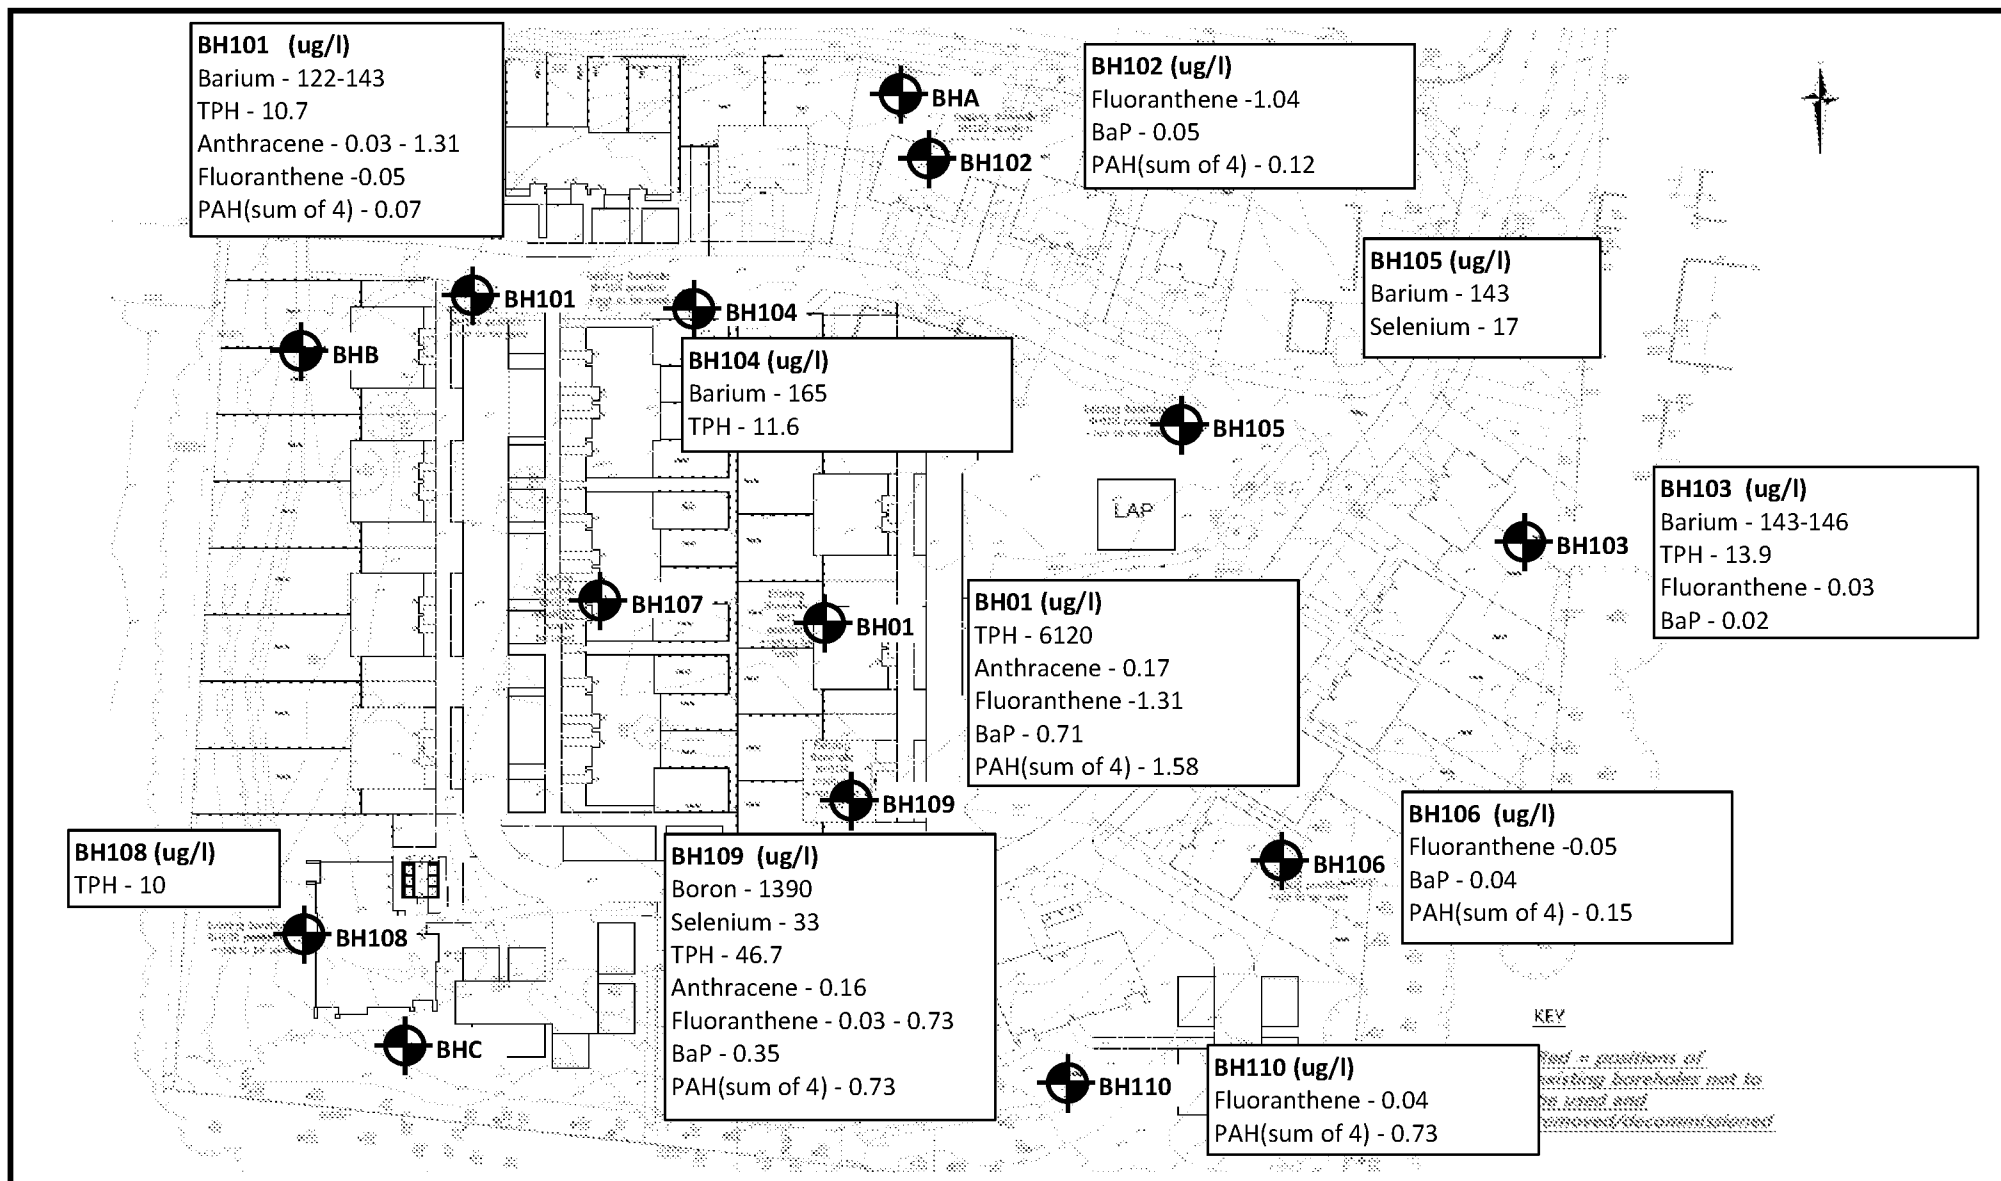
| <b>Project:</b> | Cornfield Close, Littlehampton, West Sussex | | | <b>Title</b> | Groundwater Contamination Levels | |

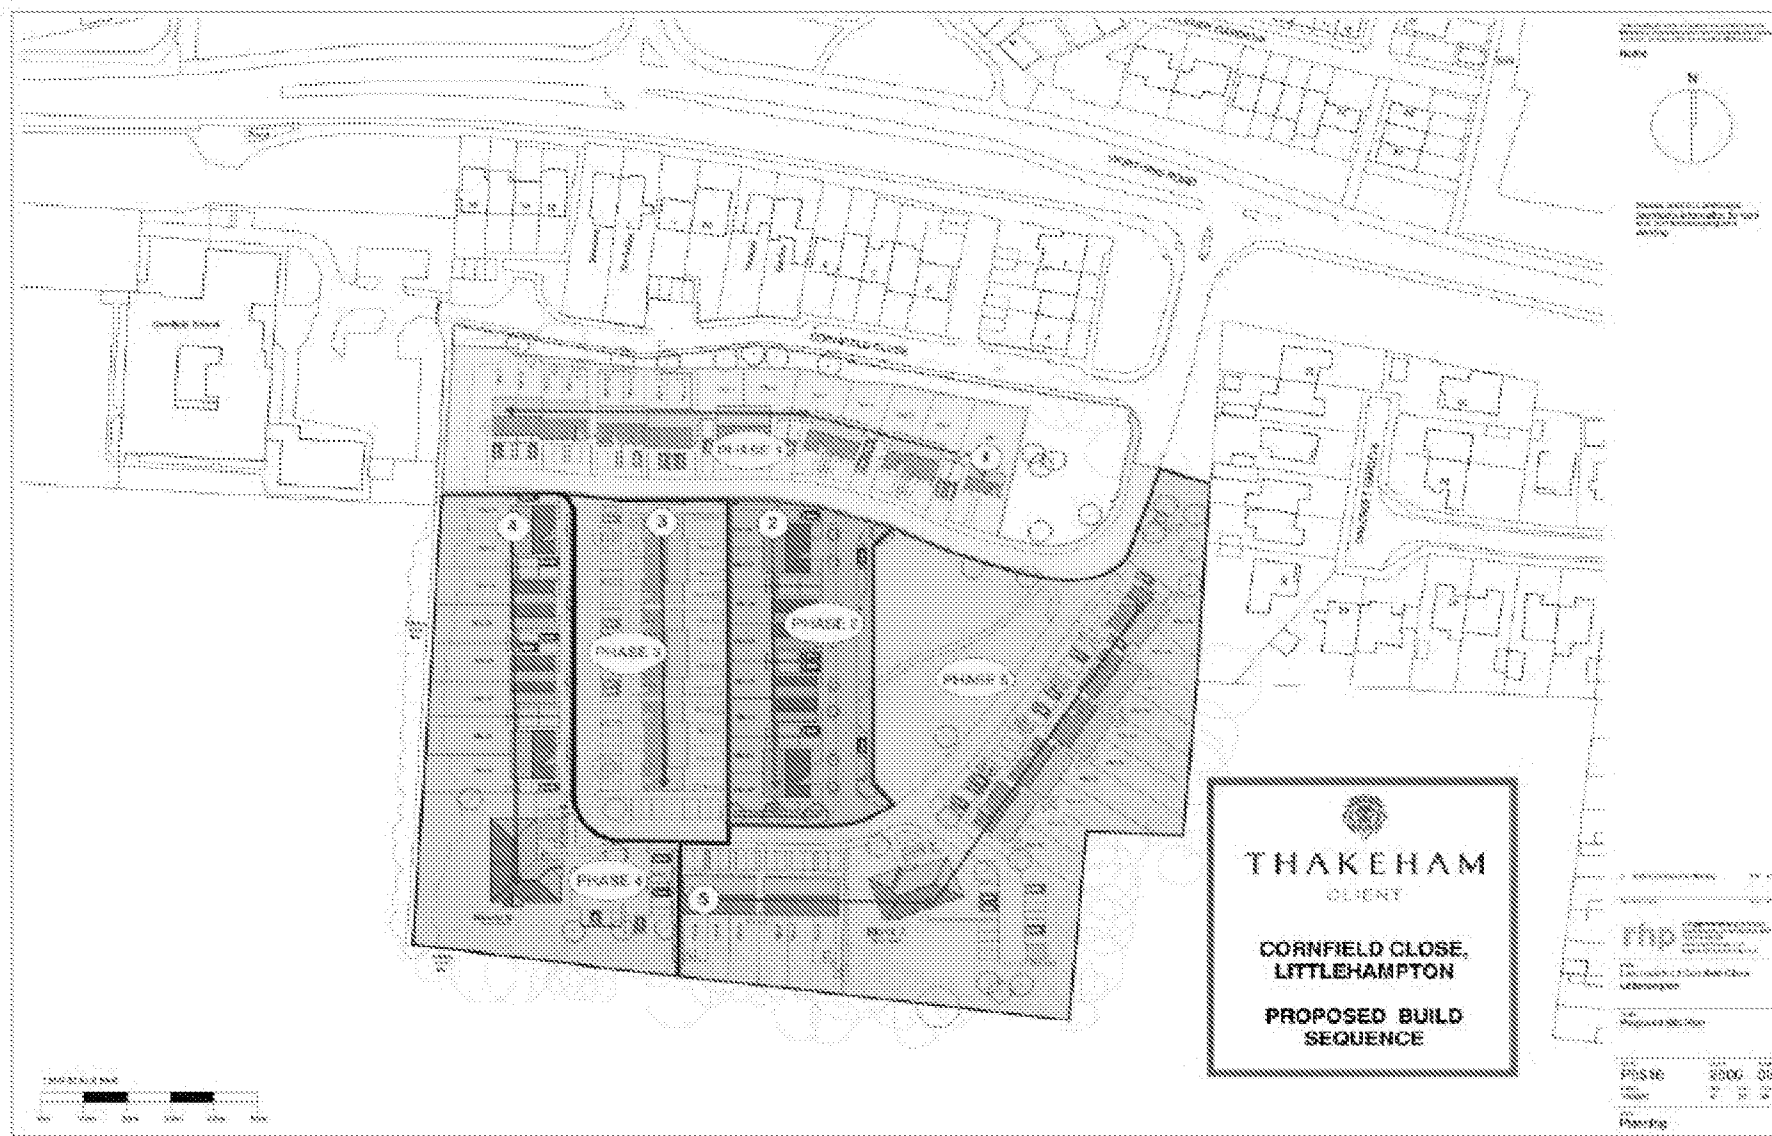
| <b>Project:</b> | Cornfield Close, Littlehampton, West Sussex | | | <b>Title</b> | Development Phasing Plan (Phase 1-5) | |

In term of the timetable for validation works, validation works will be undertaken at regular intervals following the completion of each element of the site works for each phase of development works to allow for a phased discharge of conditions and release of properties in relation to the site with a final validation report issued at the end of each phase and on completion of the development in order to formalise all the documentation on completion.
