# Former Waitrose, Avon Road, Littlehampton, West Sussex

Bat Survey

December 2018

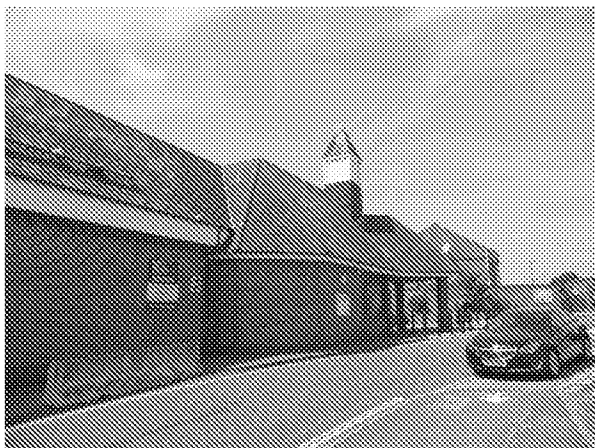
Exterior view north elevation

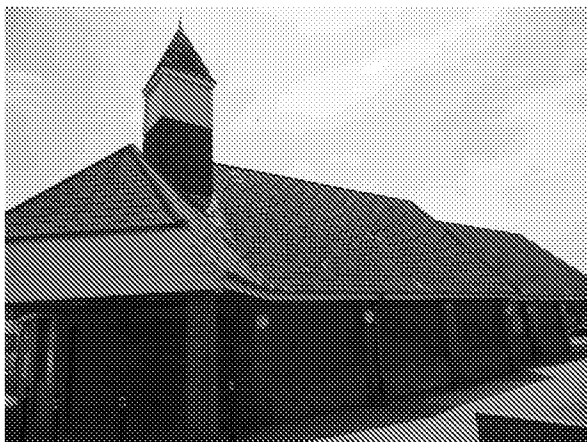
Exterior view western elevation

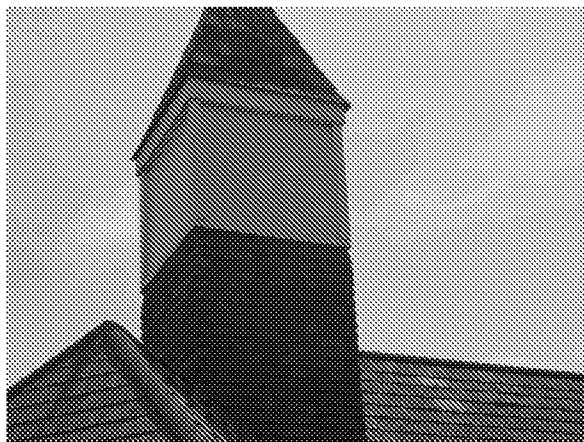
- ❖ Several raised/missing tiles on the hipped roof pitches recorded on the south and western aspects.

Clock tower, western aspect, missing/slipped hanging tiles

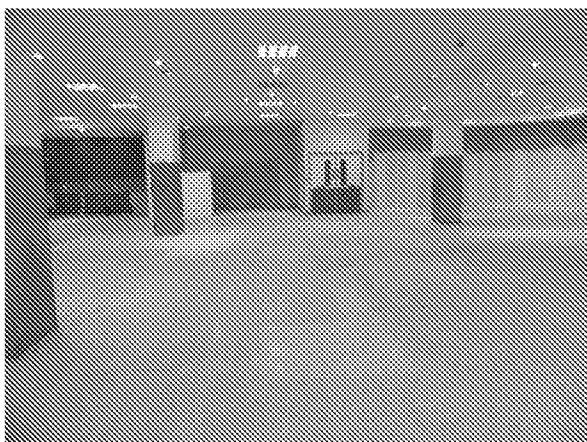
- 4.2.8 The ground floor predominantly consisted of the large open main store accommodation. The room had a suspended ceiling, plaster board walls and a concrete floor, all in generally sound condition and provided no potential roosting features for bats. A number of the ceiling tiles were broken or had been removed to gain access to the roof void. No evidence of roosting bats was found within this room.

Main ground floor shop space

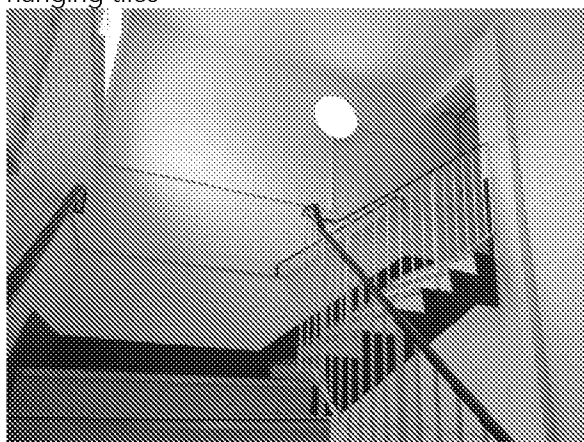
Connecting stairwell

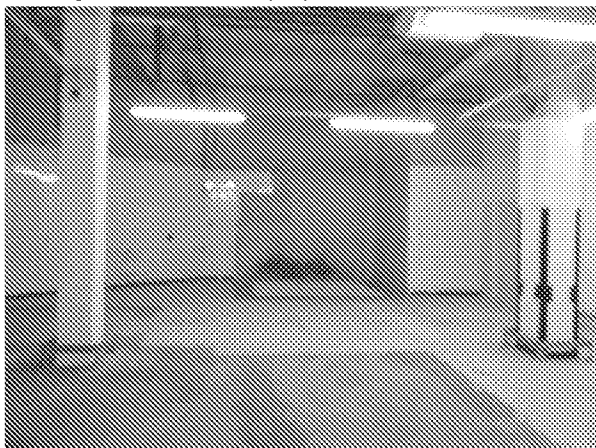
- 4.2.13 The first floor predominantly consisted of a large open main storage room. The room had a corrugated metal ceiling, concrete floor and a mix of tile, plasterboard and brick walls. The construction was sound and provided no potential roosting features for bats. No evidence of roosting bats was found within this room.
- 4.2.14 The remainder of the upper floor was made up of a number of interconnected rooms, including cleaning stores, offices, corridors, and a CCTV room. These areas were located behind closed doors, they had a mixture of concrete and carpeted floors, painted brick walls, and suspended ceilings. No evidence of roosting bats was found within any of these spaces.

Upper floor, main internal storage room

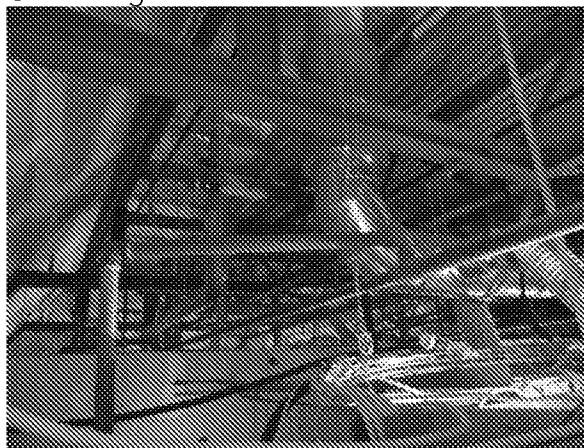
- 4.2.15 Two roof voids were accessed during the assessment. The void within the clock tower was not accessible. Roof void 1 was a large space, covering most of the western section of the building, and was approximately c.2m in height. It was accessed from three locations on the ground floor in the western section of the building via broken/removed tiles in the suspended ceiling. The void had a flat metal corrugated roof. No lining was present and there was considerable pipe work and many steel joists present within the void, making it heavily cluttered and unsuitable for species which prefer internal flight space. There was no observable evidence of bats within this roof void.

Roof void 1, very cluttered
