**RE: Soil Infiltration Testing- Arun District Council**

I write following the completion of additional soil infiltration investigation undertaken on the 27<sup>th</sup> and 28<sup>th</sup> February 2014 at four locations within the residential area of Wick, Littlehampton. The works have been carried out to assist with assessment of the soil soakage potential for each location in respect to the proposed planning applications for the area.

Project:  
 WICK ESTATE, LITTLEHAMPTON

Drawing:  
 TEST LOCATION PLAN

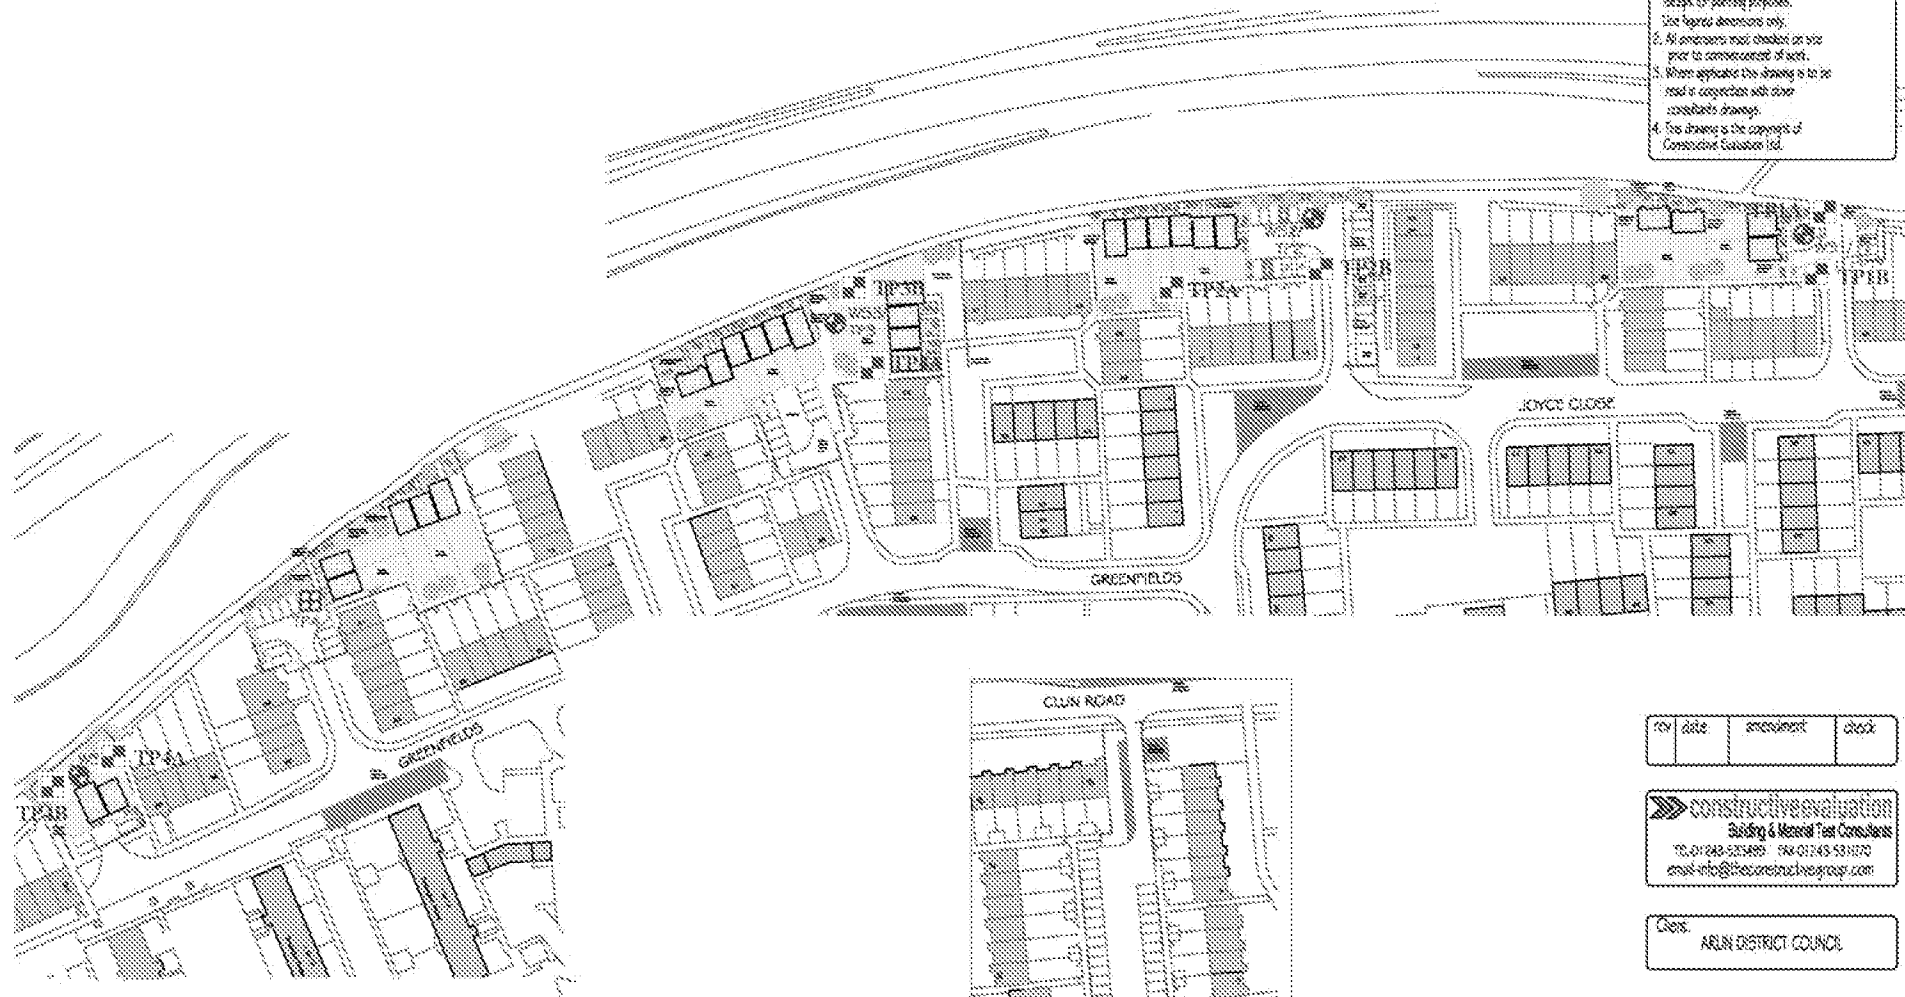
Please find enclosed full log details along with the site plan showing the test locations (superimposed on the previous hole location plan).

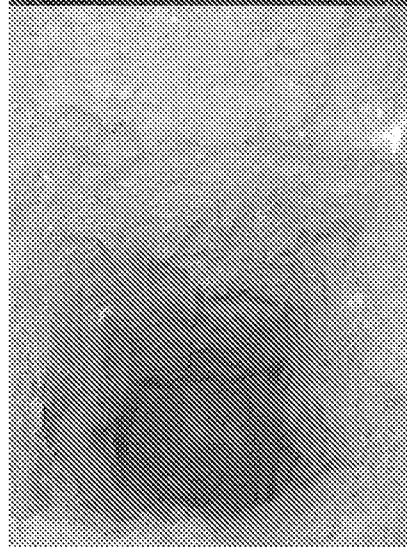
| <b>Trial Pit</b> | <b>Depth (mbgl)</b> | <b>Infiltration Rate (m/s)</b> | <b>Comments</b> |
|---|---|---|---|
| TP1B | 1.20 | $4.6 \times 10^{-5}$ | This is result from third test completed to 25% fill depth |

Again (as in the previous infiltration testing) the best results were seen towards the east of the housing area at the Joyce Close site where ‘good’ soil infiltrations to 1.20m depth were recorded (TP1B).

Subsequently it was possible to repeat the test within TP1B for second and third time with a final infiltration rate of  $4.6 \times 10^{-5}$  m/s calculated.

- A. TP1A Joyce Close
- B. TP1A Joyce Close
- C. TP1B Joyce Close
- D. TP1B Joyce Close

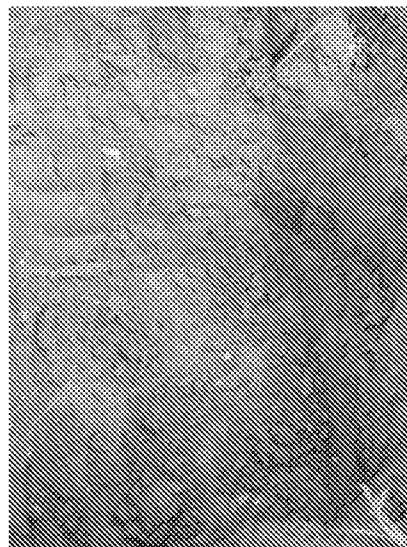
| <b>Trial Pit</b> | <b>Depth (mbgl)</b> | <b>Infiltration Rate (m/s)</b> | <b>Comments</b> |
|---|---|---|---|
| TP4A | 0.45 | N/A | Water level fell to only 96% fill depth after 371mins |

- M. TP4A Land West of Greenfields
- N. TP4A Land West of Greenfields
- O. TP4B Land West of Greenfields
- P. TP4B Land West of Greenfields
