Hastoe Housing Association – Marina House,  
17 Marina Place,  
Hampton Wick,  
Kingston upon Thames,  
Surrey,  
KT1 4BH

**RE: Soil Infiltration Testing- Arun District Council**

13.7841 – Wick, Littlehampton

Project.  
 WICK ESTATE, LITTLEHAMPTON

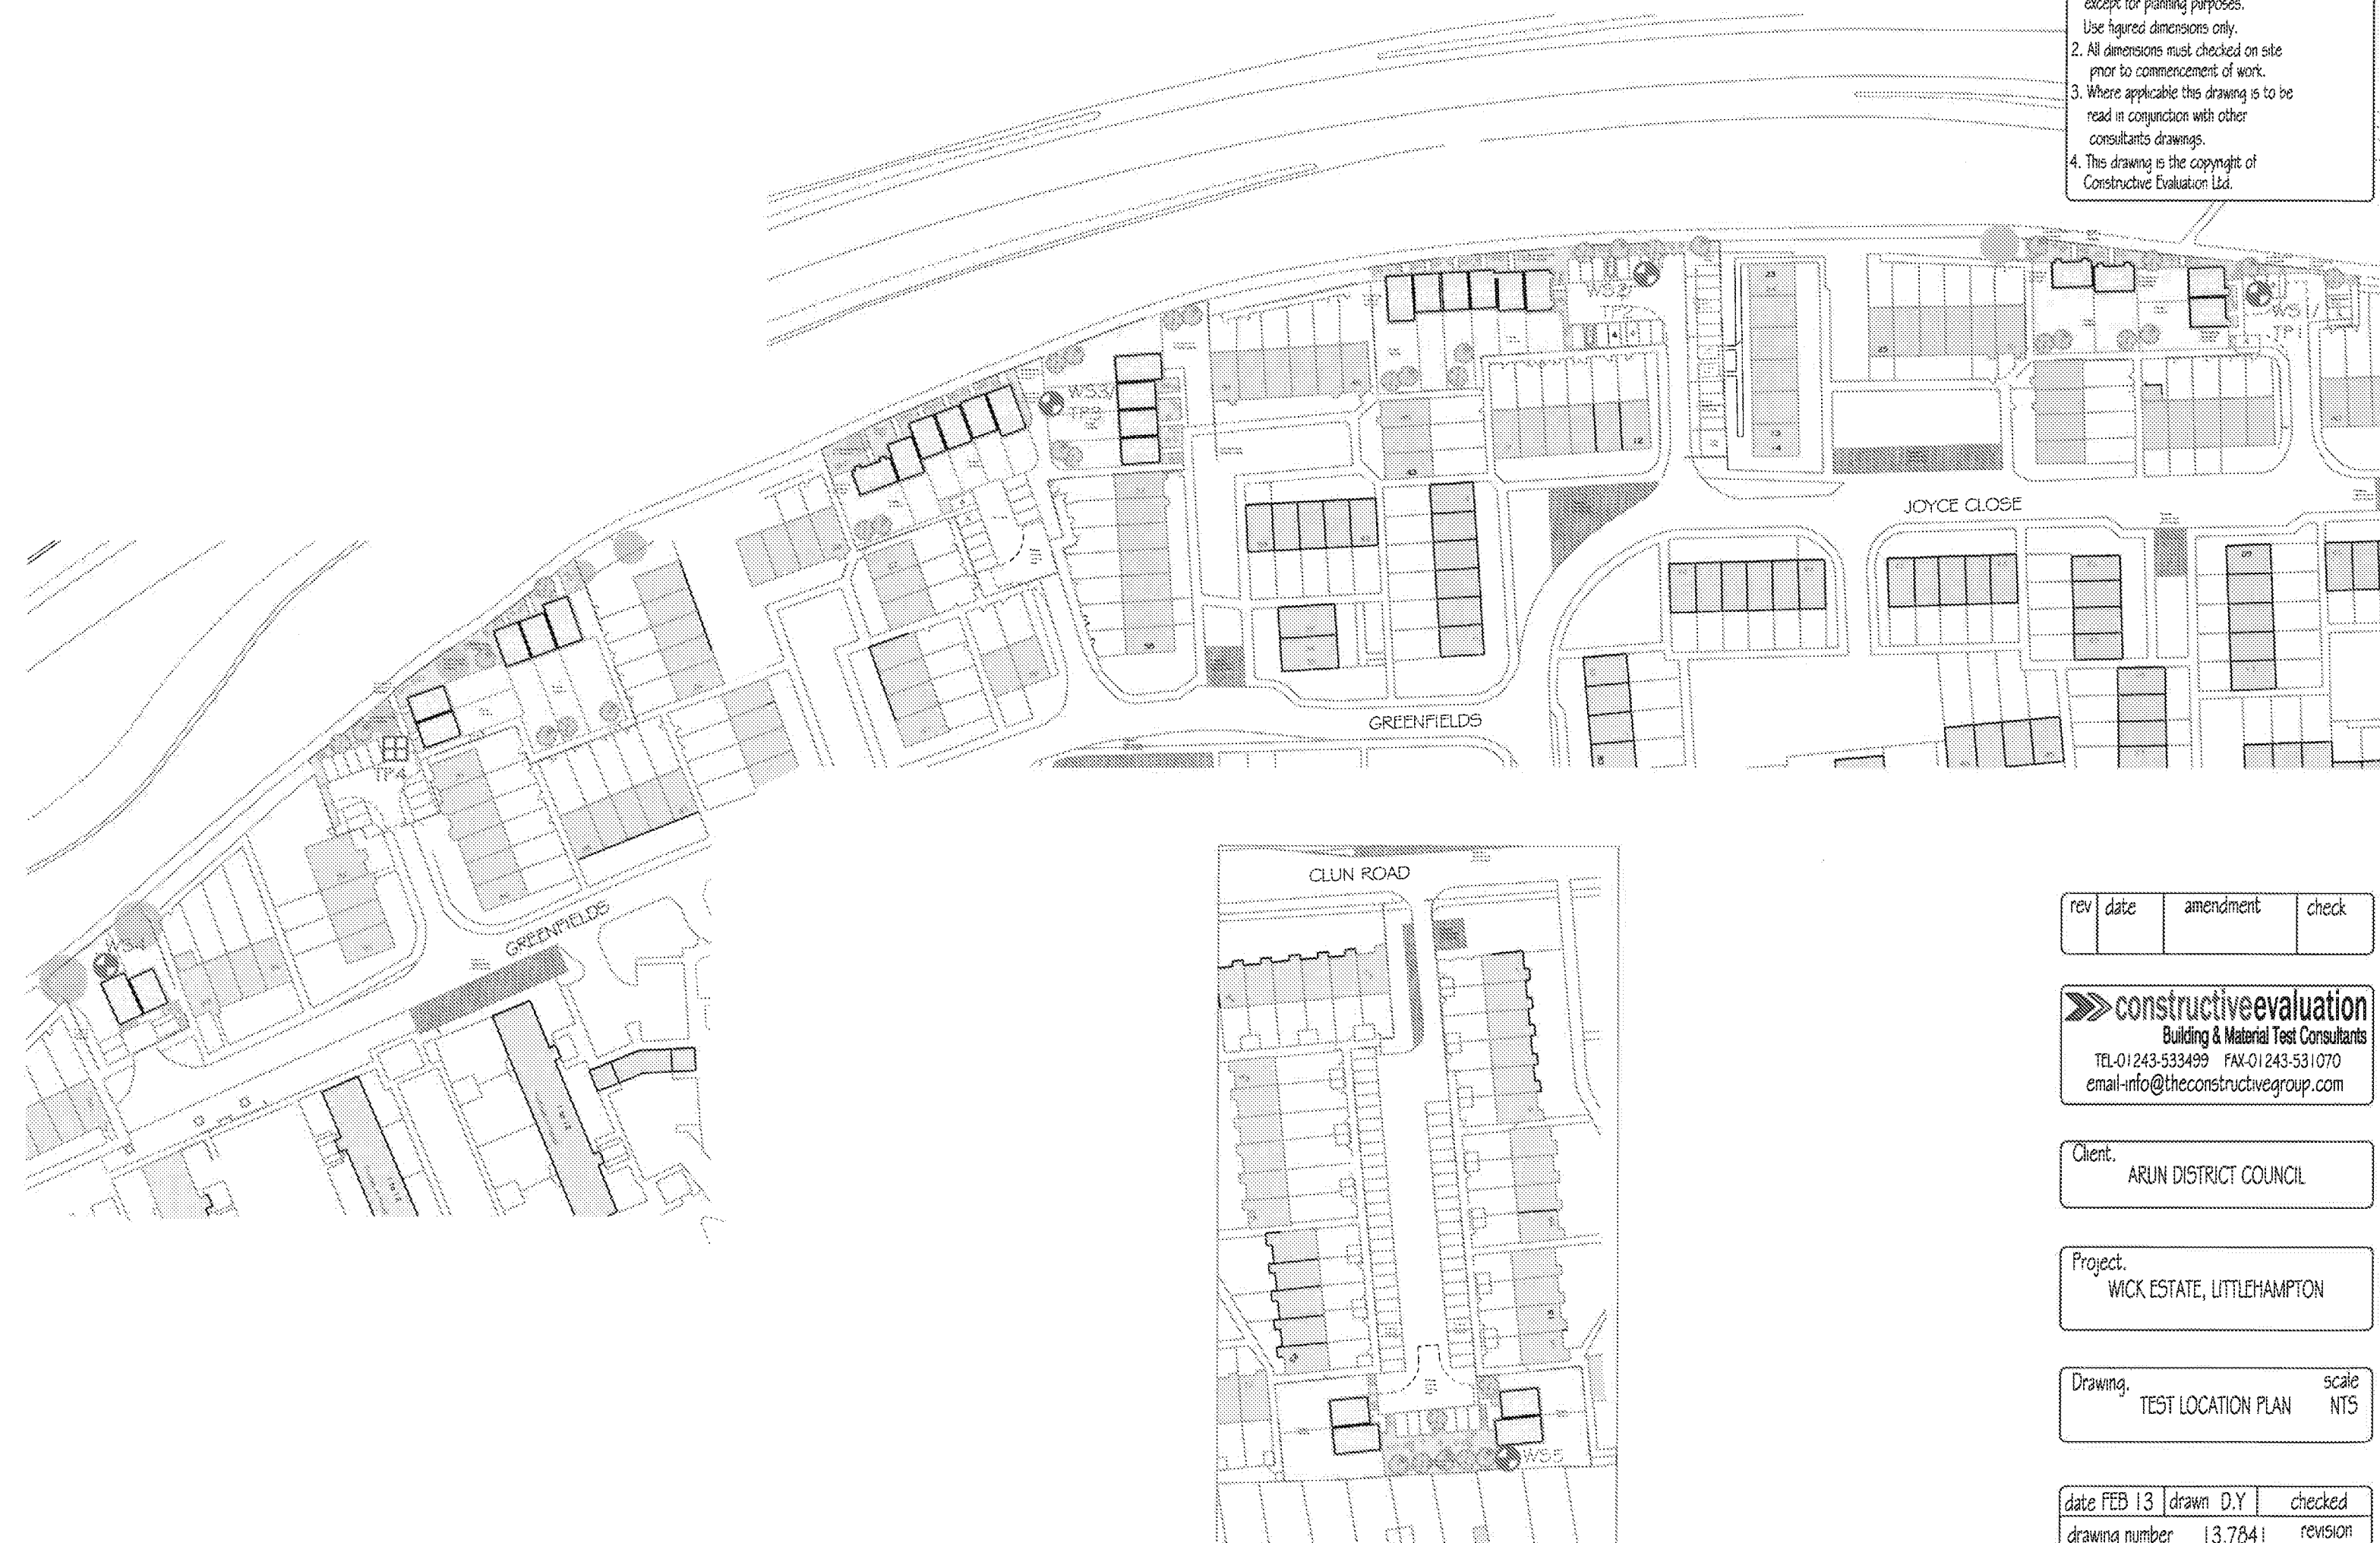
Drawing.  
 TEST LOCATION PLAN

No groundwater was encountered within any of the trial pits. Please find enclosed full log details along with the hole location plan.

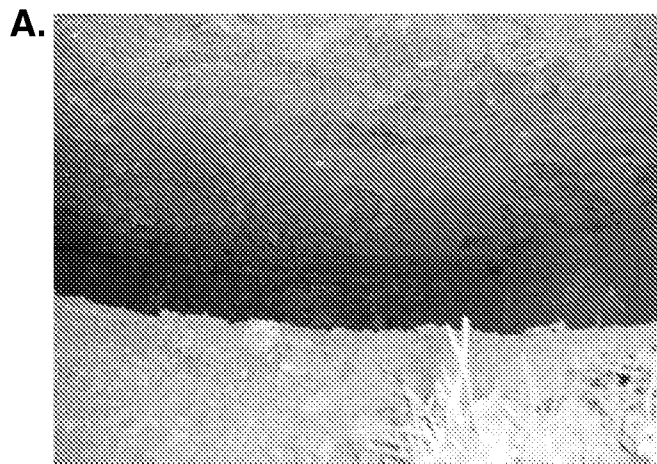
Within TP1 to TP3, which were completed adjacent to WS1 to WS3 locations respectively, the ground conditions encountered were generally consistent with those previously described. In summary a thick deposit of upper cohesive clay deposits were encountered with a change in soils towards the base of the trial pits. These latter changes were described as a cream/light brown gravely clayey Silt in TP1 at approximately 2.20mbgl, a silty fine to medium Sand at 2.10mbgl in TP2 and a fine to medium silty Sand at 2.20mbgl in TP3.

- A. TP1 GL – 2.60mbgl
- B. TP1 Basal material from pit
- C. TP2 GL – 2.70mbgl
- D. TP2 Basal material from pit

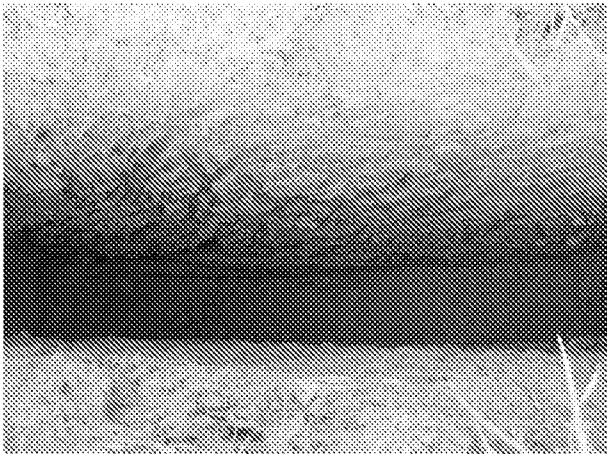
- E. TP3 GL – 2.70mbgl  
F. TP3 Material from excavation

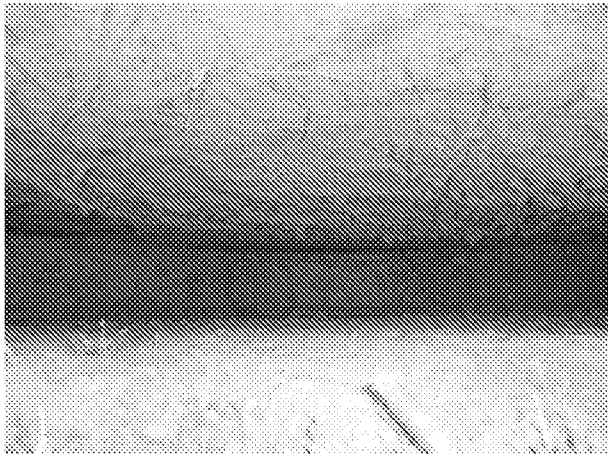
Within TP4 location soil deposits were consistent to the maximum excavation depth of 2.65mbgl and described as light brown silty Clay.

I. TP4 GL – 2.65mbgl

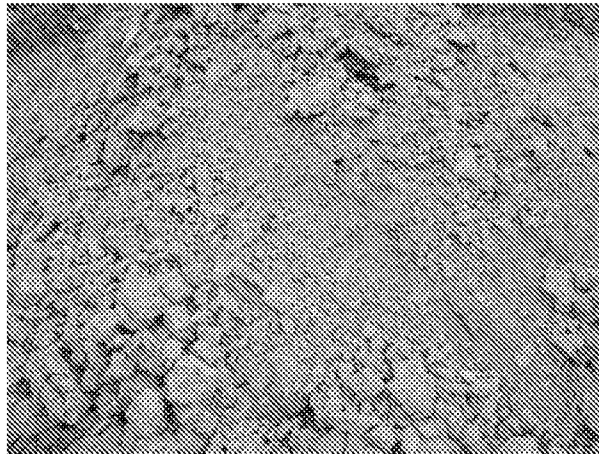
J. TP4 Material from pit

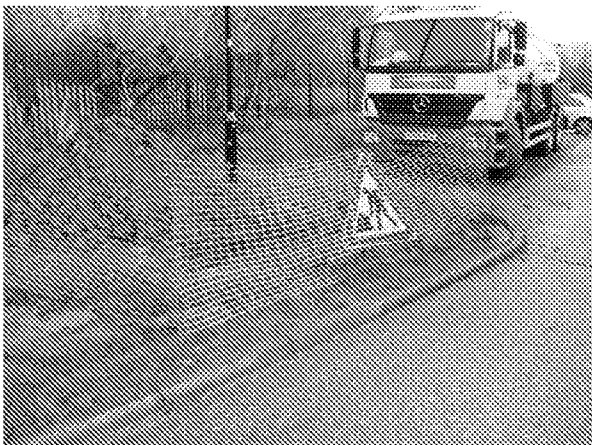
Prior to any excavations taking place a CAT (Cable Avoidance Tool) was used to check for any underlying electrical services. In addition the service plans provided to CE were consulted prior to commencing works. The excavations were completed using a 3tonne tracked excavator with a 0.30m width bucket size. Length of excavations ranged between 1.80m and 2.50m.

- M. Example site set up TP4
- N. Rapid infiltration of clean water from road tanker
- O. Infiltration monitoring

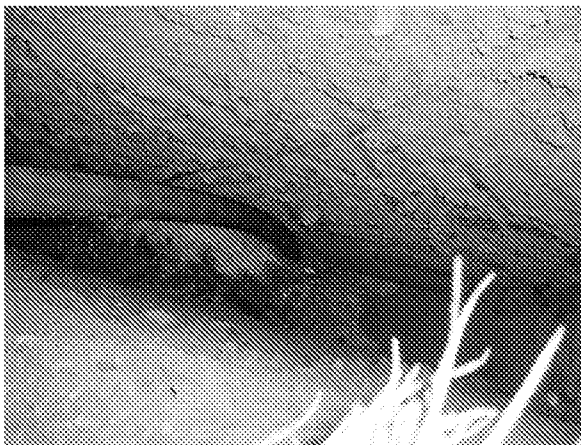
N.

Testing was completed in accordance with the methods described in BRE Digest 365 and after trimming and shaping the trial pit sides the pit were rapidly filled with clean water from a road tanker.

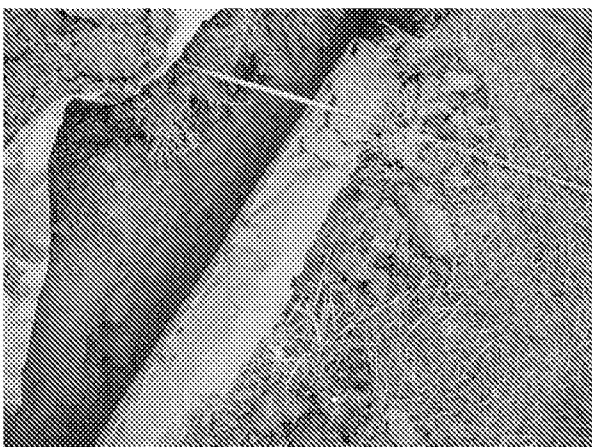
O.

Following monitoring periods that ranged from 192minutes up to 349minutes it was evident that the rate of infiltration rate was decreasing over time to such that water levels were unlikely to reach 25% fill depth. TP1 dropped most significantly to a level of 41% fill depth which calculates to infiltration rates from 75-50% fill depth of the order of  $5 \times 10^{-6}$  m/s reducing to  $2.5 \times 10^{-6}$  m/s from 50% - 41% fill depth. In all other tests fill depths between 71% to 88% only were reached describing even slower rates obtainable.
